DAILY FIELD REPORT

Project	Former A&A Brake Service Site	Report No.	105
BCP Site	NYSDEC BCP SITE C224372	Date	1/21/2025
Location	558 Sackett Street	File No.	0206384
Client	Sackett Heights LLC	Temperature	H: 20 °F L: 13 °F
Contractor	Blue Sky Builders, International Concrete	Wind Direction	W to E, up to 17 mph
Weather	Overcast	Personnel on Site	George Poulton
Humidity	51%	Time on Site	6:30 am to 4:45 pm

WEEKLY MONITORING REPORT

Weekly Monitoring
1/21/2025 - 1/21/2025

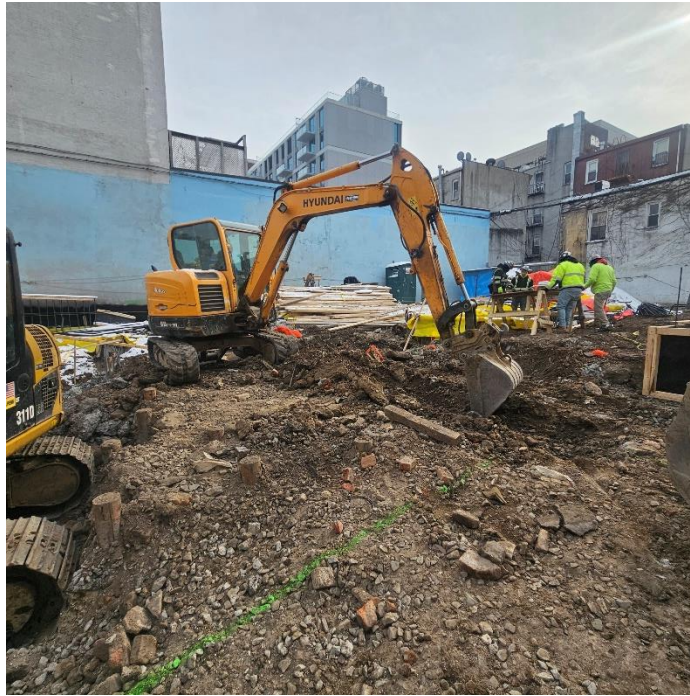
Photo 1: View of contractor grading site Soils, facing Southeast.

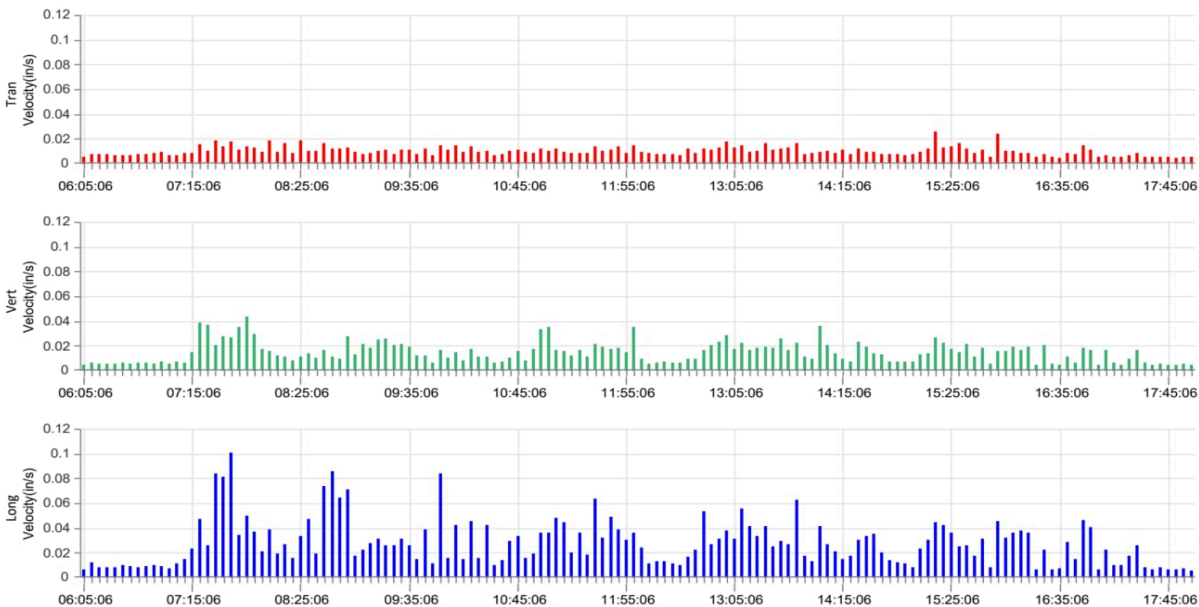
USBM R18507 And OSMRE
Velocity versus Frequency (Zero Crossing)

Tran	Vert	Long
0.0258 in/s	0.0431 in/s	0.1002 in/s
10.9 Hz	20.5 Hz	11.6 Hz
Jan 21, 2025	Jan 21, 2025	Jan 21, 2025
15:15:06	07:50:06	07:40:06
✓ Passed	✓ Passed	✓ Passed
7.1 Hz	7.5 Hz	7.3 Hz
5.1	4.9	4.6

Peak Vector Sum 0.1004 in/s at January 21, 2025 07:40:06

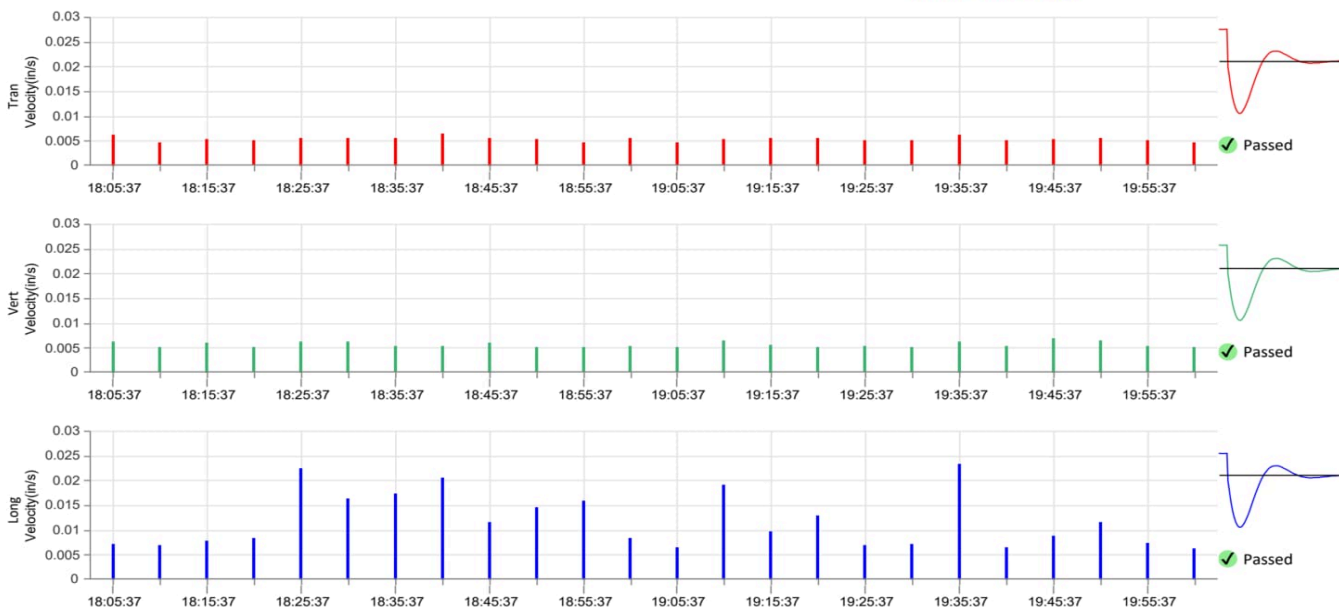
USBM R18507 And OSMRE
Velocity versus Frequency (Zero Crossing)

0.0238 in/s at January 21, 2025 19:35:37
