# DAILY FIELD REPORT

<b>Project</b>	Former A&A Brake Service Site	<b>Report No.</b>	106
<b>BCP Site</b>	NYSDEC BCP SITE C224372	<b>Date</b>	1/22/2025
<b>Location</b>	558 Sackett Street	<b>File No.</b>	0206384
<b>Client</b>	Sackett Heights LLC	<b>Temperature</b>	H: 21 °F L: 13 °F
<b>Contractor</b>	Blue Sky Builders, International Concrete, A1 Waterproofing	<b>Wind Direction</b>	NW to SE, up to 18 mph
<b>Weather</b>	Overcast	<b>Personnel on Site</b>	George Poulton
<b>Humidity</b>	42%	<b>Time on Site</b>	6:30 am to 5:00 pm

## WEEKLY MONITORING REPORT

**Weekly Monitoring**  
1/22/2025 - 1/22/2025

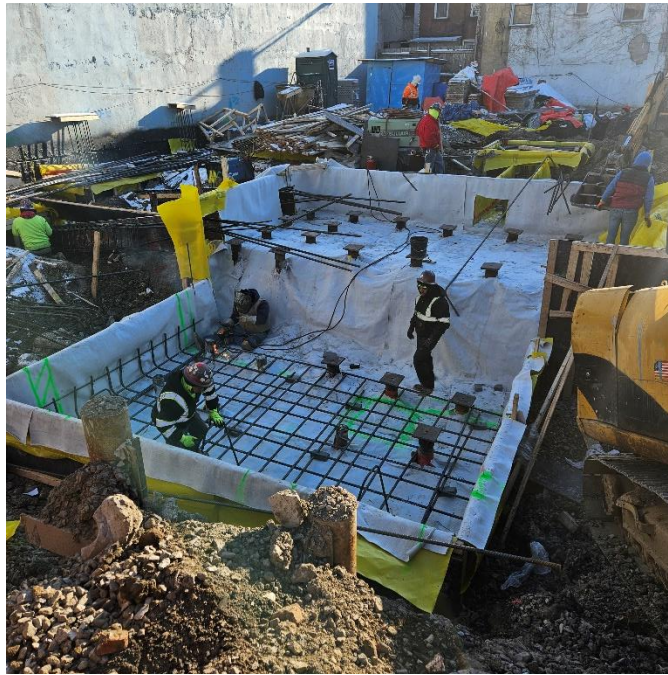
*Photo 1: View of contractor installing rebar for footing forms, facing Southeast.*

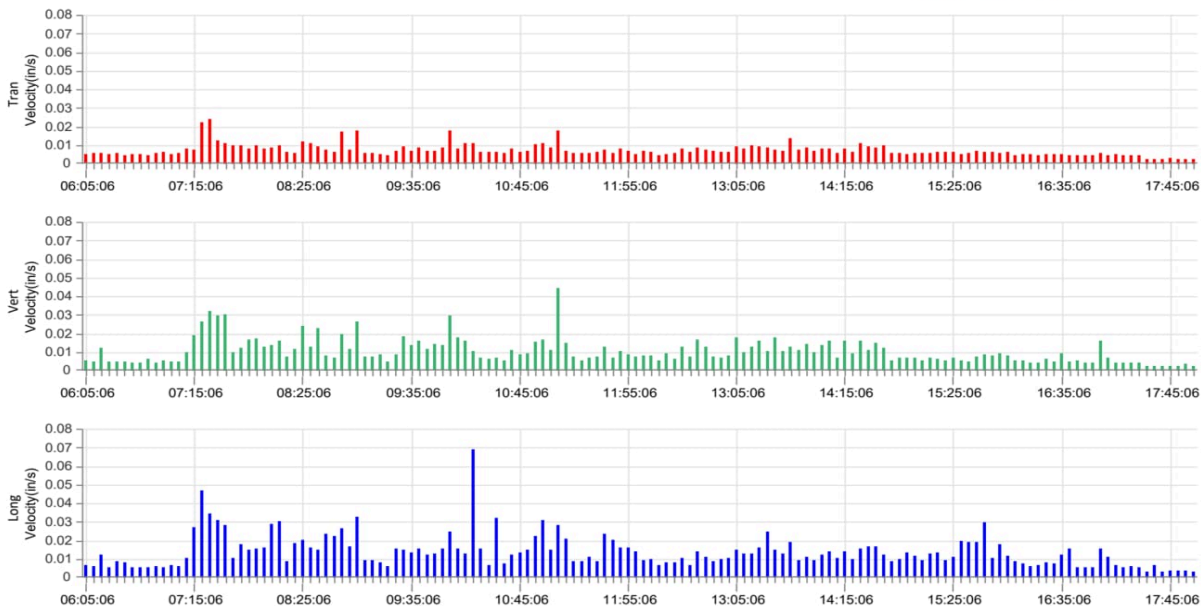
USBM R18507 And OSMRE  
Velocity versus Frequency (Zero Crossing)

Peak Vector Sum 0.0691 in/s at January 22, 2025 10:15:06
