DAILY FIELD REPORT

Project	Former A&A Brake Service Site	Report No.	107
BCP Site	NYSDEC BCP SITE C224372	Date	1/23/2025
Location	558 Sackett Street	File No.	0206384
Client	Sackett Heights LLC	Temperature	H: 29 °F L: 19 °F
Contractor	Blue Sky Builders, International Concrete, A1 Waterproofing	Wind Direction	SW to NE, up to 17 mph
Weather	Overcast	Personnel on Site	George Poulton
Humidity	43%	Time on Site	6:30 am to 6:00 pm

WEEKLY MONITORING REPORT

Project Address:
558 Sackett Street,
Brooklyn,
Brooklyn NY 11215
BBL:/443/55

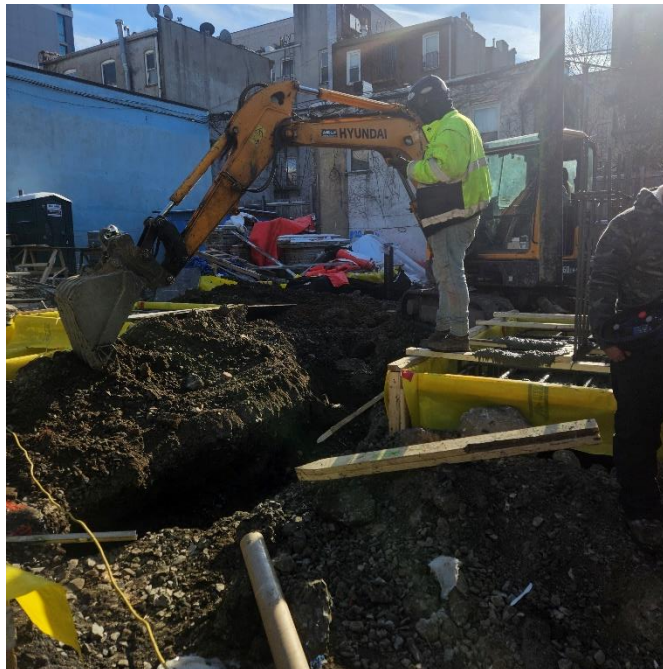
Photo 2: View of contractor grading Site soils, facing Southeast.

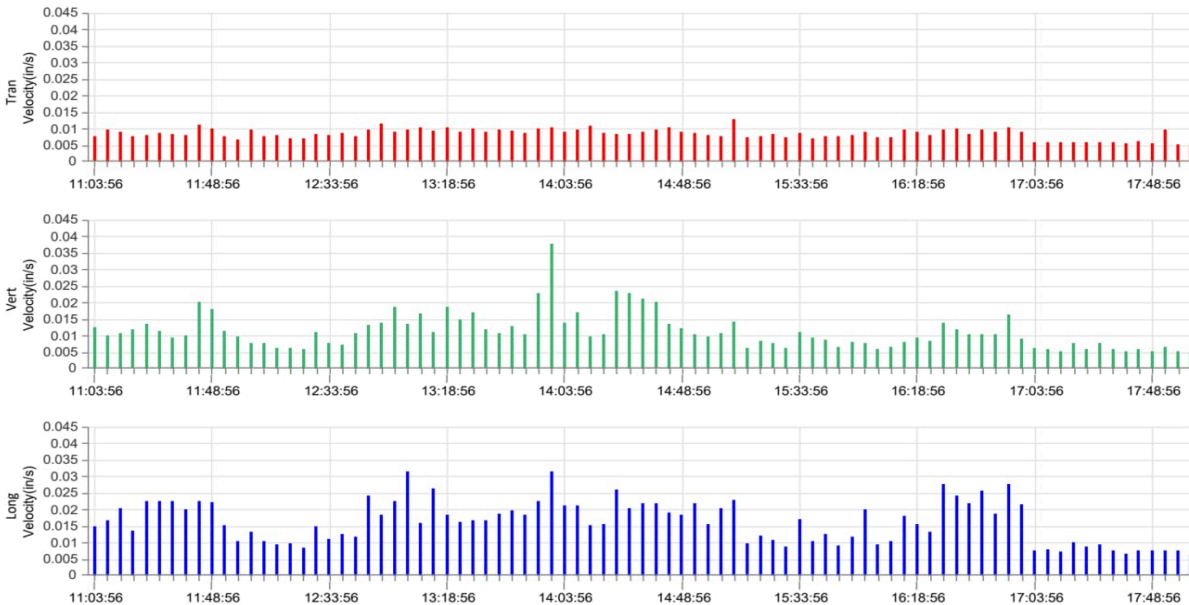
USBM RI8507 And OSMRE
Velocity versus Frequency (Zero Crossing)

Peak Vector Sum 0.0433 in/s at January 23, 2025 13:58:56

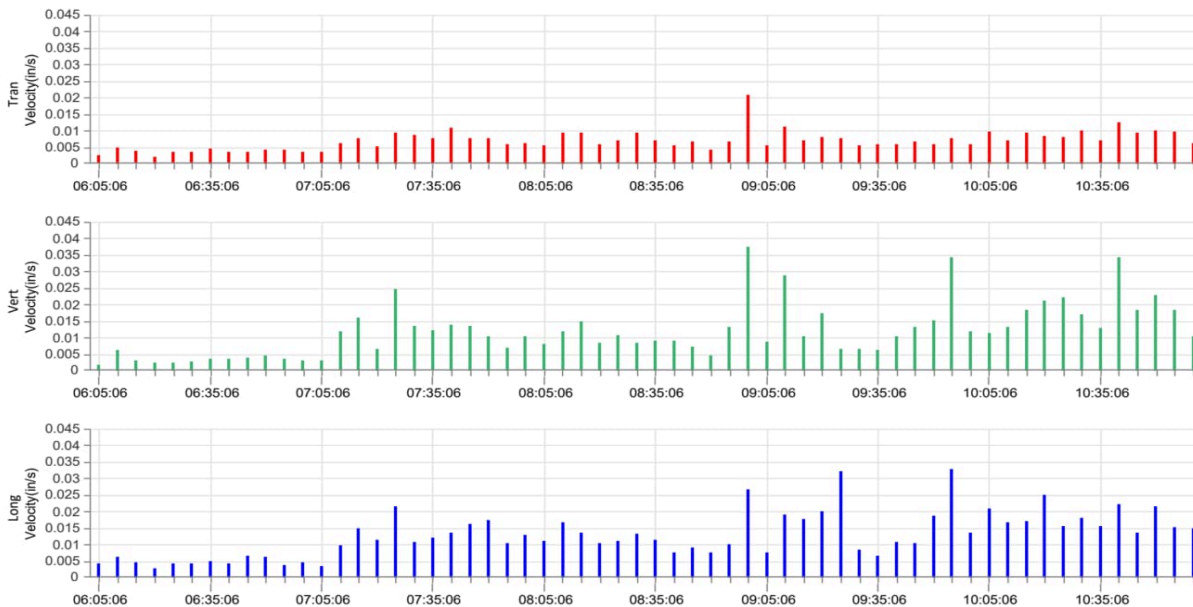
USBM R18507 And OSMRE
Velocity versus Frequency (Zero Crossing)

Peak Vector Sum 0.0418 in/s at January 23, 2025 09:00:06
