DAILY FIELD REPORT

Project	Former A&A Brake Service Site	Report No.	110
BCP Site	NYSDEC BCP SITE C224372	Date	1/28/2025
Location	558 Sackett Street	File No.	0206384
Client	Sackett Heights LLC	Temperature	H: 42 °F L: 34 °F
Contractor	Blue Sky Builders, International Concrete, A1 Waterproofing	Wind Direction	NW to SE, up to 29 mph
Weather	Clear	Personnel on Site	George Poulton
Humidity	35%	Time on Site	6:30 am to 4:30 pm

WEEKLY MONITORING REPORT

Weekly Monitoring
1/28/2025 - 1/28/2025

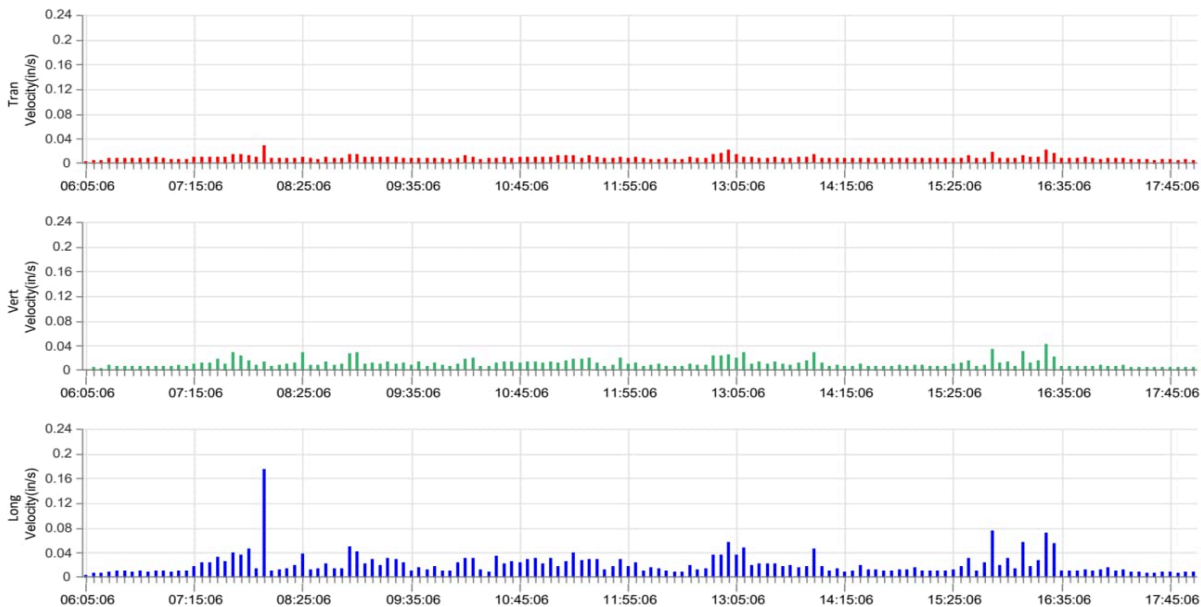
USBM R18507 And OSMRE
Velocity versus Frequency (Zero Crossing)

Peak Vector Sum 0.1767 in/s at January 28, 2025 08:00:06

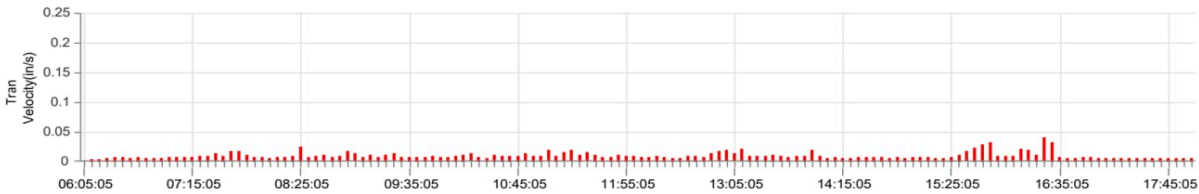
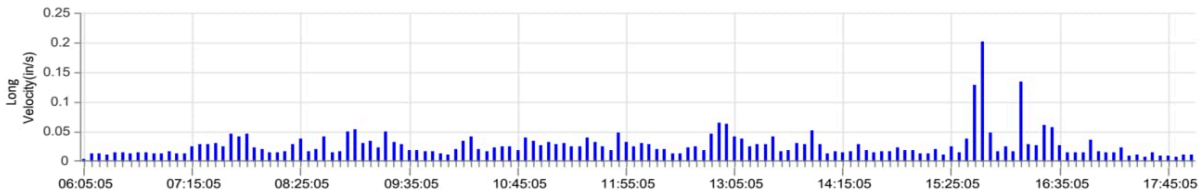
USBM R18507 And OSMRE
Velocity versus Frequency (Zero Crossing)

Peak Vector Sum 0.2061 in/s at January 28, 2025 15:45:05
