Project	Former A&A Brake Service Site	Report No.	111
BCP Site	NYSDEC BCP SITE C224372	Date	1/29/2025
Location	558 Sackett Street	File No.	0206384
Client	Sackett Heights LLC	Temperature	H: 53 °F L: 38 °F
Contractor	Blue Sky Builders, International Concrete	Wind Direction	SW to NE, up to 25 mph
Weather	Clear	Personnel on Site	George Poulton
Humidity	38%	Time on Site	6:30 am to 5:00 pm

H & A of New York Engineering and Geology, LLP (Haley & Aldrich) was present document implementation of the May 2024 NYSDEC-Approved Remedial Action Work Plan (RAWP) and Decision Document for the Former A&A Brake Service Site C224372, located at 558 Sackett Street, Brooklyn, NY. Site observations are summarized below.

WEEKLY MONITORING REPORT

Weekly Monitoring
1/29/2025 - 1/29/2025

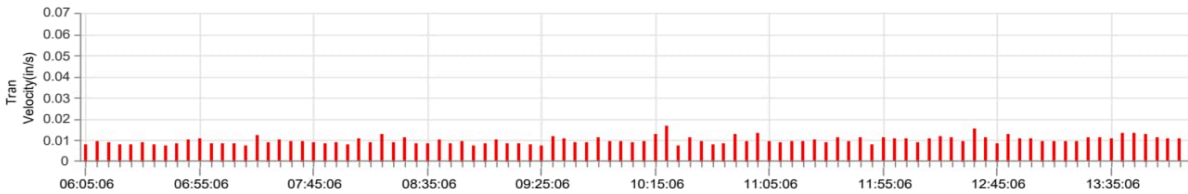
USBM R18507 And OSMRE
Velocity versus Frequency (Zero Crossing)

Geophone	Tran	Vert	Long
Peak Particle Velocity	0.0164 in/s	0.0270 in/s	0.0593 in/s
Zero Crossing Frequency	7.8 Hz	12.2 Hz	10.9 Hz
Date	Jan 29, 2025	Jan 29, 2025	Jan 29, 2025
Time	10:20:06	11:00:06	11:00:06
Sensor Check	✓ Passed	✓ Passed	✓ Passed
Frequency	7.3 Hz	7.5 Hz	7.3 Hz
Overswing Ratio	4.9	4.7	4.5

Peak Vector Sum 0.0624 in/s at January 29, 2025 11:00:06

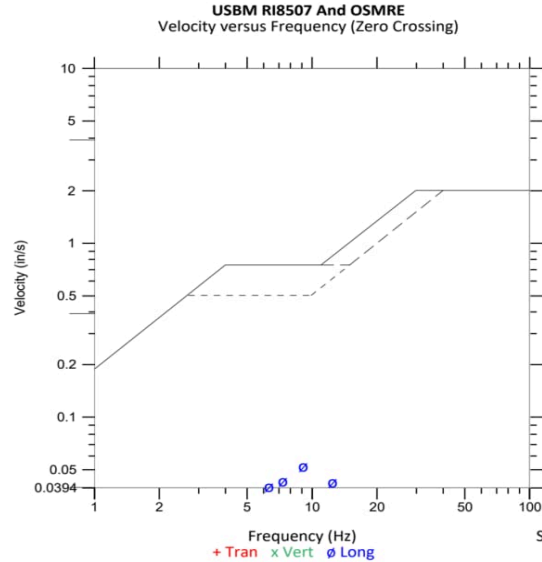
Geophone	Tran	Vert	Long
Peak Particle Velocity	0.0180 in/s	0.0245 in/s	0.0521 in/s
Zero Crossing Frequency	11.9 Hz	11.9 Hz	9.1 Hz
Date	Jan 29, 2025	Jan 29, 2025	Jan 29, 2025
Time	10:20:05	11:00:05	11:00:05
Sensor Check	✓ Passed	✓ Passed	✓ Passed
Frequency	7.5 Hz	7.3 Hz	7.3 Hz
Overswing Ratio	4.8	4.9	5.2
Peak Vector Sum	0.0537 in/s at January 29, 2025 11:00:05

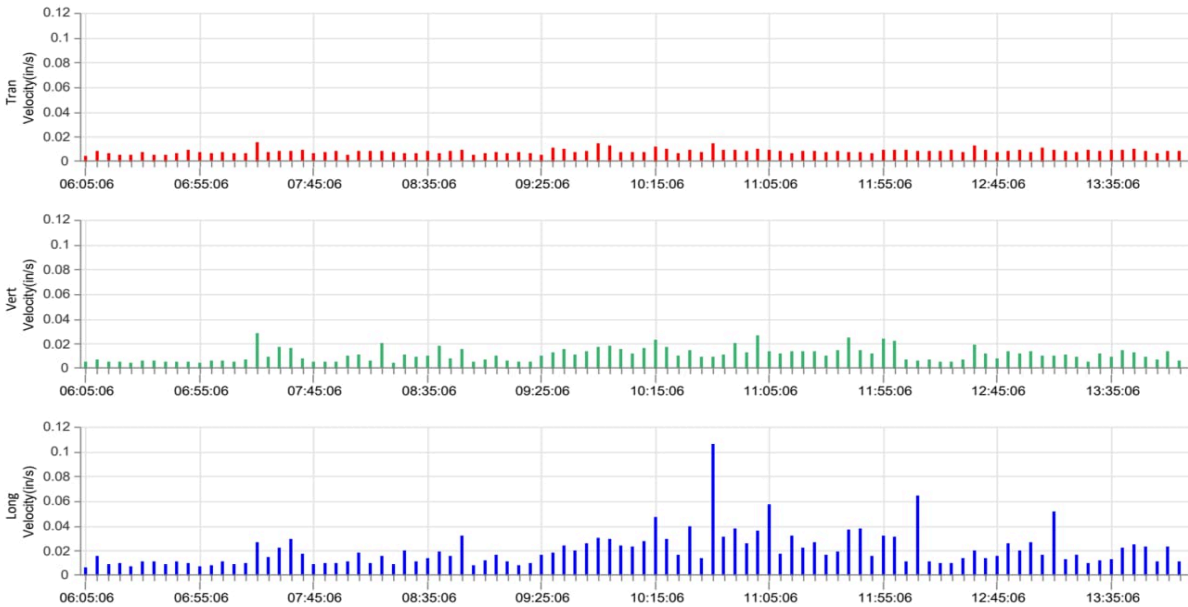
Geophone	Tran	Vert	Long
Peak Particle Velocity	0.0155 in/s	0.0285 in/s	0.1058 in/s
Zero Crossing Frequency	26.9 Hz	15.5 Hz	>100 Hz
Date	Jan 29, 2025	Jan 29, 2025	Jan 29, 2025
Time	07:20:06	07:20:06	10:40:06
Sensor Check	✓ Passed	✓ Passed	✓ Passed
Frequency	7.5 Hz	7.7 Hz	7.3 Hz
Overswing Ratio	4.3	4.0	4.5

Peak Vector Sum 0.1062 in/s at January 29, 2025 10:40:06
