DAILY FIELD REPORT

Project	Former A&A Brake Service Site	Report No.	114
BCP Site	NYSDEC BCP SITE C224372	Date	2/3/2025
Location	558 Sackett Street	File No.	0206384
Client	Sackett Heights LLC	Temperature	H: 48 °F L: 31 °F
Contractor	Blue Sky Builders, International Concrete	Wind Direction	SW to NE, up to 12 mph
Weather	Overcast	Personnel on Site	George Poulton
Humidity	60%	Time on Site	6:30 am to 4:30 pm

WEEKLY MONITORING REPORT

Weekly Monitoring
2/3/2025 - 2/3/2025

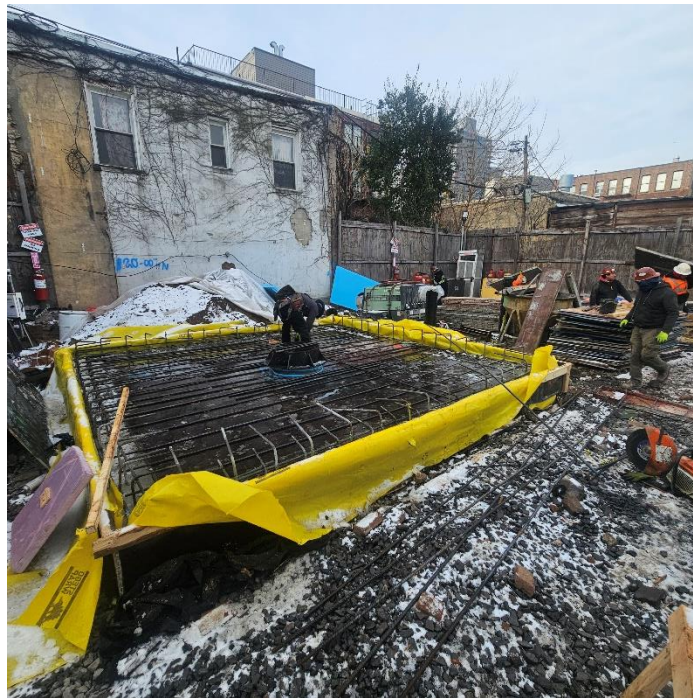
Photo 2: View of contractor installing rebar for water tank, facing Southwest.
