DAILY FIELD REPORT

Project	Former A&A Brake Service Site	Report No.	116
BCP Site	NYSDEC BCP SITE C224372	Date	2/5/2025
Location	558 Sackett Street	File No.	0206384
Client	Sackett Heights LLC	Temperature	H: 37 °F L: 28 °F
Contractor	Blue Sky Builders, International Concrete	Wind Direction	NW to SE, up to 18 mph
Weather	Overcast	Personnel on Site	George Poulton
Humidity	34%	Time on Site	6:30 am to 5:00 pm

WEEKLY MONITORING REPORT

Weekly Monitoring
2/5/2025 - 2/5/2025

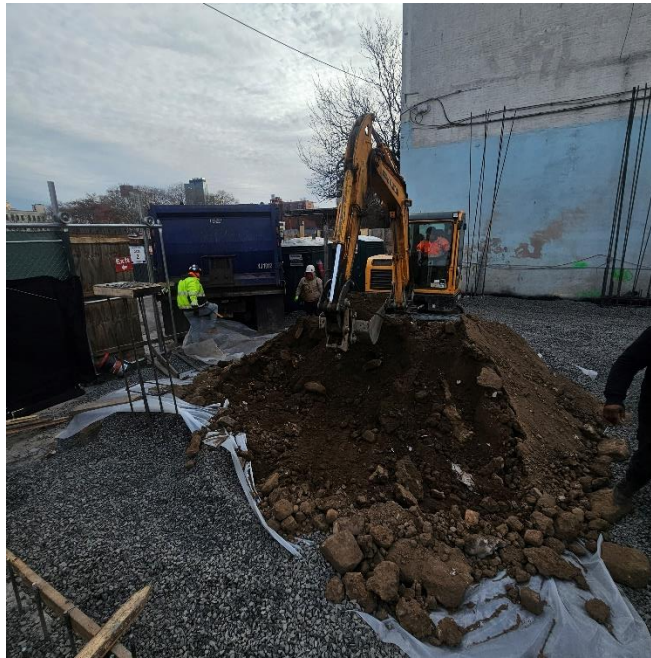
Photo 1: View of contractor loading soil for off-Site disposal, facing Northeast.

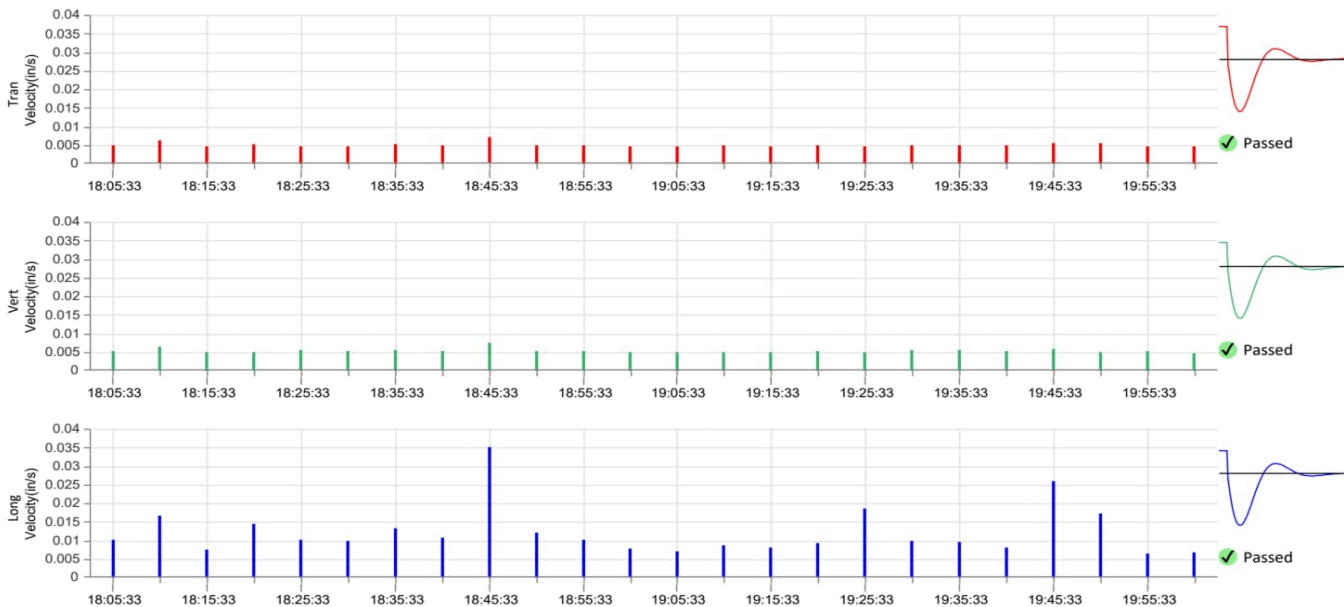
USBM RI8507 And OSMRE
Velocity versus Frequency (Zero Crossing)

0.0353 in/s at February 5, 2025 18:45:33
