DAILY FIELD REPORT

Project	Former A&A Brake Service Site	Report No.	117
BCP Site	NYSDEC BCP SITE C224372	Date	2/6/2025
Location	558 Sackett Street	File No.	0206384
Client	Sackett Heights LLC	Temperature	H: 40 °F L: 28 °F
Contractor	Blue Sky Builders, International Concrete, MPI Plumbing	Wind Direction	NW to SE, up to 15 mph
Weather	Light snow, moderate rain	Personnel on Site	George Poulton
Humidity	86%	Time on Site	6:30 am to 3:30 pm

WEEKLY MONITORING REPORT

Weekly Monitoring
2/6/2025 - 2/6/2025

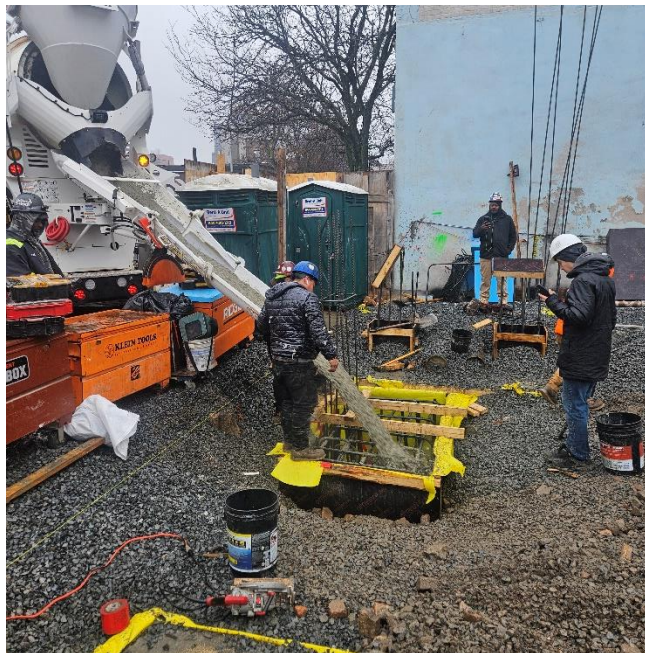
Photo 2: View of contractor pouring concrete for footing, facing East.
