DAILY FIELD REPORT

Project	Former A&A Brake Service Site	Report No.	118
BCP Site	NYSDEC BCP SITE C224372	Date	2/7/2025
Location	558 Sackett Street	File No.	0206384
Client	Sackett Heights LLC	Temperature	H: 43 °F L: 30 °F
Contractor	Blue Sky Builders, International Concrete, MPI Plumbing	Wind Direction	NW to SE, up to 24 mph
Weather	Overcast	Personnel on Site	George Poulton
Humidity	30%	Time on Site	6:30 am to 3:30 pm

WEEKLY MONITORING REPORT

Project Address:
558 Sackett Street, Brooklyn,
Brooklyn NY 11215

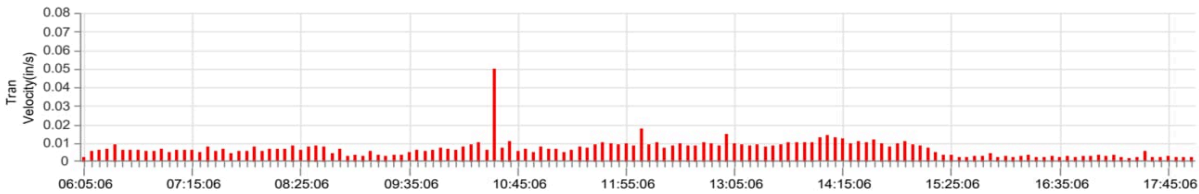
Peak Vector Sum 0.0676 in/s at February 7, 2025 13:05:06

Extended Note IF VIBRATIONS REACH 0.25 IN/S ALERT THE CONSTRUCTION MANAGER AND ENGINEER. IF VIBRATIONS EXCEEDED 0.50 IN/S STOP ALL VIBRATION PRODUCING ACTIVITIES AND NOTIFY THE CONSTRUCTION MANAGER AND ENGINEER. FOLLOW UP WITH OPTICAL AND CRACK GAUGE MONITORS AND SUBMIT ALL RESULTS TO THE PROJECT ENGINEER. WORK SHALL RESUME WHEN APPROVED BY CONSTRUCTION MANAGER AND ENGINEER.

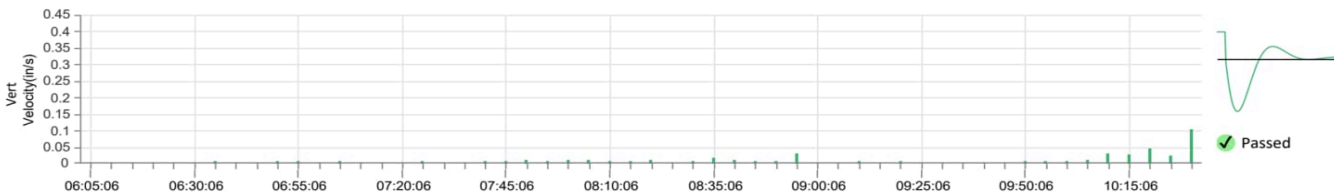
Geophone	Tran	Vert	Long
Peak Particle Velocity	0.2098 in/s	0.1055 in/s	0.3702 in/s
Zero Crossing Frequency	36.6 Hz	>100 Hz	64.0 Hz
Date	Feb 7, 2025	Feb 7, 2025	Feb 7, 2025
Time	10:28:15	10:28:15	10:28:15
Sensor Check	✓ Passed	✓ Passed	✓ Passed
Frequency	7.5 Hz	7.7 Hz	7.3 Hz
Overswing Ratio	4.2	4.0	4.4
Peak Vector Sum	0.3782 in/s at February 7, 2025 10:30:06
