# DAILY FIELD REPORT

<b>Project</b>	Former A&A Brake Service Site	<b>Report No.</b>	120
<b>BCP Site</b>	NYSDEC BCP SITE C224372	<b>Date</b>	2/11/2025
<b>Location</b>	558 Sackett Street	<b>File No.</b>	0206384
<b>Client</b>	Sackett Heights LLC	<b>Temperature</b>	H: 36 °F L: 28 °F
<b>Contractor</b>	Blue Sky Builders, International Concrete, MPI Plumbing	<b>Wind Direction</b>	NW to SE, up to 12 mph
<b>Weather</b>	Overcast	<b>Personnel on Site</b>	George Poulton
<b>Humidity</b>	33%	<b>Time on Site</b>	6:30 am to 3:30 pm

## WEEKLY MONITORING REPORT

**Project Address:**  
558 Sackett Street,  
Brooklyn,  
Brooklyn NY 11215  
BBL:/443/55

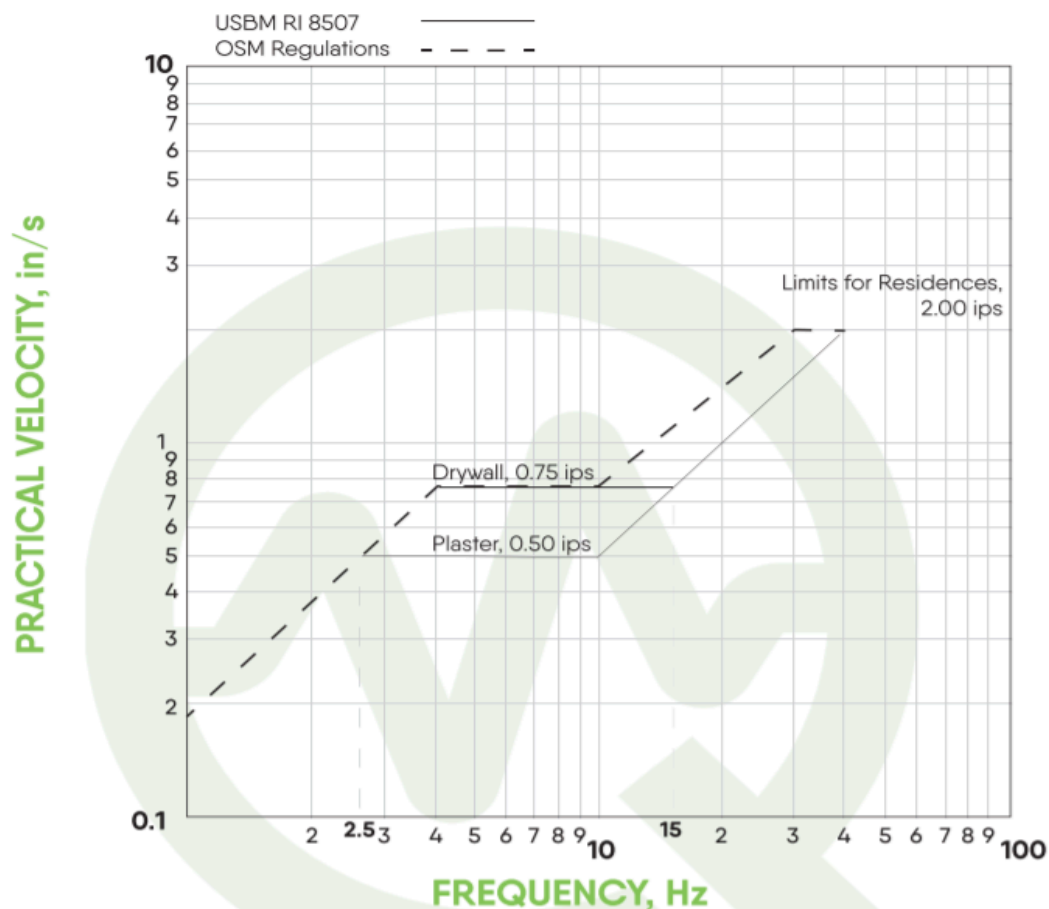
# USBM REPORT OF INVESTIGATION 8507

Classification	Description of Damage
Threshold	Loosening of paint, small plaster cracks of joints between elements, lengthening of old cracks.
Minor	Loosening and falling of plaster, hairline cracks in masonry around openings near partitions, falling of loose mortar.
Major Weakening	Cracks of several millimeter sin walls, structural fall of masonry, e.g. chimneys, and load support ability.

The USBM Report of Investigation 8507 graph is shown on the following page. Above 12 hertz, the allowable vibration intensity Increases to 2.0 inches per second as the frequency increases up to 40 hertz. Above 40 hertz, a constant 2.0 inches per second level is recommended to protect

the interior walls and ceiling of structures, regardless of construction material. With respect to vibration induced soil settlement, and underground structure and utility damage, other research has shown that vibration levels in excess of 5.0 inches per second are required for this to occur.
