DAILY FIELD REPORT

Project	Former A&A Brake Service Site	Report No.	121
BCP Site	NYSDEC BCP SITE C224372	Date	2/12/2025
Location	558 Sackett Street	File No.	0206384
Client	Sackett Heights LLC	Temperature	H: 36 °F L: 30 °F
Contractor	Blue Sky Builders, International Concrete, MPI Plumbing	Wind Direction	NW to SE, up to 17 mph
Weather	Overcast	Personnel on Site	George Poulton, Siara Greco, Eddy Nunez
Humidity	70%	Time on Site	6:30 am to 3:30 pm

H & A of New York Engineering and Geology, LLP (Haley & Aldrich) was present document implementation of the May 2024 NYSDEC-Approved Remedial Action Work Plan (RAWP) and Decision Document for the Former A&A Brake Service Site C224372, located at 558 Sackett Street, Brooklyn, NY. Site observations are summarized below.

WEEKLY MONITORING REPORT

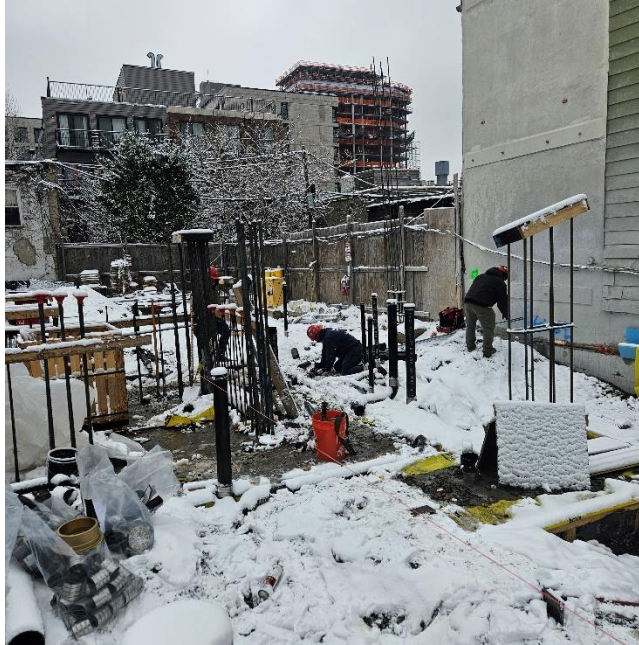
Photo 1: View of contractor installing plumbing elements, facing Southwest.
