DAILY FIELD REPORT

Project	Former A&A Brake Service Site	Report No.	123
BCP Site	NYSDEC BCP SITE C224372	Date	2/14/2025
Location	558 Sackett Street	File No.	0206384
Client	Sackett Heights LLC	Temperature	H: 37 °F L: 31 °F
Contractor	Blue Sky Builders, International Concrete, MPI Plumbing	Wind Direction	NE to SW, up to 28 mph
Weather	Overcast	Personnel on Site	George Poulton
Humidity	30%	Time on Site	6:30 am to 3:30 pm

WEEKLY MONITORING REPORT

Project Address:
558 Sackett Street, Brooklyn,
Brooklyn NY 11215

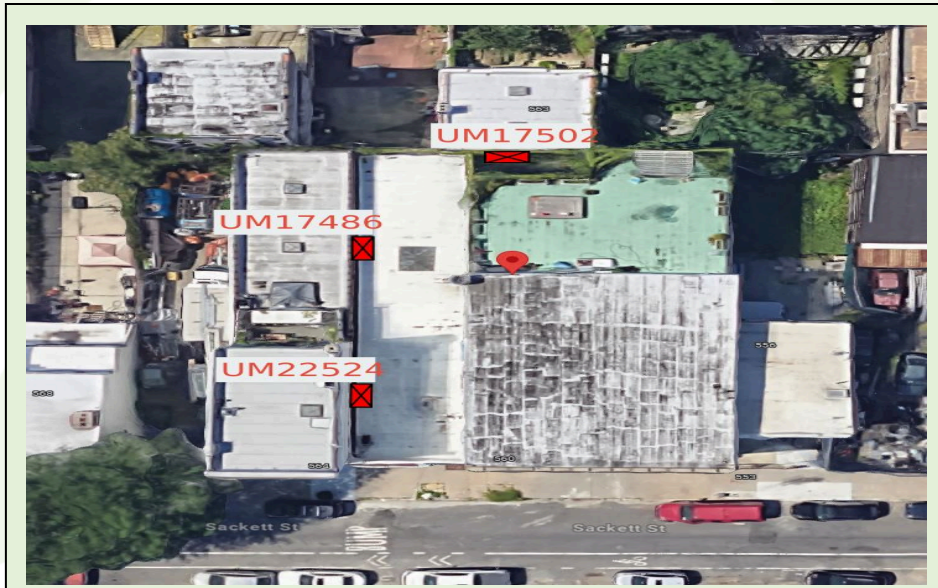
Quiver Monitoring recommends the following vibration monitoring layout.

1. **UM17486:** Is installed at the 564 Sackett Street Exterior, front.
2. **UM17502:** Is installed at the 563 Union Street Exterior.
3. **UM22524:** Is installed at the 564 Sackett Street Exterior, rear.

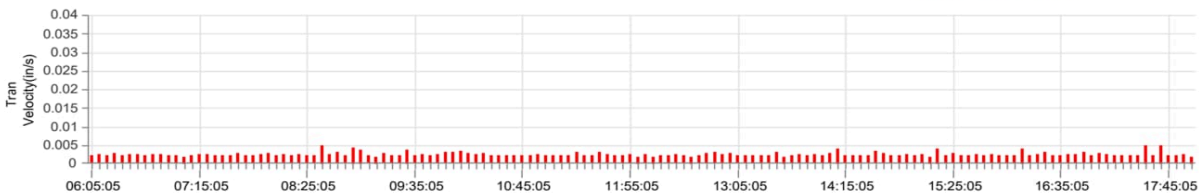
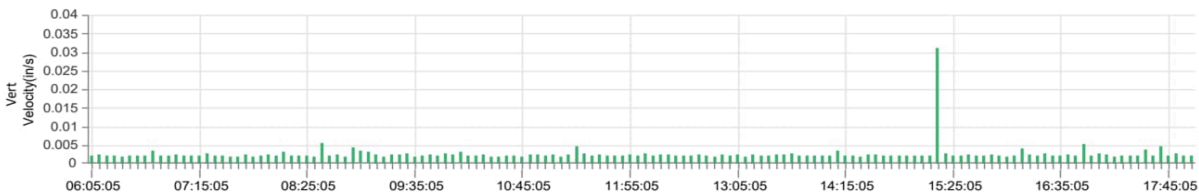
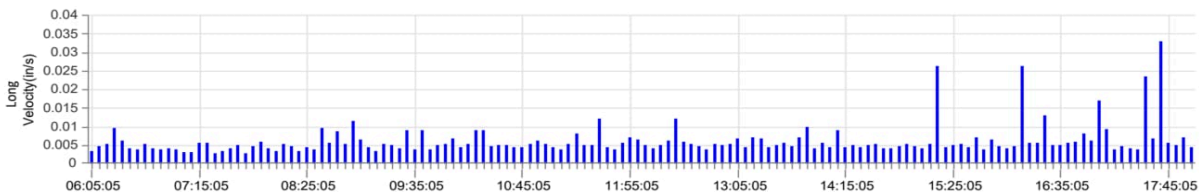
Geophone	Tran	Vert	Long
Peak Particle Velocity	<0.005 in/s	0.0310 in/s	0.0329 in/s
Zero Crossing Frequency	11.6 Hz	>100 Hz	4.7 Hz
Date	Feb 15, 2025	Feb 15, 2025	Feb 15, 2025
Time	08:35:05	15:15:05	17:40:05
Sensor Check	✓ Passed	✓ Passed	✓ Passed
Frequency	7.3 Hz	7.3 Hz	7.3 Hz
Overswing Ratio	4.8	5.0	5.2
Peak Vector Sum	0.0331 in/s at February 15, 2025 17:40:05

Start February 15, 2025 18:02:05
Finish February 15, 2025 19:59:59
Number of Intervals/Interval 23.58/300 sec
Sample Rate 1024 sps
Setup File Name 558 Sackett Street S2.mmb
Operator Quiver League

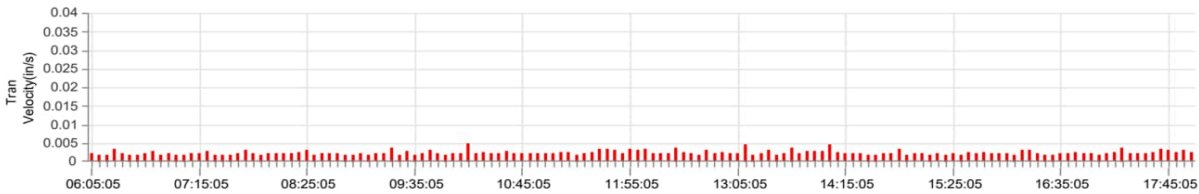
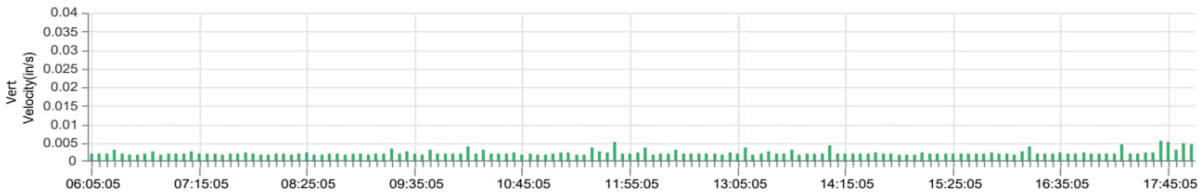
Geophone	Tran	Vert	Long
Peak Particle Velocity	<0.005 in/s	0.0056 in/s	0.0341 in/s
Zero Crossing Frequency	10.2 Hz	14.2 Hz	9.7 Hz
Date	Feb 16, 2025	Feb 16, 2025	Feb 16, 2025
Time	10:10:05	17:40:05	17:40:05
Sensor Check	✓ Passed	✓ Passed	✓ Passed
Frequency	7.3 Hz	7.3 Hz	7.3 Hz
Overswing Ratio	4.8	5.0	5.2
Peak Vector Sum	0.0342 in/s at February 16, 2025 17:40:05

Start February 16, 2025 18:02:05
Finish February 16, 2025 19:59:59
Number of Intervals/Interval 23.58/300 sec
Sample Rate 1024 sps
Setup File Name 558 Sackett Street S2.mmb
Operator Quiver League

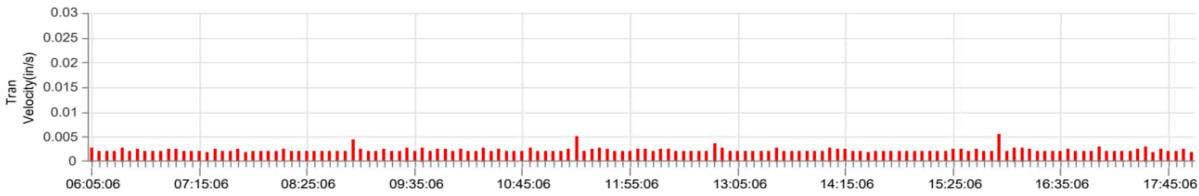
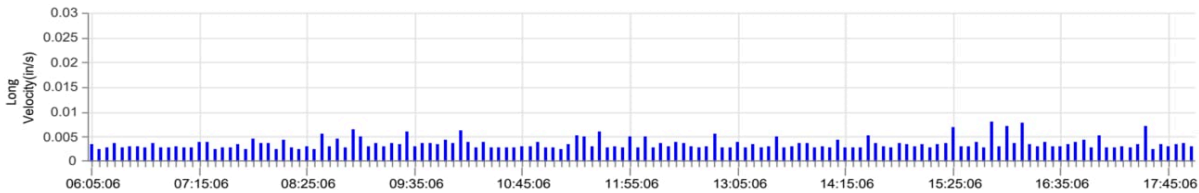
Geophone	Tran	Vert	Long
Peak Particle Velocity	0.0056 in/s	0.0267 in/s	0.0081 in/s
Zero Crossing Frequency	1.0 Hz	<1 Hz	<1 Hz
Date	Feb 15, 2025	Feb 15, 2025	Feb 15, 2025
Time	15:55:06	15:30:06	15:50:06
Sensor Check	✓ Passed	✓ Passed	✓ Passed
Frequency	7.1 Hz	7.5 Hz	7.3 Hz
Overswing Ratio	4.9	4.8	4.5
Peak Vector Sum	0.0268 in/s at February 15, 2025 15:30:06

Start February 15, 2025 18:02:05
Finish February 15, 2025 19:59:59
Number of Intervals/Interval 23.58/300 sec
Sample Rate 1024 sps
Setup File Name 558 Sackett Street S1.mmb
Operator Quiver League

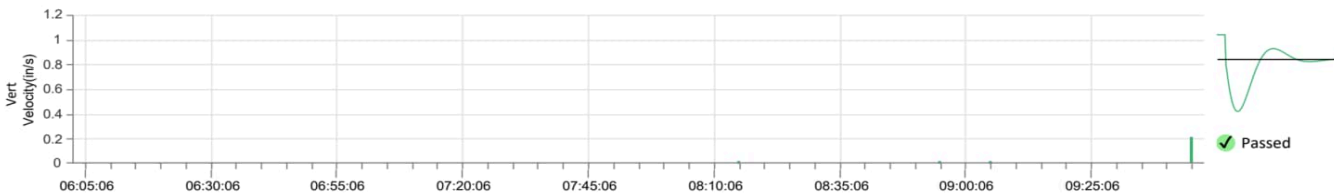
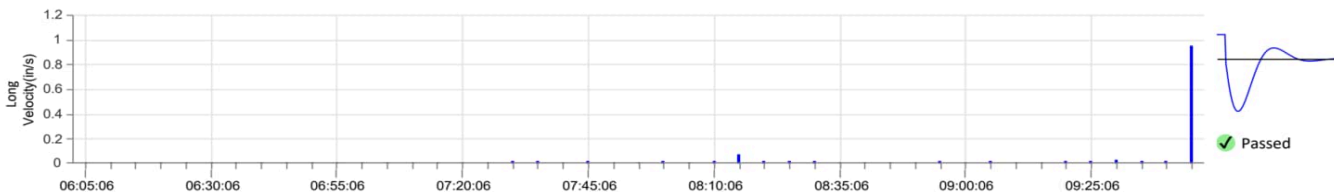
Geophone	Tran	Vert	Long
Peak Particle Velocity	0.0599 in/s	0.2104 in/s	0.9480 in/s
Zero Crossing Frequency	>100 Hz	>100 Hz	>100 Hz
Date	Feb 17, 2025	Feb 17, 2025	Feb 17, 2025
Time	09:43:11	09:43:11	09:43:11
Sensor Check	✓ Passed	✓ Passed	✓ Passed
Frequency	7.3 Hz	7.5 Hz	7.3 Hz
Overswing Ratio	4.9	4.8	4.5
Peak Vector Sum	0.9514 in/s at February 17, 2025 09:45:06

Long at February 17, 2025 09:43:08
 Geo 0.2500 in/s
 0.25 sec/3.0 sec (Fixed)
 1024 sps
 558 Sackett Street S1.mmb
 Quiver League

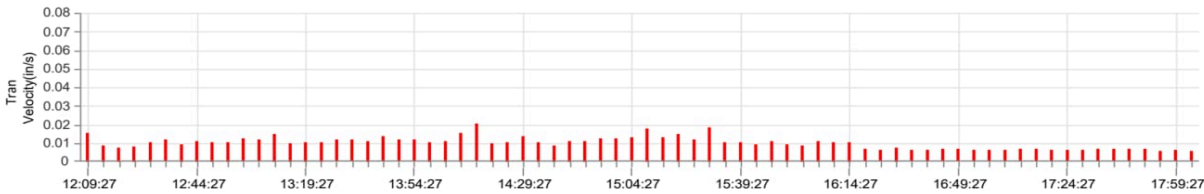
Geophone	Tran	Vert	Long
Peak Particle Velocity	0.0202 in/s	0.0360 in/s	0.0673 in/s
Zero Crossing Frequency	6.4 Hz	12.5 Hz	85.3 Hz
Date	Feb 13, 2025	Feb 13, 2025	Feb 13, 2025
Time	14:14:27	15:09:27	16:04:27
Sensor Check	✓ Passed	✓ Passed	✓ Passed
Frequency	7.5 Hz	7.7 Hz	7.3 Hz
Overswing Ratio	4.2	3.9	4.4
Peak Vector Sum	0.0677 in/s at February 13, 2025 16:04:27

Start February 13, 2025 18:00:39
Finish February 13, 2025 19:59:59
Number of Intervals/Interval 23.87/300 sec
Sample Rate 1024 sps
Setup File Name 558 Sackett Street S4.mmb
Operator Quiver League

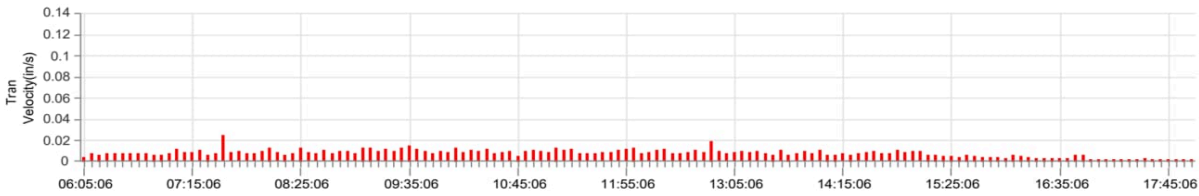
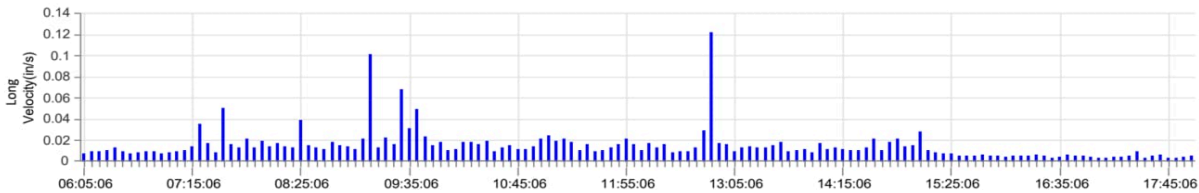
Peak Vector Sum 0.1219 in/s at February 14, 2025 12:50:06

Start February 14, 2025 18:02:06
Finish February 14, 2025 19:59:59
Number of Intervals/Interval 23.58/300 sec
Sample Rate 1024 sps
Setup File Name 558 Sackett Street S4.mmb
Operator Quiver League

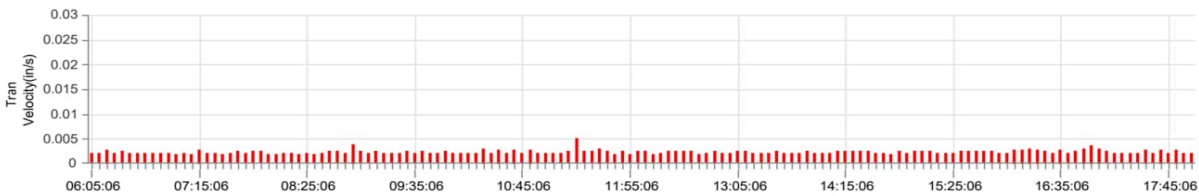
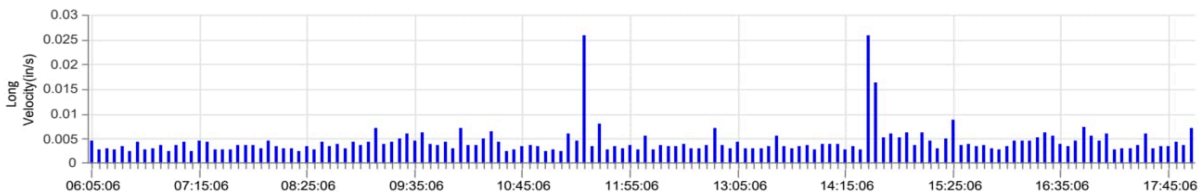
Geophone	Tran	Vert	Long
Peak Particle Velocity	<0.005 in/s	0.0071 in/s	0.0258 in/s
Zero Crossing Frequency	4.7 Hz	5.0 Hz	11.9 Hz
Date	Feb 15, 2025	Feb 15, 2025	Feb 15, 2025
Time	11:20:06	11:20:06	11:25:06
Sensor Check	✓ Passed	✓ Passed	✓ Passed
Frequency	7.5 Hz	7.7 Hz	7.3 Hz
Overswing Ratio	4.3	4.0	4.5

Peak Vector Sum 0.0259 in/s at February 15, 2025 11:25:06

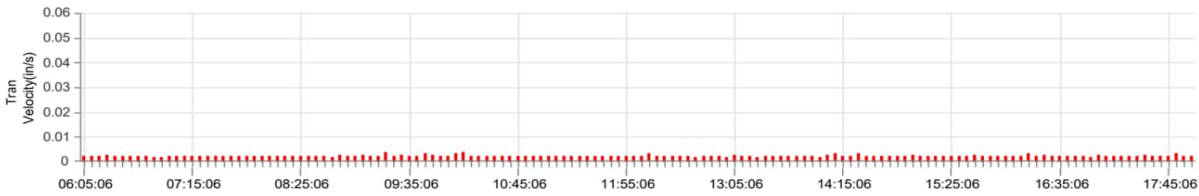
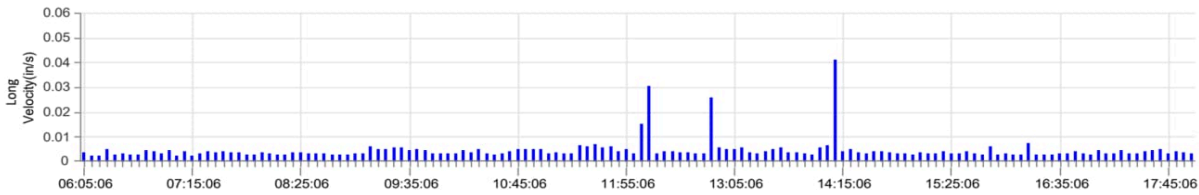
Geophone	Tran	Vert	Long
Peak Particle Velocity	<0.005 in/s	<0.005 in/s	0.0413 in/s
Zero Crossing Frequency	5.4 Hz	11.6 Hz	13.5 Hz
Date	Feb 16, 2025	Feb 16, 2025	Feb 16, 2025
Time	09:20:06	16:15:06	14:10:06
Sensor Check	✓ Passed	✓ Passed	✓ Passed
Frequency	7.5 Hz	7.7 Hz	7.3 Hz
Overswing Ratio	4.2	4.0	4.5
Peak Vector Sum	0.0414 in/s at February 16, 2025 14:10:06

Start February 16, 2025 18:02:06
Finish February 16, 2025 19:59:59
Number of Intervals/Interval 23.58/300 sec
Sample Rate 1024 sps
Setup File Name 558 Sackett Street S4.mmb
Operator Quiver League

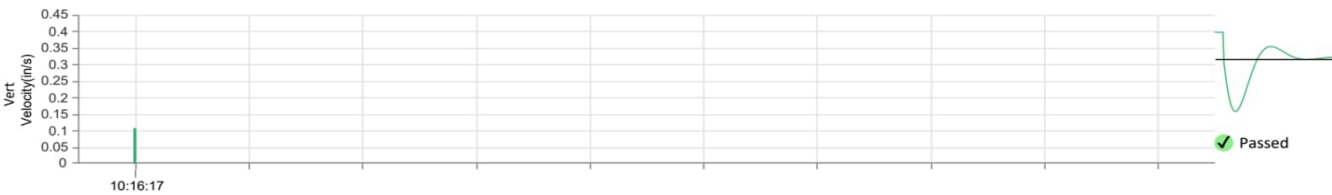
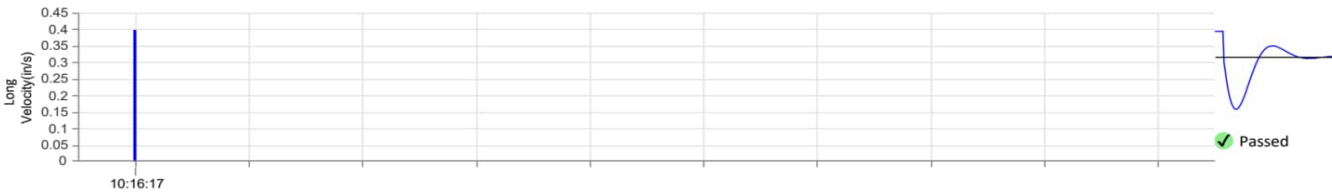
Geophone	Tran	Vert	Long
Peak Particle Velocity	0.0919 in/s	0.1061 in/s	0.3966 in/s
Zero Crossing Frequency	>100 Hz	>100 Hz	>100 Hz
Date	Feb 17, 2025	Feb 17, 2025	Feb 17, 2025
Time	10:16:17	10:16:17	10:16:17
Sensor Check	✓ Passed	✓ Passed	✓ Passed
Frequency	7.5 Hz	7.7 Hz	7.3 Hz
Overswing Ratio	4.3	4.0	4.5

Peak Vector Sum 0.3987 in/s at February 17, 2025 10:21:05

Waveform Trigger Source Long at February 17, 2025 10:16:14
 Trigger Level(s) Geo 0.2500 in/s
 Pre-Trigger/Record Time 0.25 sec/3.0 sec (Fixed)
 Sample Rate 1024 sps
 Setup File Name 558 Sackett Street S4.mmb
 Operator Quiver League
