DAILY FIELD REPORT

Project	Former A&A Brake Service Site	Report No.	126
BCP Site	NYSDEC BCP SITE C224372	Date	2/19/2025
Location	558 Sackett Street	File No.	0206384
Client	Sackett Heights LLC	Temperature	H: 30 °F L: 19 °F
Contractor	Blue Sky Builders, International Concrete, Silvercup Scaffolding	Wind Direction	NE to SW, up to 17 mph
Weather	Clear	Personnel on Site	George Poulton, Owen Hennigan
Humidity	38%	Time on Site	6:30 am to 3:30 pm

WEEKLY MONITORING REPORT

Weekly Monitoring
2/19/2025 - 2/20/2025

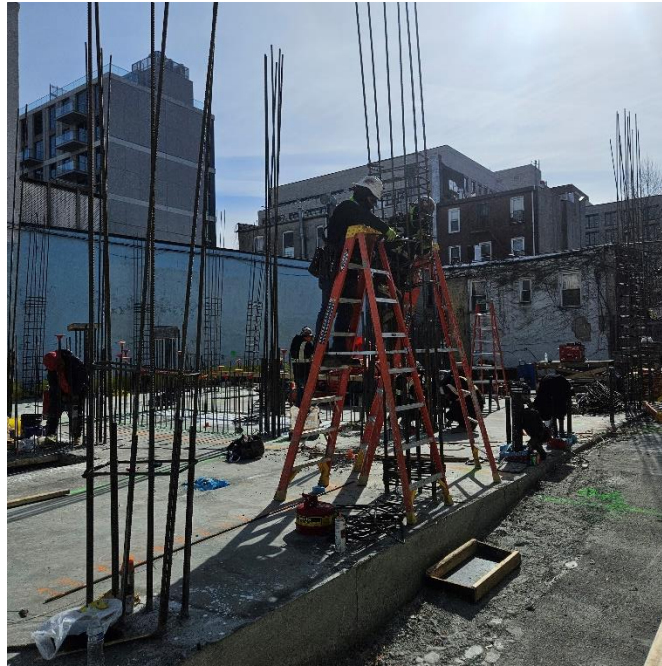
Photo 1: View of contractor installing rebar for superstructure, facing Southeast.

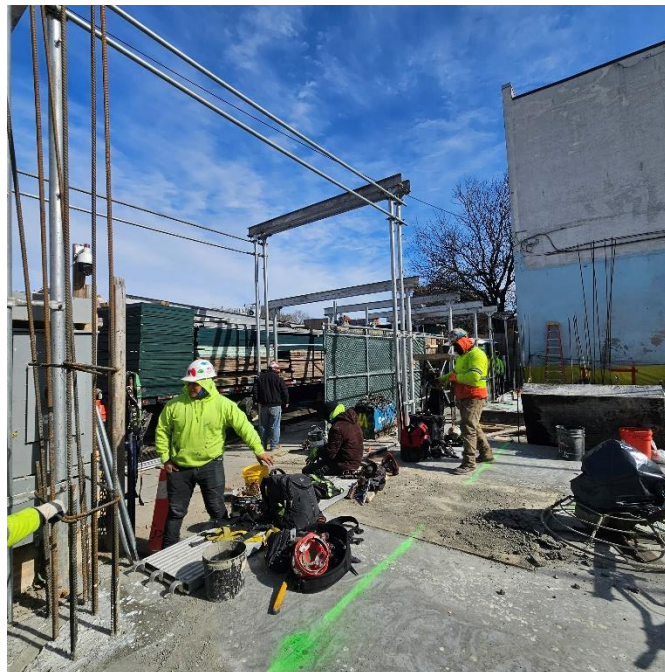
Photo 2: View of contractor constructing scaffolding, facing Northeast.

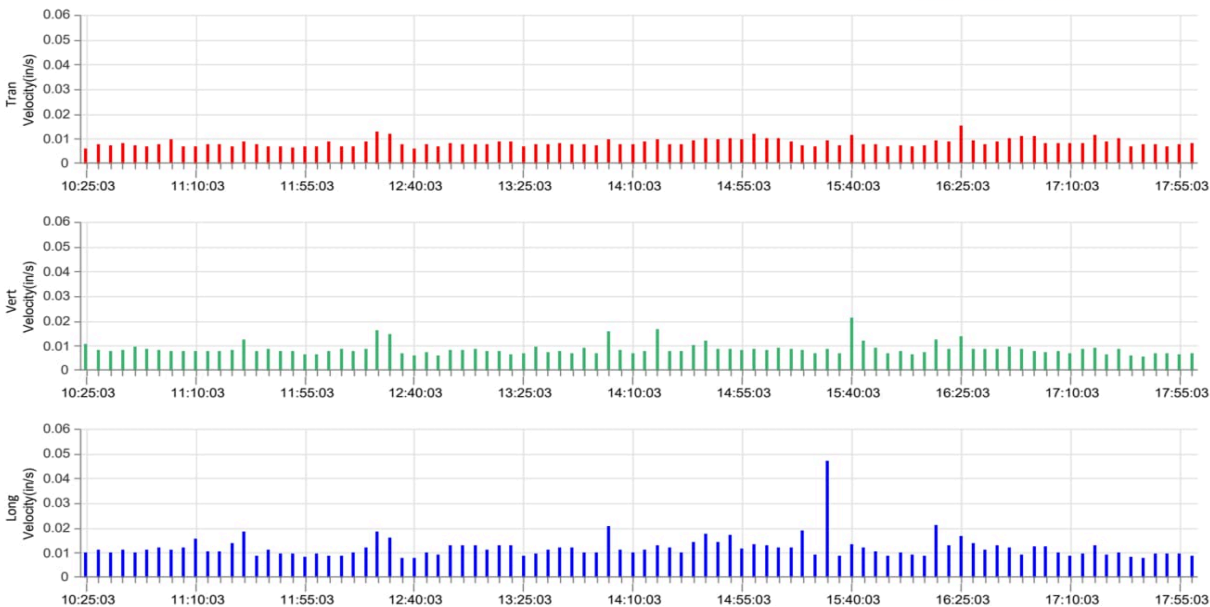
USBM R18507 And OSMRE
Velocity versus Frequency (Zero Crossing)

Peak Vector Sum 0.0481 in/s at February 19, 2025 15:30:03

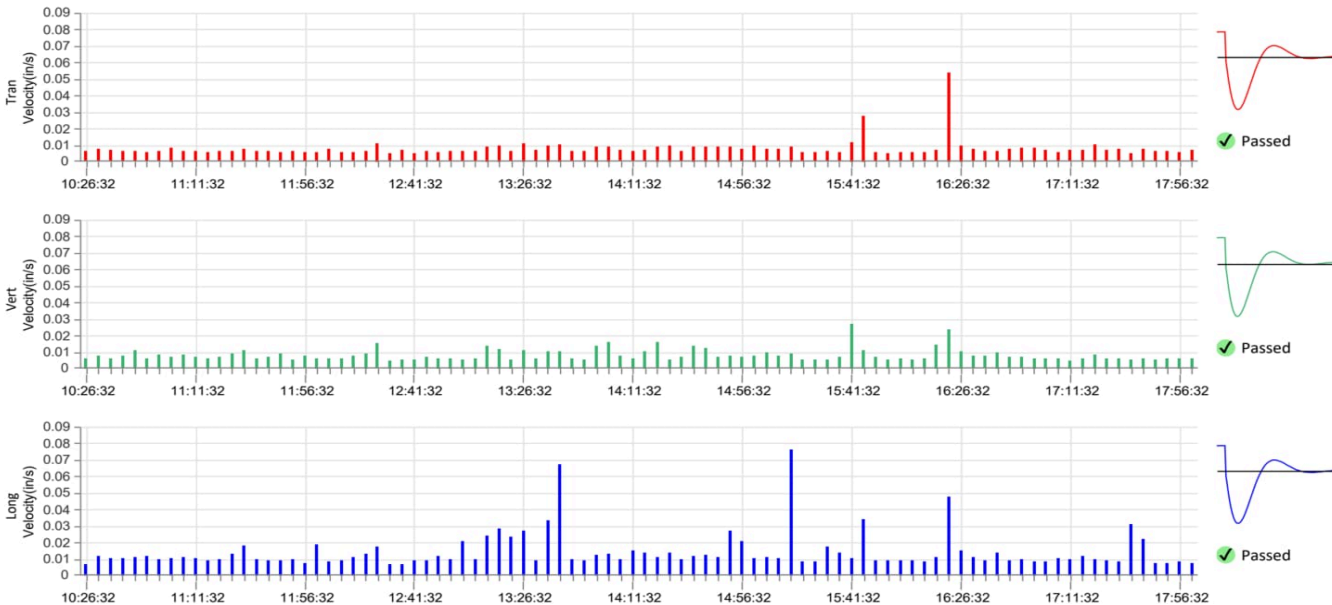
USBM RI8507 And OSMRE
Velocity versus Frequency (Zero Crossing)

Peak Vector Sum 0.0763 in/s at February 19, 2025 15:16:32
