SITE OBSERVATION REPORT

PROJECT No.: 170747001 PROJECT: C224398 – 1709 Surf Avenue LOCATION: 1709 Surf Avenue, Brooklyn, New York	CLIENT: Coney Island Associates Phase 3 LLC c/o BFC Partners	DATE: Fri, April 18, 2025 WEATHER: Partly Cloudy, 44-61°F Wind: SSE at 1-13 mph TIME: 6:45am to 3:30pm
CONTRACTOR'S EQUIPMENT: Doosan DL 300 Loader Doosan DX300LC Excavator Bobcat S590 Skid Steer Bobcat E45 Mini Excavator CAT 345C Excavator CAT 350L Excavator	PRESENT AT SITE: RAWP Implementation Day 28 Environmental (Langan) – Michael Pinnella General Contractor (BFC Construction) Foundation Contractor (Precise Contracting [Precise]) Deep Foundation Contractor (RYC Turbos Corp.)	
OBSERVATIONS, DISCUSSIONS, TEST RESULTS, ETC.: Langan was present to oversee implementation of the November 20, 2024 Remedial Action Work Plan (RAWP) for Brownfield Cleanup Program (BCP) Site No. C224398 at 1709 Surf Avenue. Observed activities were as follows: Site Activities <ul style="list-style-type: none"> Precise excavated an about 130-foot-long by 15-foot-wide by 4-foot-deep area in the central part of the site. Excavated material consisted of non-hazardous fill/soil and was screened for staining, odors, and in

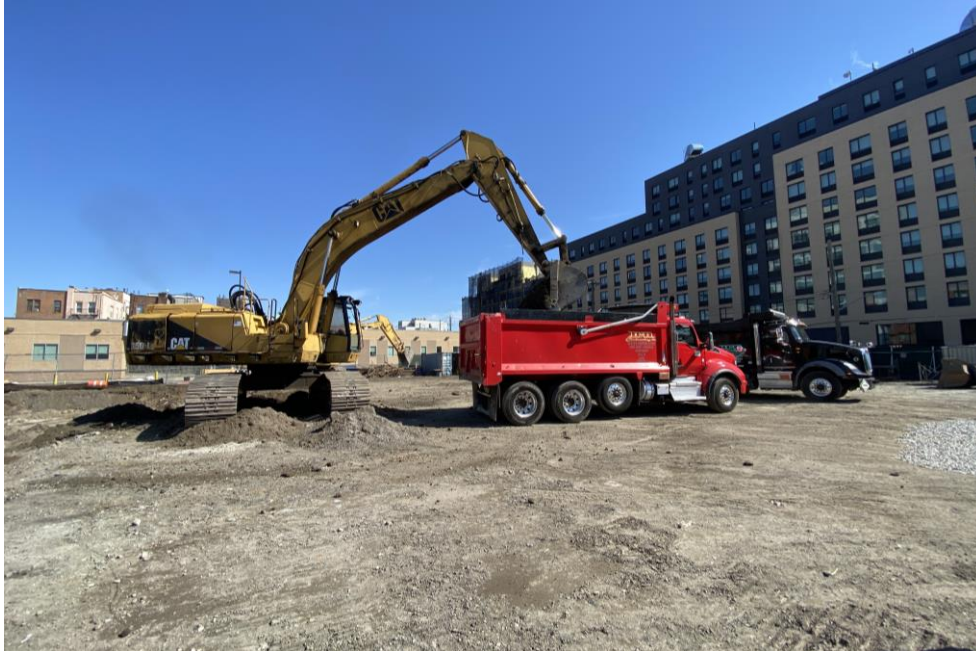
Photo 1: Precise live-loading non-hazardous fill/soil for offsite disposal in the central part of the site (facing northeast).

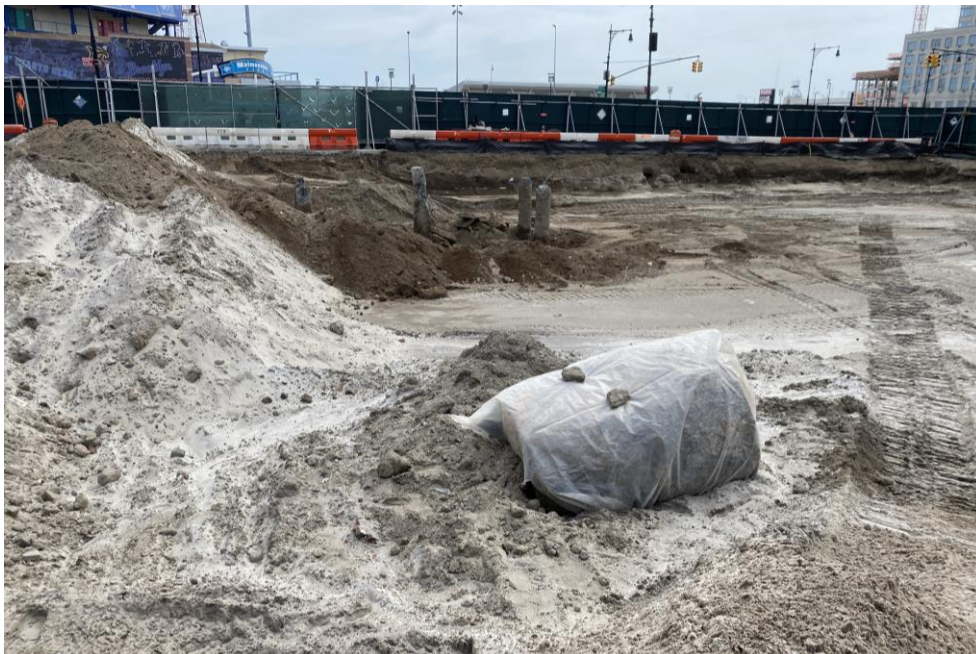
Photo 2: View of uncovered UST in the central part of the site covered with polyethylene sheeting (facing southwest).

- Precise will continue site wide excavation and offsite disposal of non-hazardous fill/soil.
- Cleaning, decommissioning, and offsite disposal of uncovered UST.
- Langan will continue to collect endpoint and sidewall samples from remedial subgrade across the site.
