SITE OBSERVATION REPORT

| PROJECT No.: 170747001 PROJECT: C224398 – 1709 Surf Avenue LOCATION: 1709 Surf Avenue, Brooklyn, New York | CLIENT: Coney Island Associates Phase 3 LLC c/o BFC Partners | DATE: Fri, May 23, 2025 WEATHER: Cloudy, 48-65°F Wind: ESE at 1-6 mph TIME: 6:45am to 3:45pm |

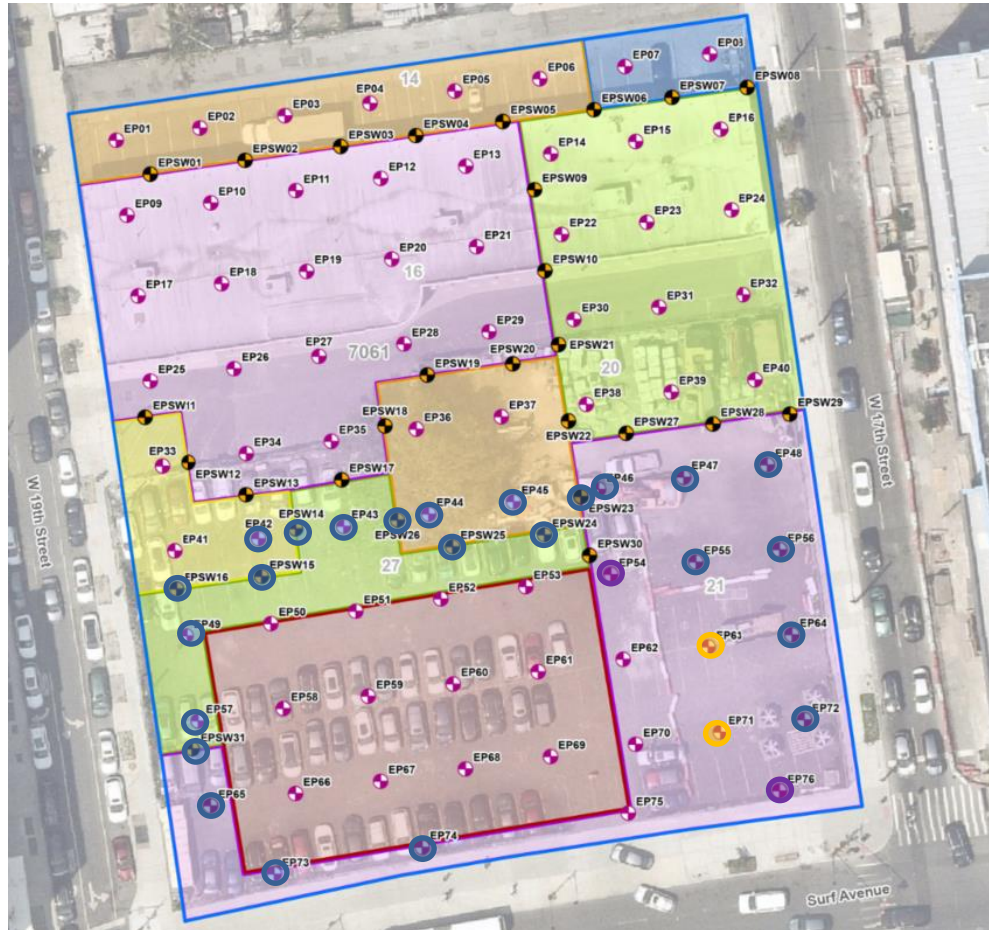
FIGURE 2: ENDPOINT/SIDEWALL SAMPLE LOCATION MAP

- Langan collected four endpoint soil samples from the east-central and southeastern parts of the site, and submitted the samples to York Analytical Laboratories, an Environmental Laboratory Accredited Program (ELAP)-certified laboratory, under standard chain-of-custody protocols. The following samples will be analyzed for target compound list (TCL)/Part 375 volatile organic compounds (VOCs), semi-volatile organic compounds (SVOCs), pesticides, herbicides, polychlorinated biphenyls (PCBs), cyanide, target analyte list (TAL) metals including hexavalent and trivalent chromium, per- and polyfluoroalkyl substances (PFAS), and/or 1,4-dioxane:
 - EP54_EL3
 - EP63_EL4
 - EP71_EL4
 - EP76_EL3
- Langan collected the following quality assurance/quality control (QA/QC) sample that will be analyzed at York as noted:
 - Field Blanks: PFAS_FB12_052325 to be analyzed for PFAS

- Precise will continue site wide excavation and offsite disposal of non-hazardous fill/soil.
- Langan will continue to collect endpoint and sidewall samples from remedial subgrade across the site.

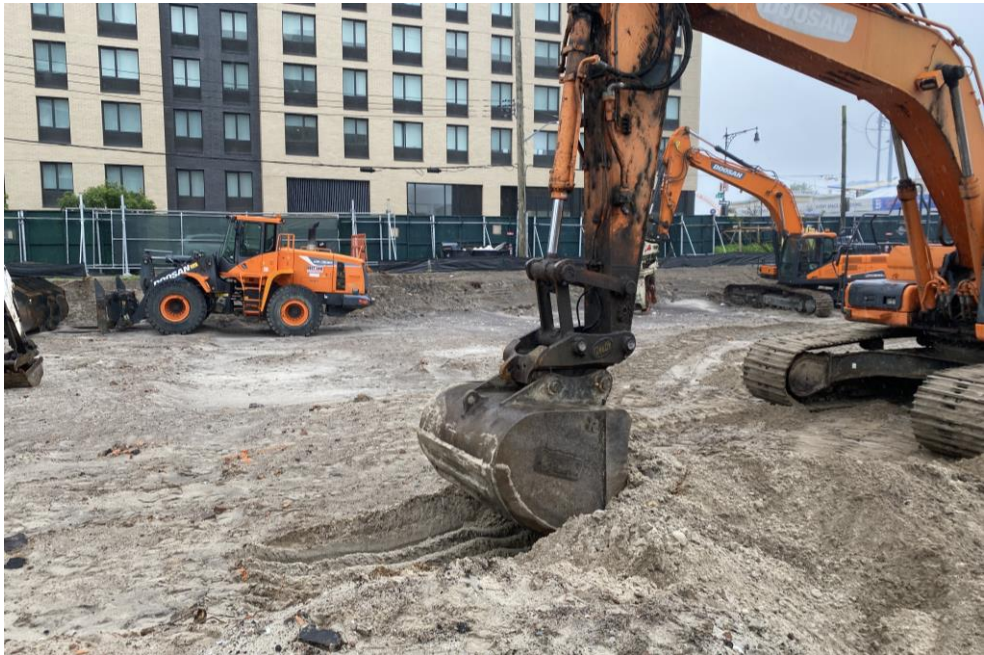
Photo 1: Precise excavating non-hazardous fill/soil in the east-central part of the site (facing southeast).
