# AQUATERRA

## **PHASE I ENVIRONMENTAL AUDIT**

**252 3RD STREET  
BROOKLYN, NEW YORK  
AT91-PA-031**

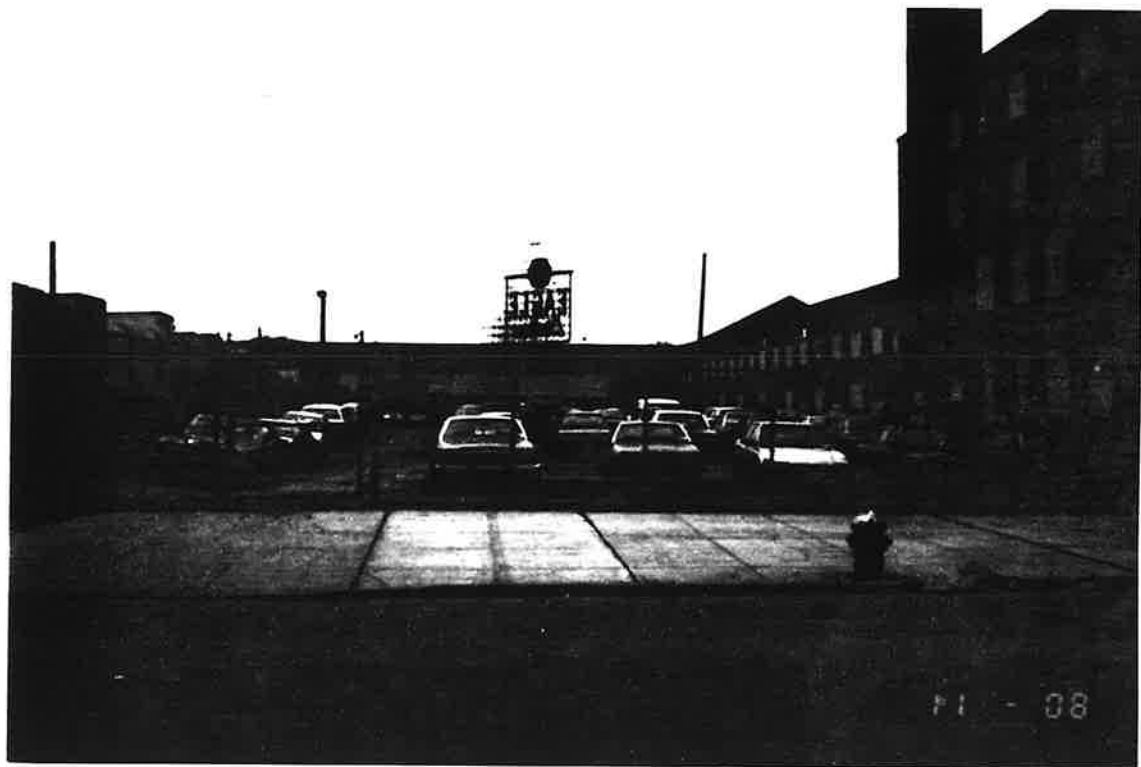
**PICTURE # 1:** View of the subject property from across the street.

The subject property, designated as tax block 980, tax lot 19, is located at 252 3rd Street between 3rd Avenue and 4th Avenue in Brooklyn, New York. The subject lot measures approximately 26,000 square feet and is enclosed within a chain link fence along the north, south and west sides of the property and is abutted by a brick building to the east. There are no buildings or structures on the subject property. The ground cover of the lot is loose gravel over packed dirt. The property is currently leased to Consolidated Edison Co. and is used as a parking facility for Consolidated Edison Co.'s employees. Please refer to Picture #1 and #2 in Appendix A.

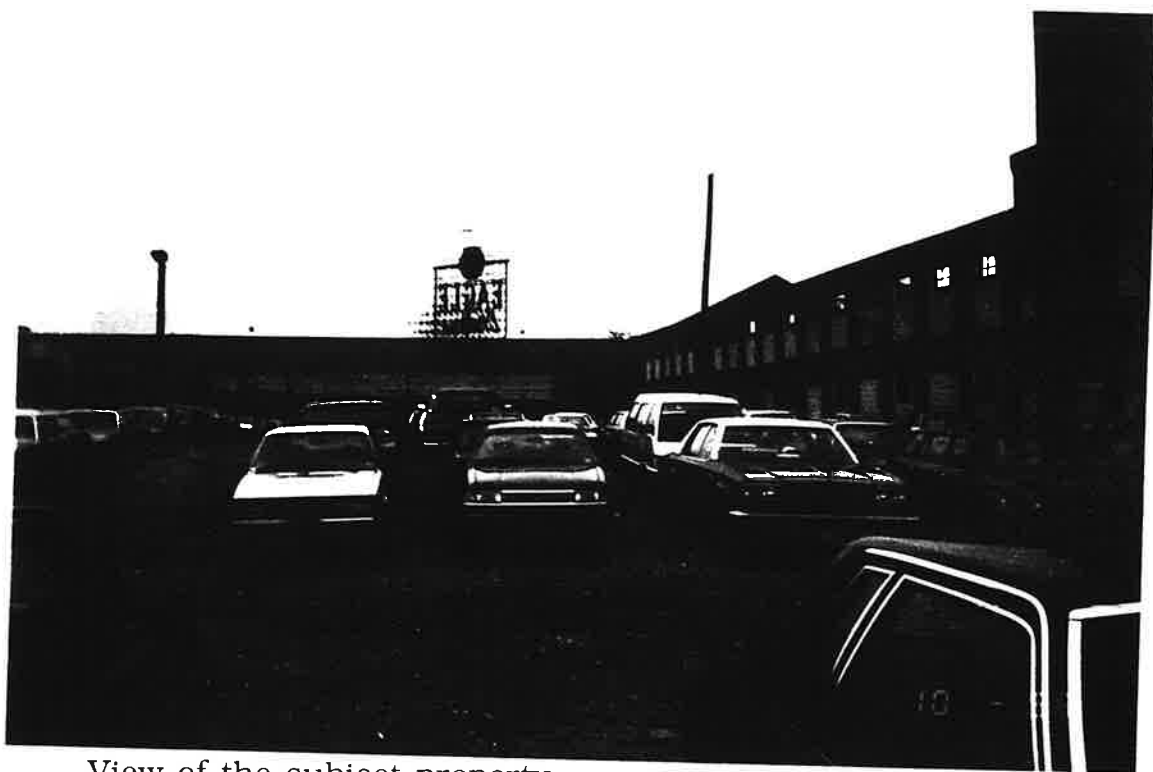
**PICTURE # 2:** View of the subject property.

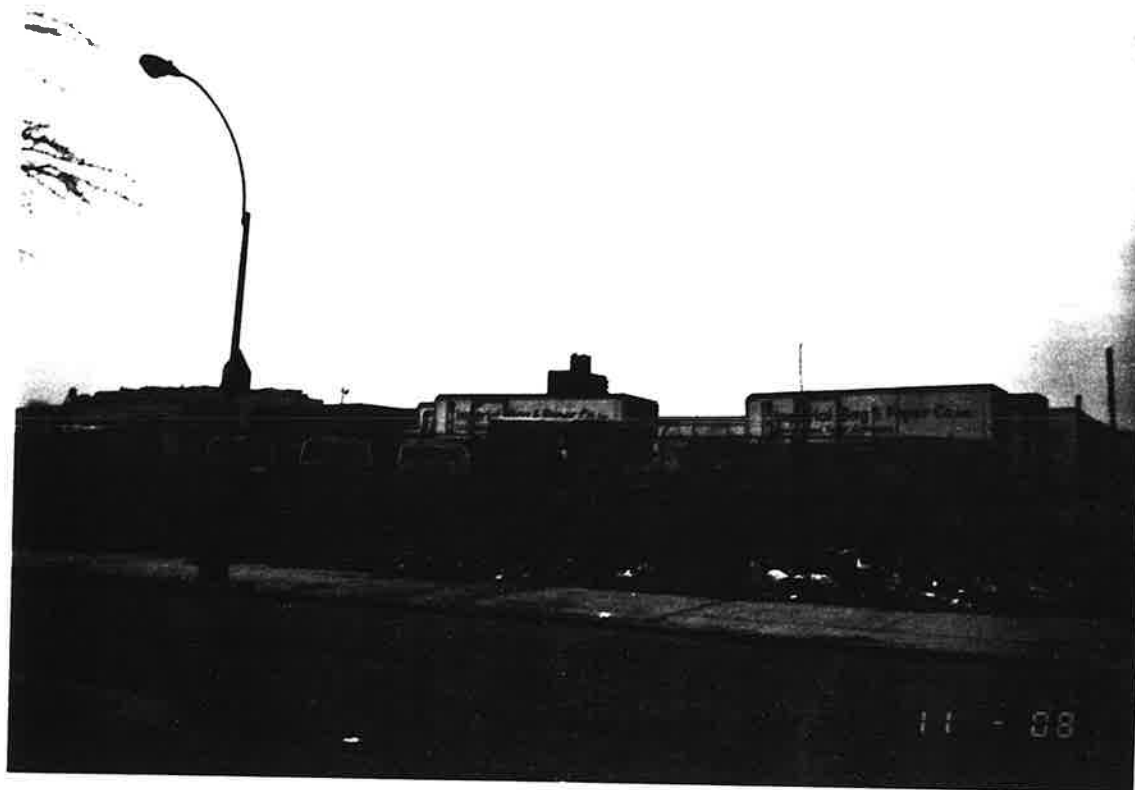
**PICTURE # 3:** View of Mendon Truck Rental and Leasing located adjacent and to the west of the site.

The property is in an M1-2 zoning district which permits light manufacturing facilities. Located directly across the street, to the north of the subject property is the Consolidated Edison Co. maintenance and garage facility which encompasses the entire block bounded by 2nd and 3rd Street, and 3rd and 4th Avenue. Further north of the property are commercial/retail establishments as well as some multiple story residential buildings. Located directly behind the subject property to the south is a U-Haul Truck Rental Facility. Located to the east of the subject property is the Mendon Truck Leasing and Rental Company and to the west is a multiple story loft building currently under renovation. Further west of the property and perpendicular to Third Avenue is the Gowanus Canal street basin. The basin is several hundred feet from the subject property. Please refer to Picture #3 to #6 in Appendix A.

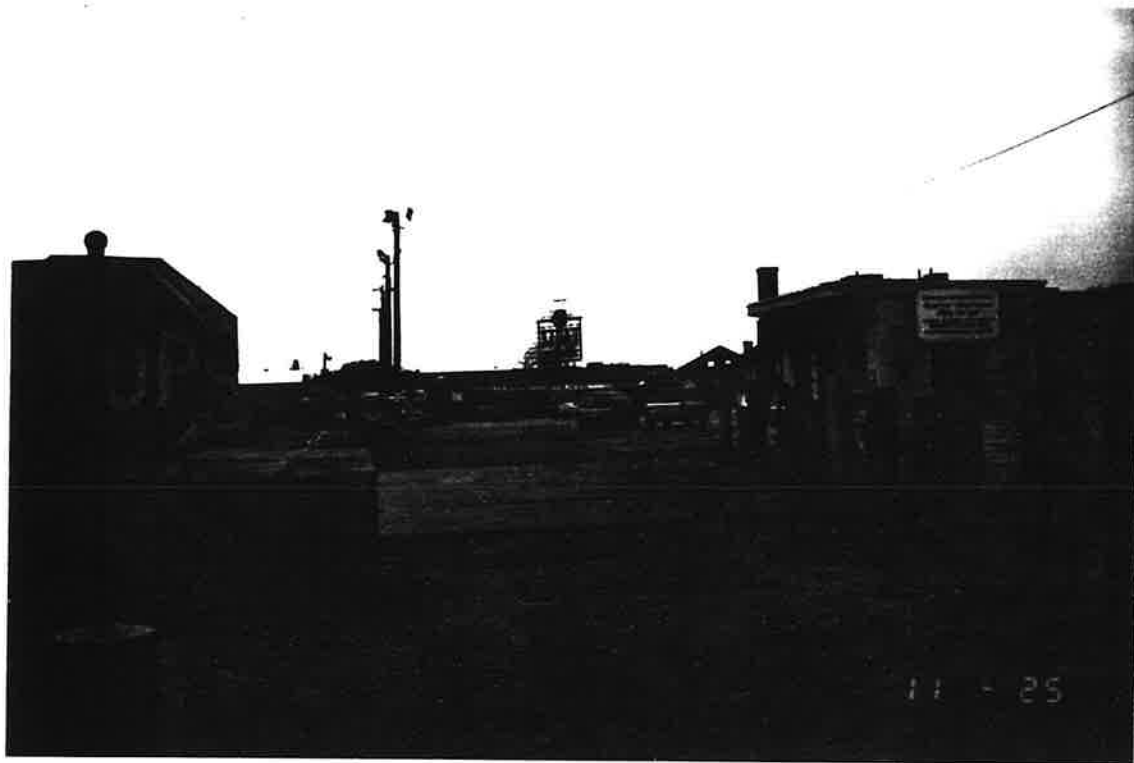
**PICTURE # 5:** View of Con Edison facility located across the street from subject property. Picture taken from 2nd Street.

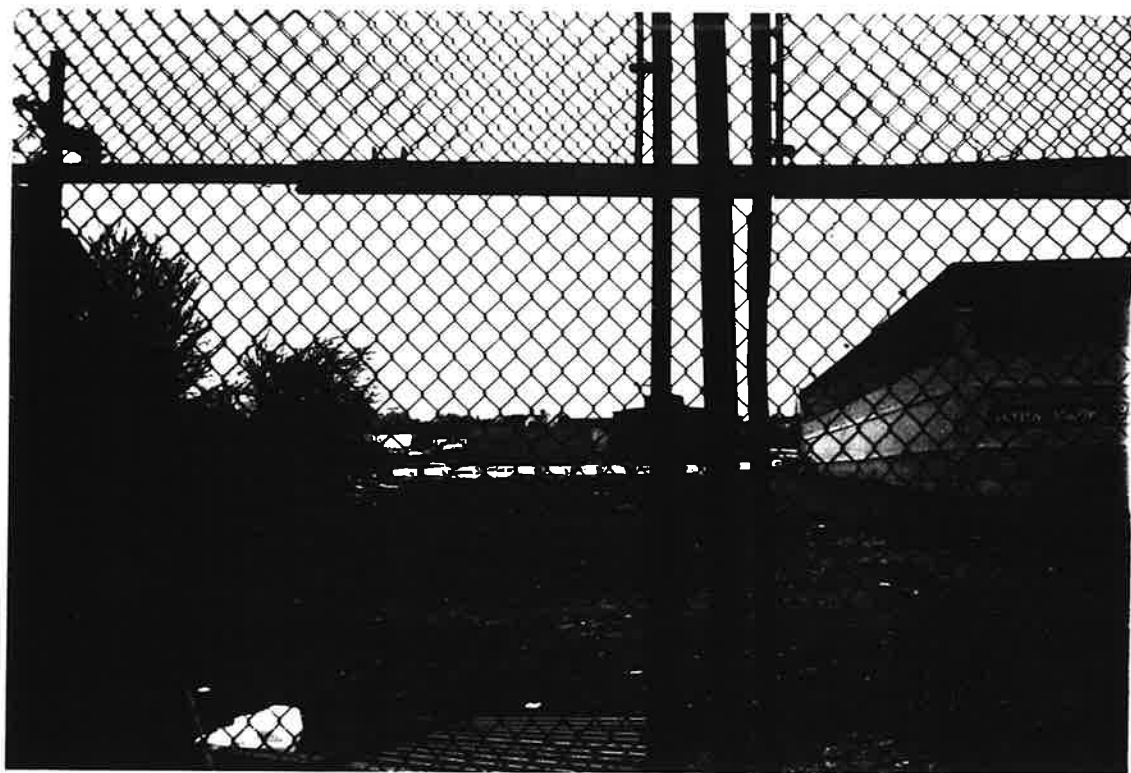
**PICTURE # 6:** View of U-Haul Truck Rental located south of the subject property.
