# PERIODIC REVIEW REPORT

**For the Property Located at  
West 19<sup>th</sup> Street Development Site, New York, NY**

*Prepared for*  
**HTRF Realty, LLC**  
555 West 18<sup>th</sup> Street  
New York, NY 10011

March 13, 2023

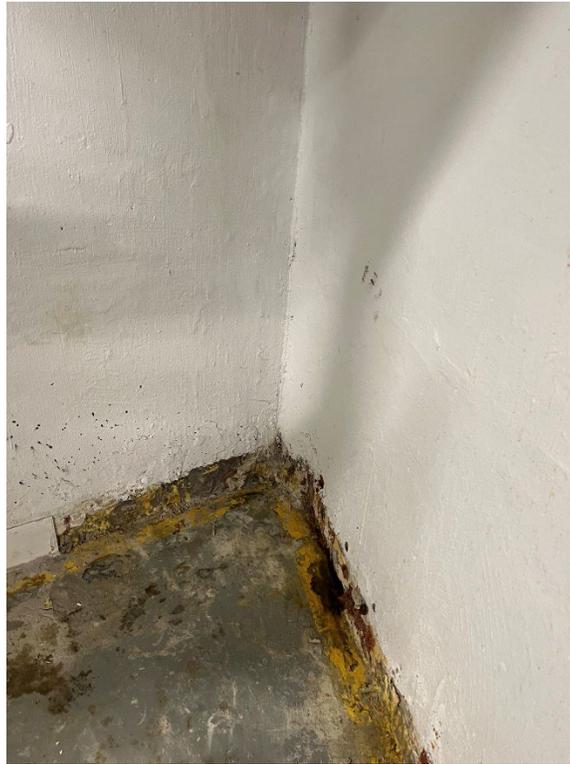
In March 2022, one location in the north west corner of the North Water Meter Room with evidence of water infiltration was repaired with hydro active grout injection, in accordance with Appendix A to the OMP. Integral observed this location during the 2023 visit and found that it remained effective in terms of preventing water infiltration.

Photograph 1. Previous Grout Injection from 2022 in Corner of North Water Meter Room (January 25, 2023).

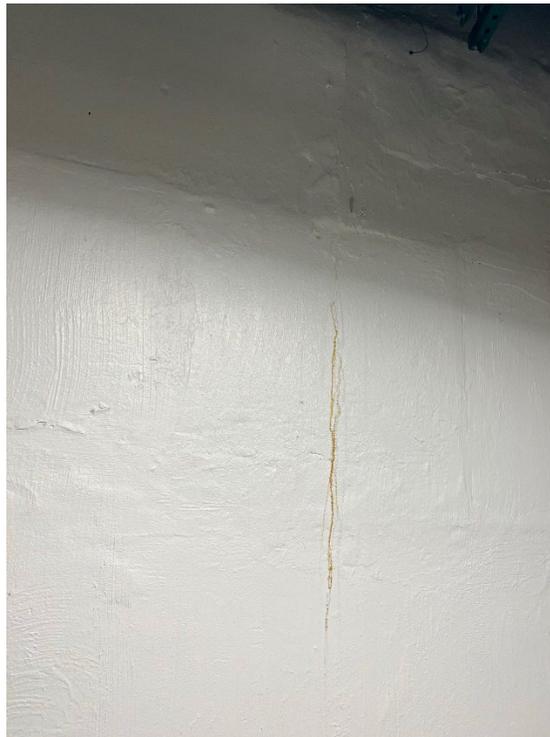
During the inspection, evidence of water infiltration was noted in two locations. A long vertical rust-colored stain was noted which originated near a seam between two cast-in-place concrete foundation wall sections of the North Water Meter Room. A member of the building

engineering staff made Integral staff aware during the inspection that he had recently noted moisture at this stain location. Moisture and efflorescence buildup was noted in the concrete foundation wall of the South Lobby AC Unit Room. Integral also observed historical evidence of staining or efflorescence (but not active water infiltration) at various locations along the perimeter foundation wall. See Figure 1 for the locations of these observations.

Photograph 2. Staining Evidence of Water Infiltration in North Water Meter Room (January 25, 2023).

Upon completion of the January 2023 visit, Integral recommended that the noted areas of water infiltration listed in Section 6.2 above be repaired using the grout injection technique described in the OMP.

The repair of the locations identified in the January 2023 inspection was performed by Starbrite on February 17, 2023, under the observation of Integral. The area was grout-injected following the OMP guidelines.

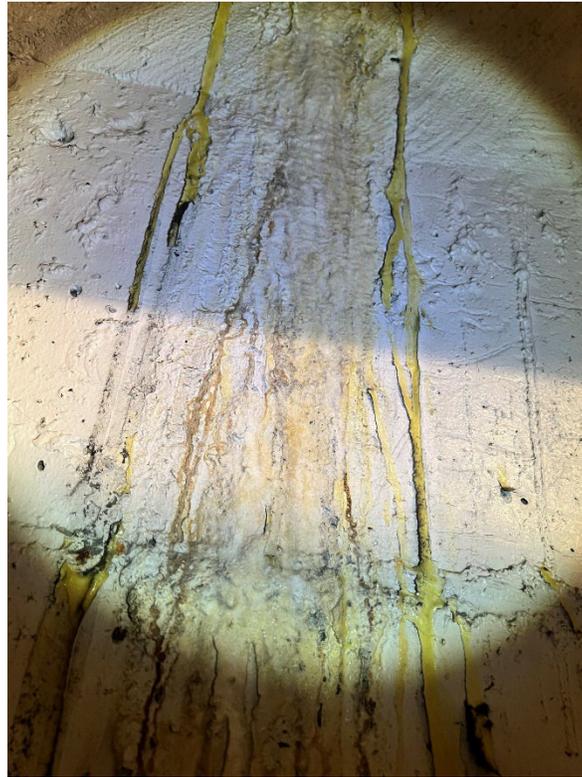
Photograph 3. Evidence of Water Infiltration and Efflorescence in South Lobby AC Unit Room (January 25, 2023).

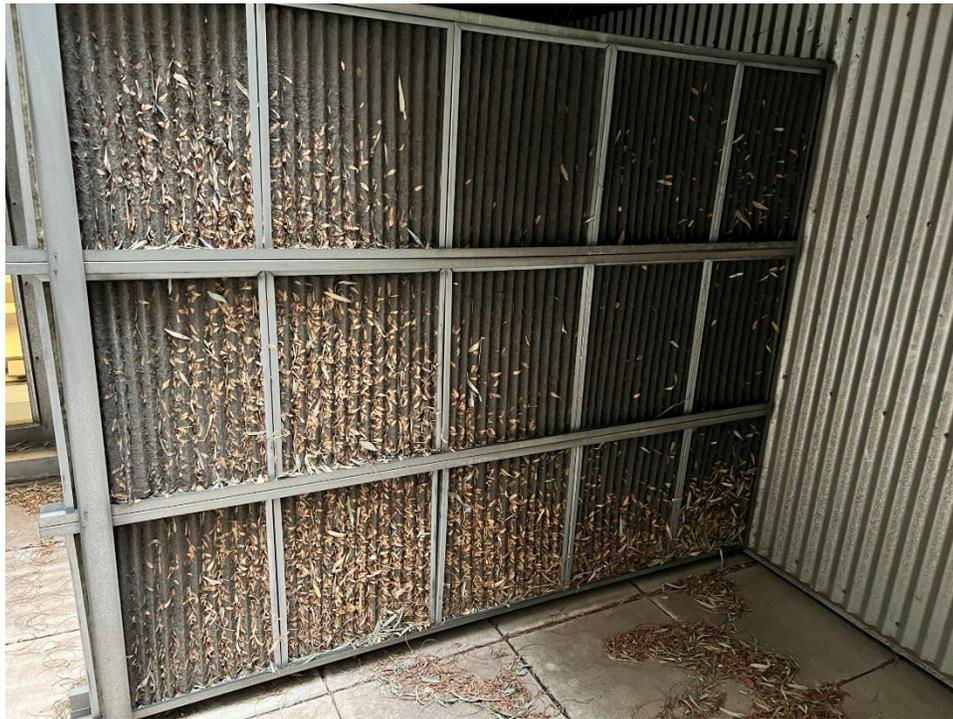
During the January 25, 2023 Site visit, the exhaust system was running at 80% capacity, due primarily to exhaust fan GEF-C-1 operating at 75% of design capacity. Integral discussed the low exhaust airflow with the building engineering team and learned that, even with supply fan GSF-C-1 operating at design capacity, building operational issues (e.g., airflow noise in the elevator bank, difficulty opening doors) occurred when GEF-C-1 was operated at a higher flow rate. To allow GEF-C-1 to operate closer to the design airflow, Integral suggested that the intake vent filters for GSF-C-1, which appeared clogged with dust and debris, be replaced for increased supply airflow.

Photograph 4. GSF-C-1 Intake Filters Clogged with Debris and Dust (January 25, 2023).

Integral suggested to the building engineering staff that they continue to change the GSF-C-1 intake vent filters when they appear to be clogged, and to continue to operate GEF-C-1 at an airflow rate close to its design.

The IAC Building Engineer stated that they will increase the filter replacement schedule for the GSF-C-1 intake vents from bi-annual to quarterly in order to better match the intake and exhaust of the basement air handling system and be able to run them at higher airflow.

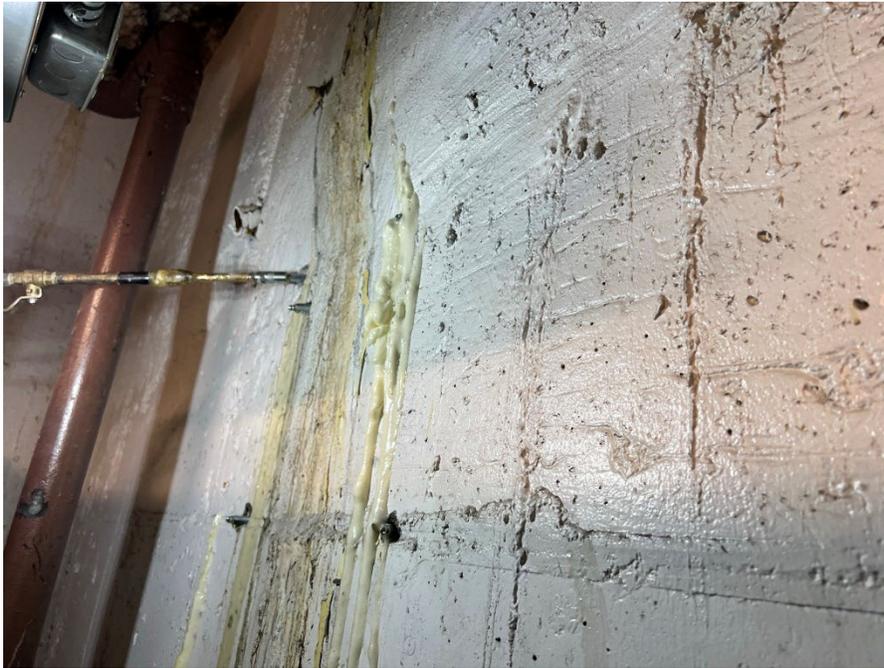
Photograph 5. Grout Injection in South Lobby AC Unit Room Wall (February 17, 2023).

The location of the repairs made during this reporting period are shown on Figure 1 (shows as “Active Water Infiltration” in the North Water Meter Room and South Lobby AC Unit Room). Photographs of the repairs can be found in Appendix B.

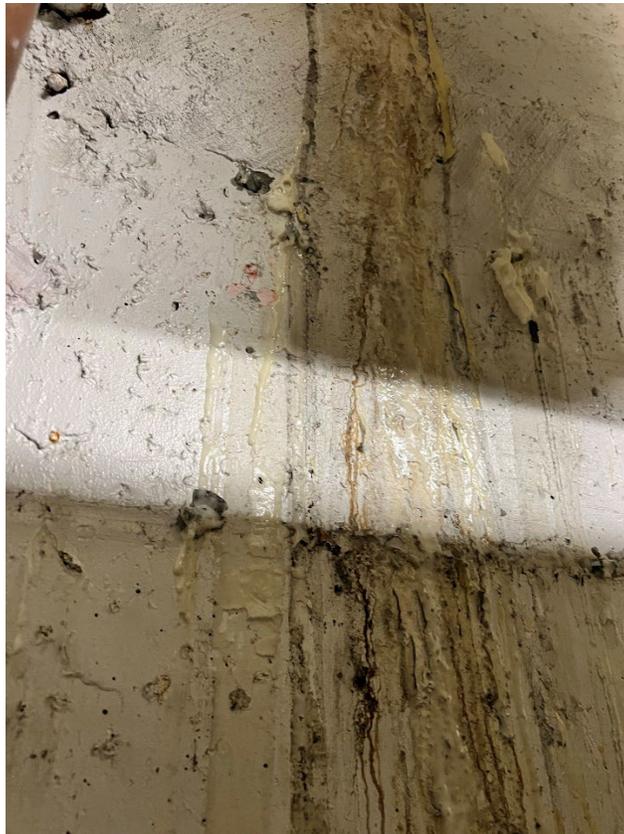
Photograph 6. Completed Grout Injection in South Lobby AC Unit Room Wall (February 17, 2023).

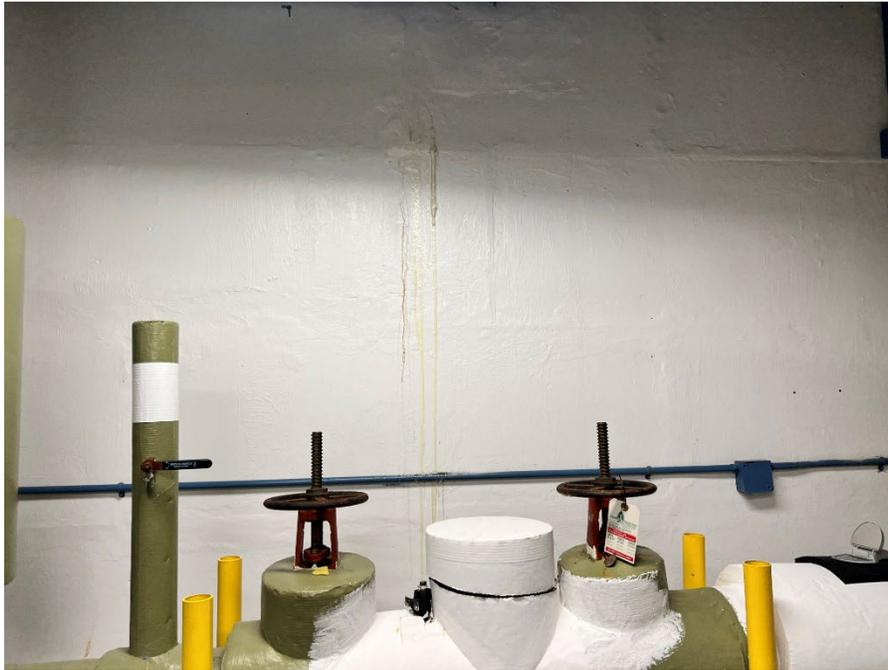
Photograph 7. Completed Grout Injection in North Water Meter Room (February 17, 2023).

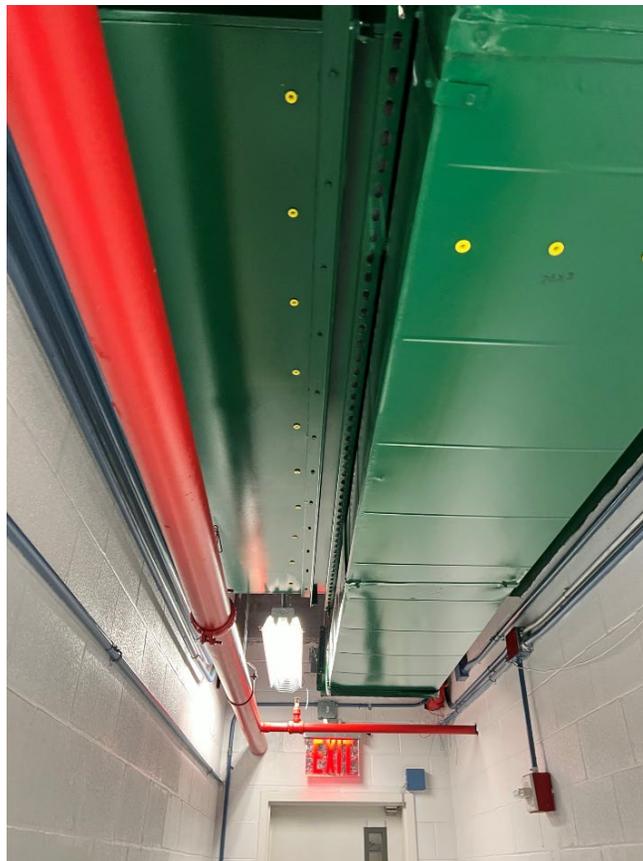
On February 17, 2023, Integral staff returned to the Site for the grout injection repairs described in Section 6.4 below and remeasured the airflow at GEF-C-1. Upon remeasurement, the airflow of GEF-C-1 was at 93% of the design airflow, and the total airflow of all fans together was consistent with the total design flow.

Photograph 8. GEF-C-1 and GEF-C-5 Duct Access Points (February 17, 2023).
