**PERIODIC REVIEW REPORT
MARCH 12, 2021 TO MARCH 12, 2022**

**4566 BROADWAY AVENUE (NAGLE)
4566 BROADWAY
NEW YORK, NEW YORK 10040
BCP ID No.: C231054**

**JCB PROJECT #: 22-51414
APRIL 2022**

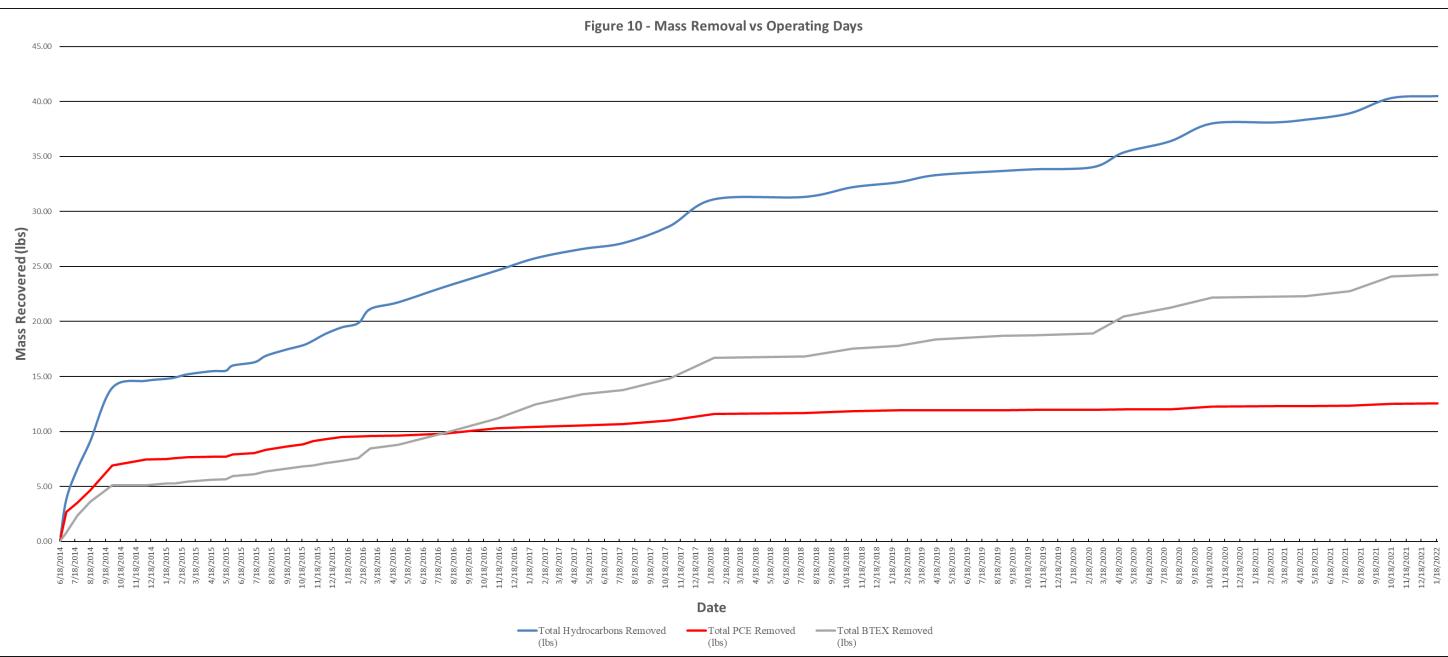
A total of 40.48 pounds of targeted volatile organics have been removed as of January 21, 2022. Of these materials, over 12.5 pounds of PCE and just over 24 pounds of BTEX have been removed. The PCE recovery has reached an asymptotic condition as only 0.24 pounds of PCE was removed over the reporting period and the recovery of BTEX has decreased to 1.9 pounds removed during the same reporting period.

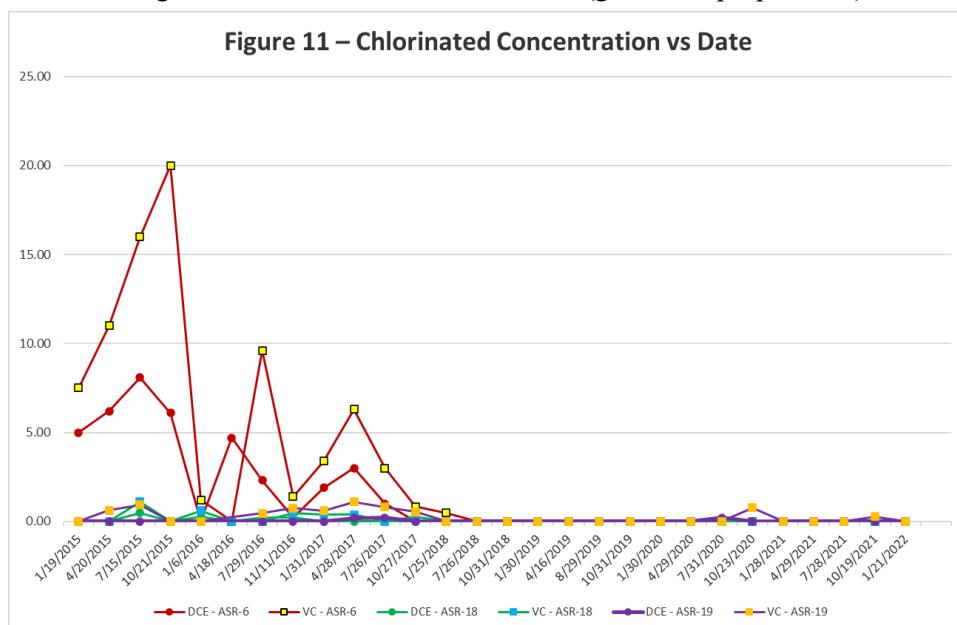
During this reporting period, Vinyl Chloride, Trichloroethylene, and cis-1,2-Dichloroethylene was detected above their respective guidance values in only one (1) groundwater monitoring well (MW-23). A continued downward trend in Cis-1,2-Dichloroethylene (DCE) and Vinyl Chloride (VC) is apparent as shown in Figure 11. DCE and VC in ASR-6 is no longer detected (red line). DCE and VC is also no longer detected in downgradient wells ASR-18 and ASR-19 (green and purple lines)

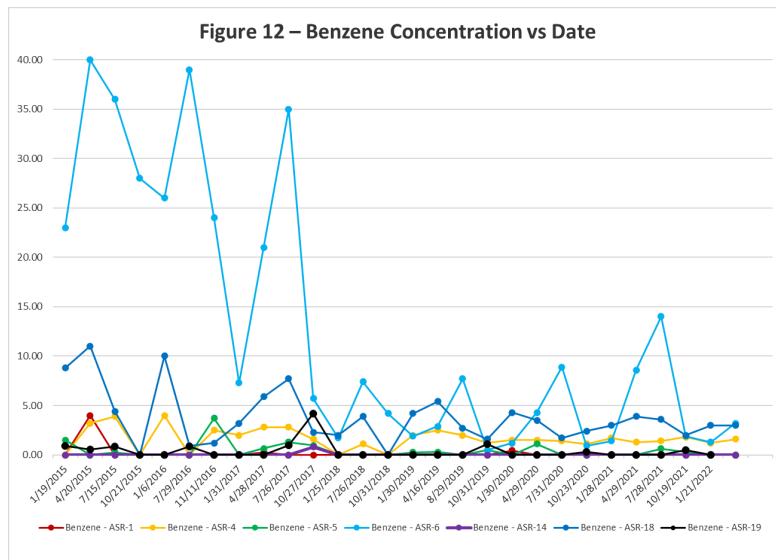
The off-site downgradient wells ASR-6, ASR-18 and ASR-19 are trending downward in concentrations with seasonal fluctuations partially obscuring the trend. Figure 12 shows the trend of benzene in these wells compared to the trend in on-site well ASR-4 near the former tank fields.

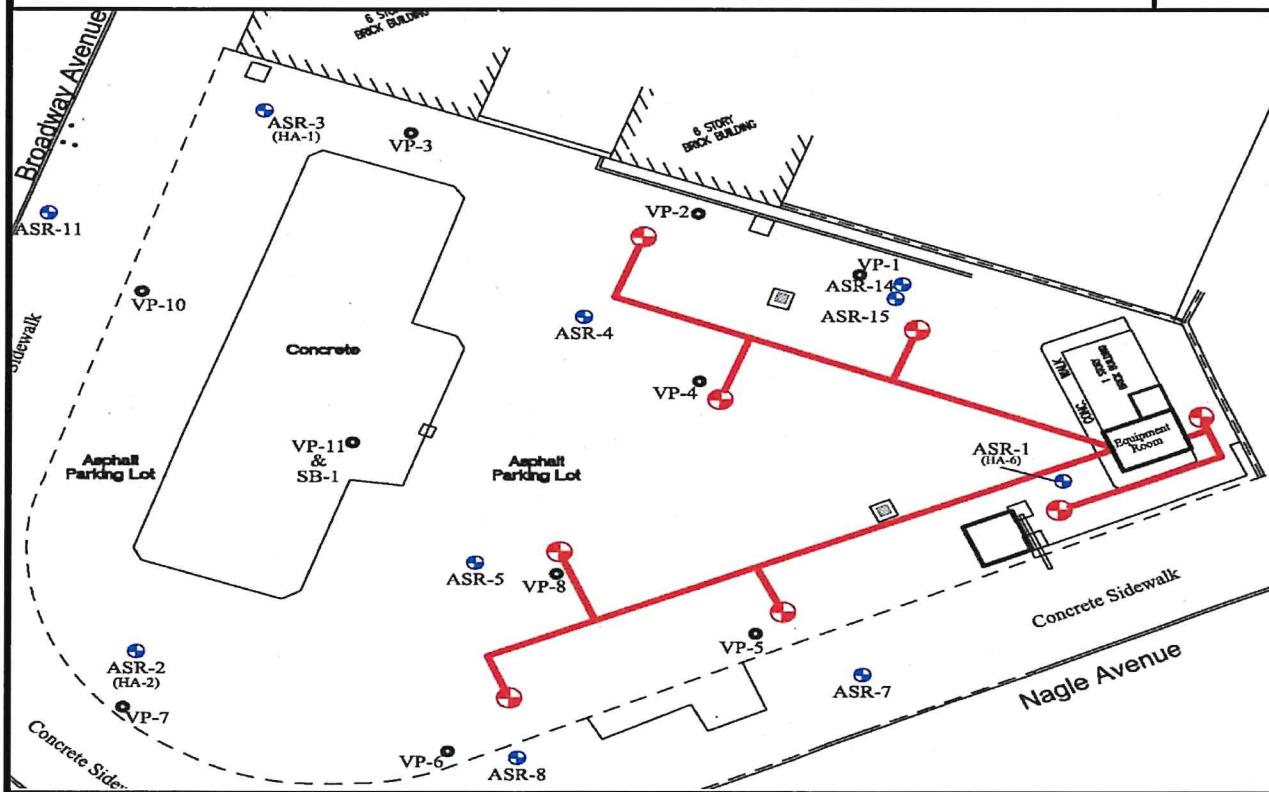
Site Pavement Conditions:

Condition of Monitoring Well Covers:	<input checked="" type="radio"/> Good	<input type="radio"/> Fair	<input type="radio"/> Poor
--------------------------------------	---------------------------------------	----------------------------	----------------------------

Additional Notes: *No pavement deformities were observed*

Were Site Repairs Made?	Yes	or	<input checked="" type="radio"/> No
-------------------------	-----	----	-------------------------------------

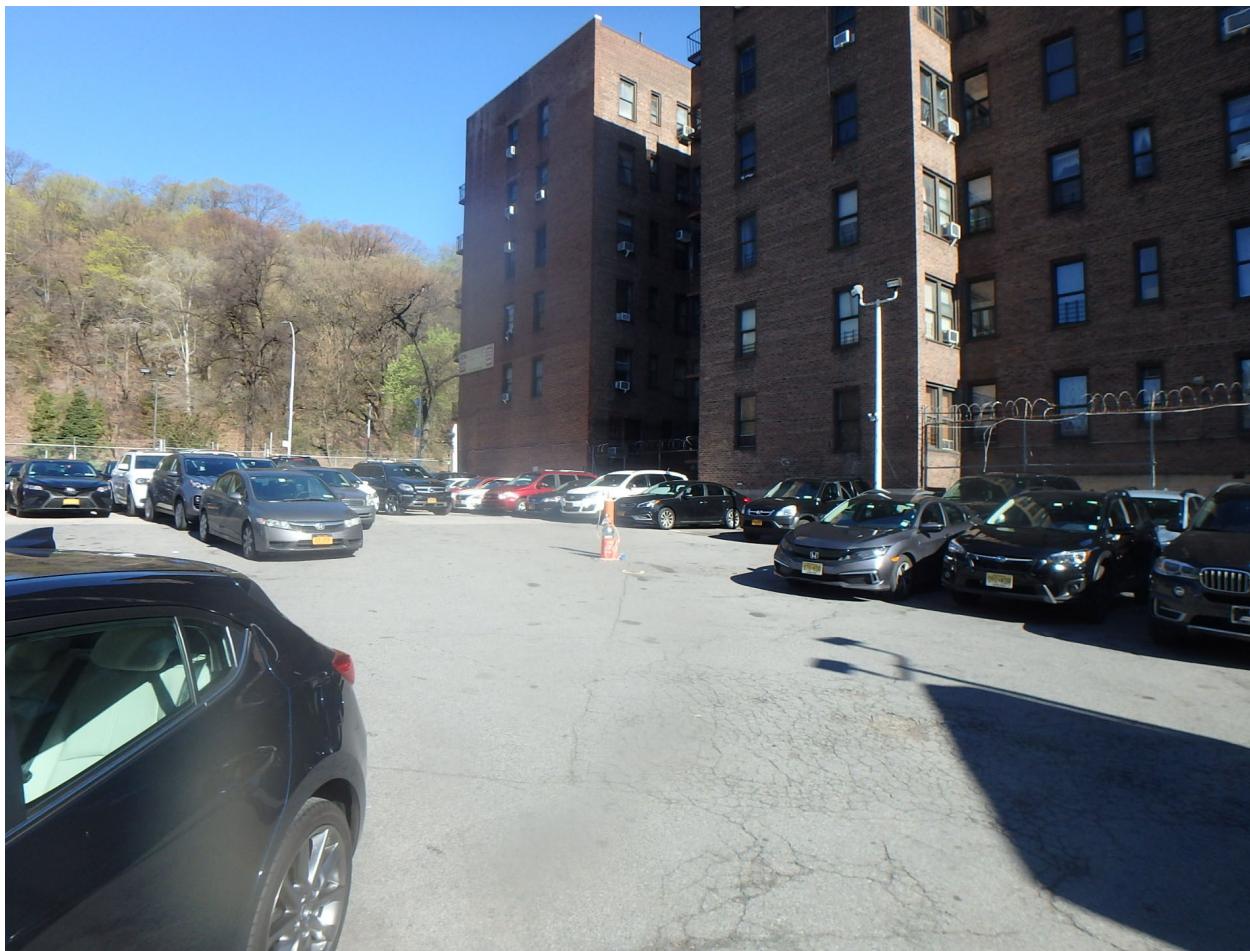
Overview of Subject Site

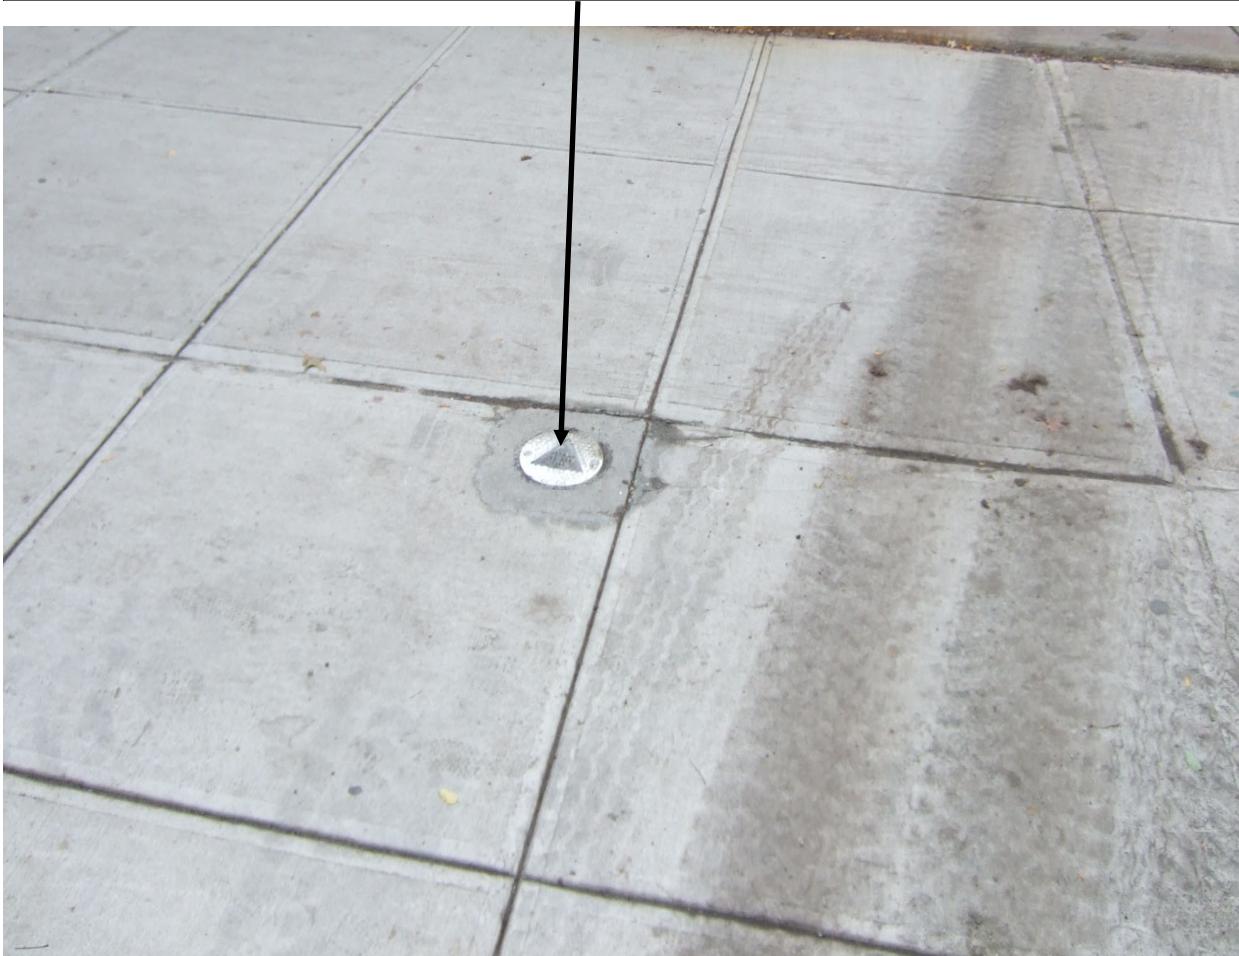
Photo No. 01

Typical Groundwater Monitoring Well Location

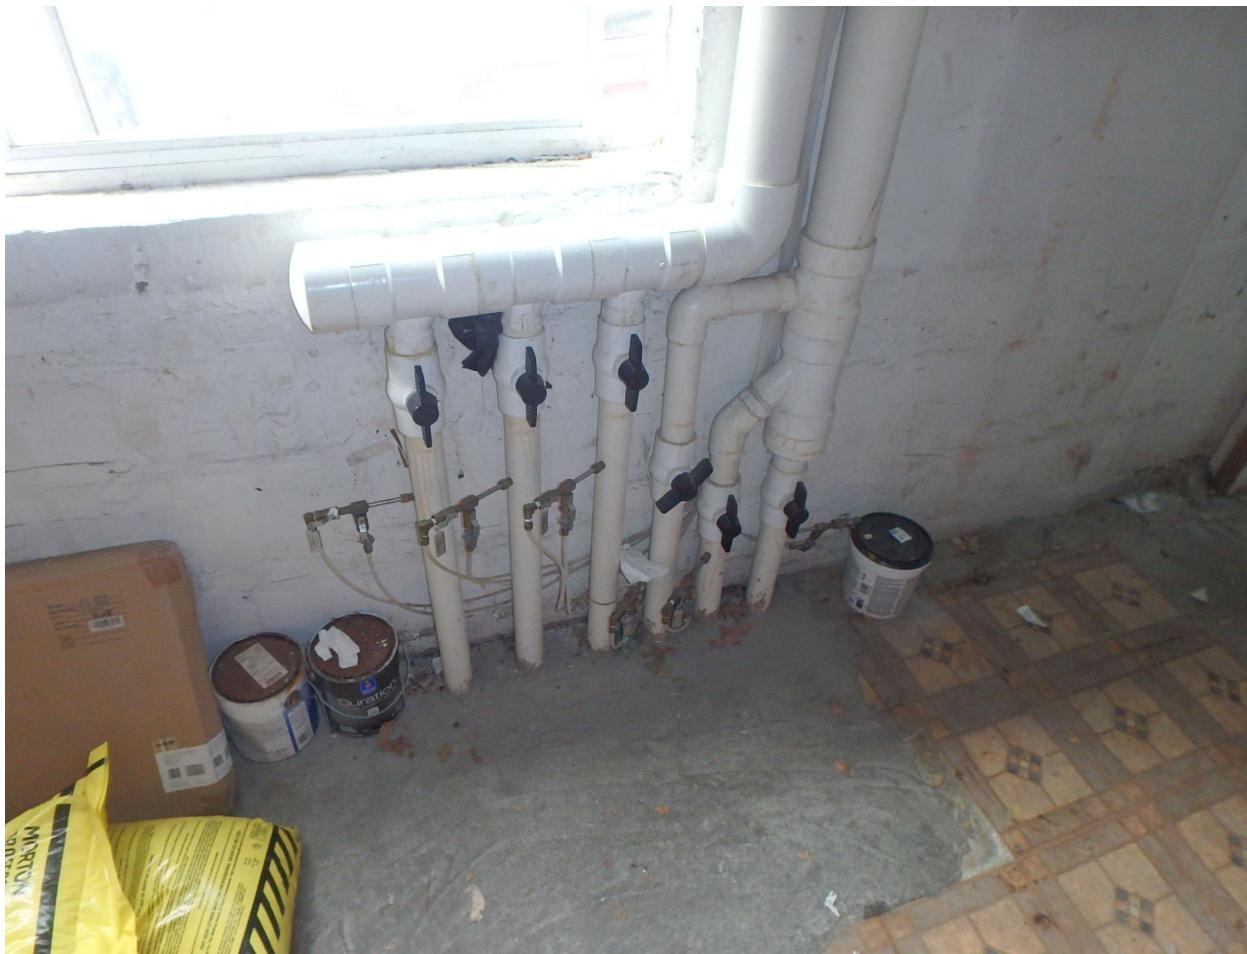
Photo No. 02

SVES System Manifold Within Equipment Area

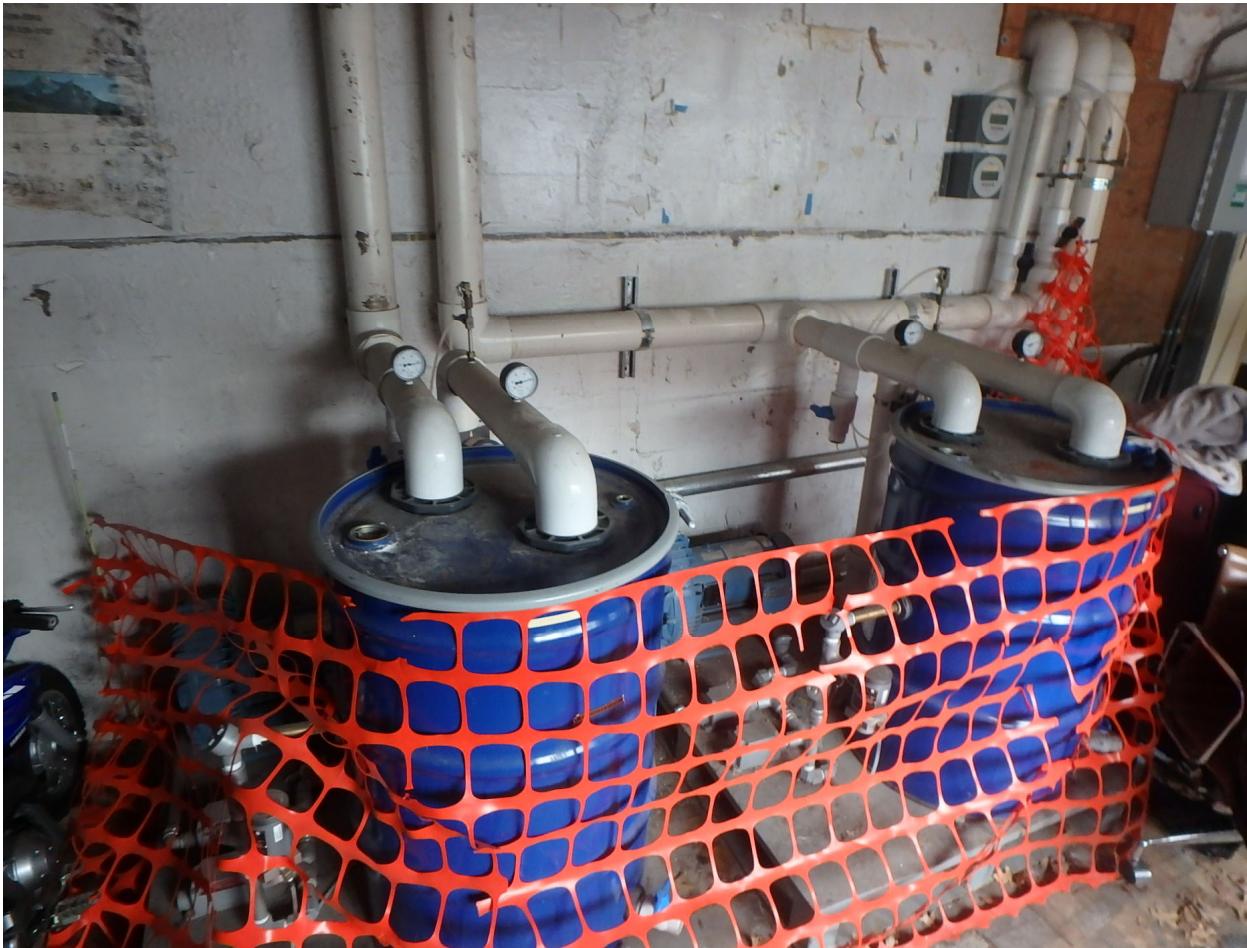
Photo No. 03

SVES Equipment Located Within Equipment Area

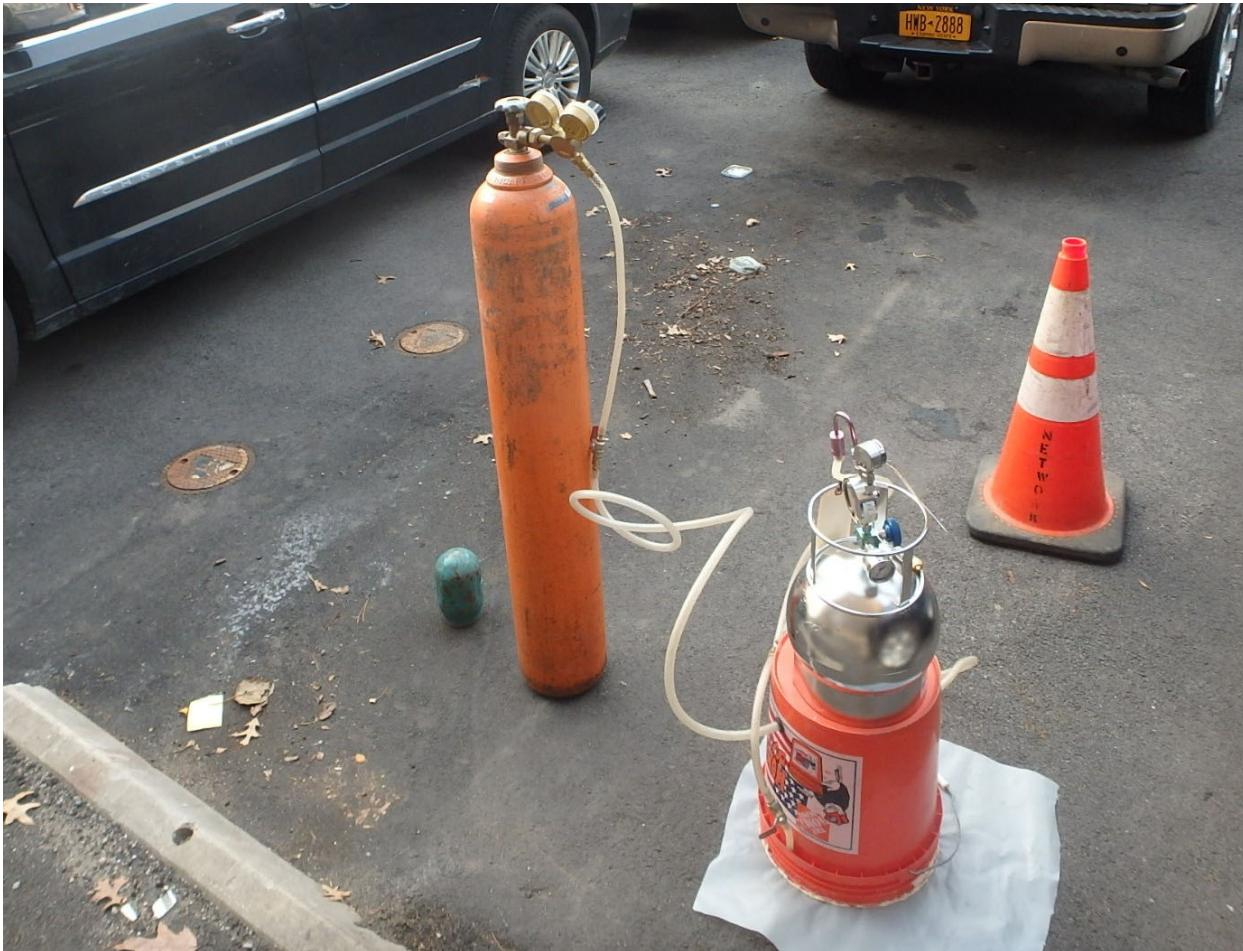
Photo No. 04

**Vapor Point Sampling
03/28/2022**
