**511 West 21st Street
New York, New York**

PERIODIC REVIEW REPORT

NYSDEC BCP Site No. C231080

**Fleming, Lee Shue Environmental
Engineering and Geology, D.P.C.**

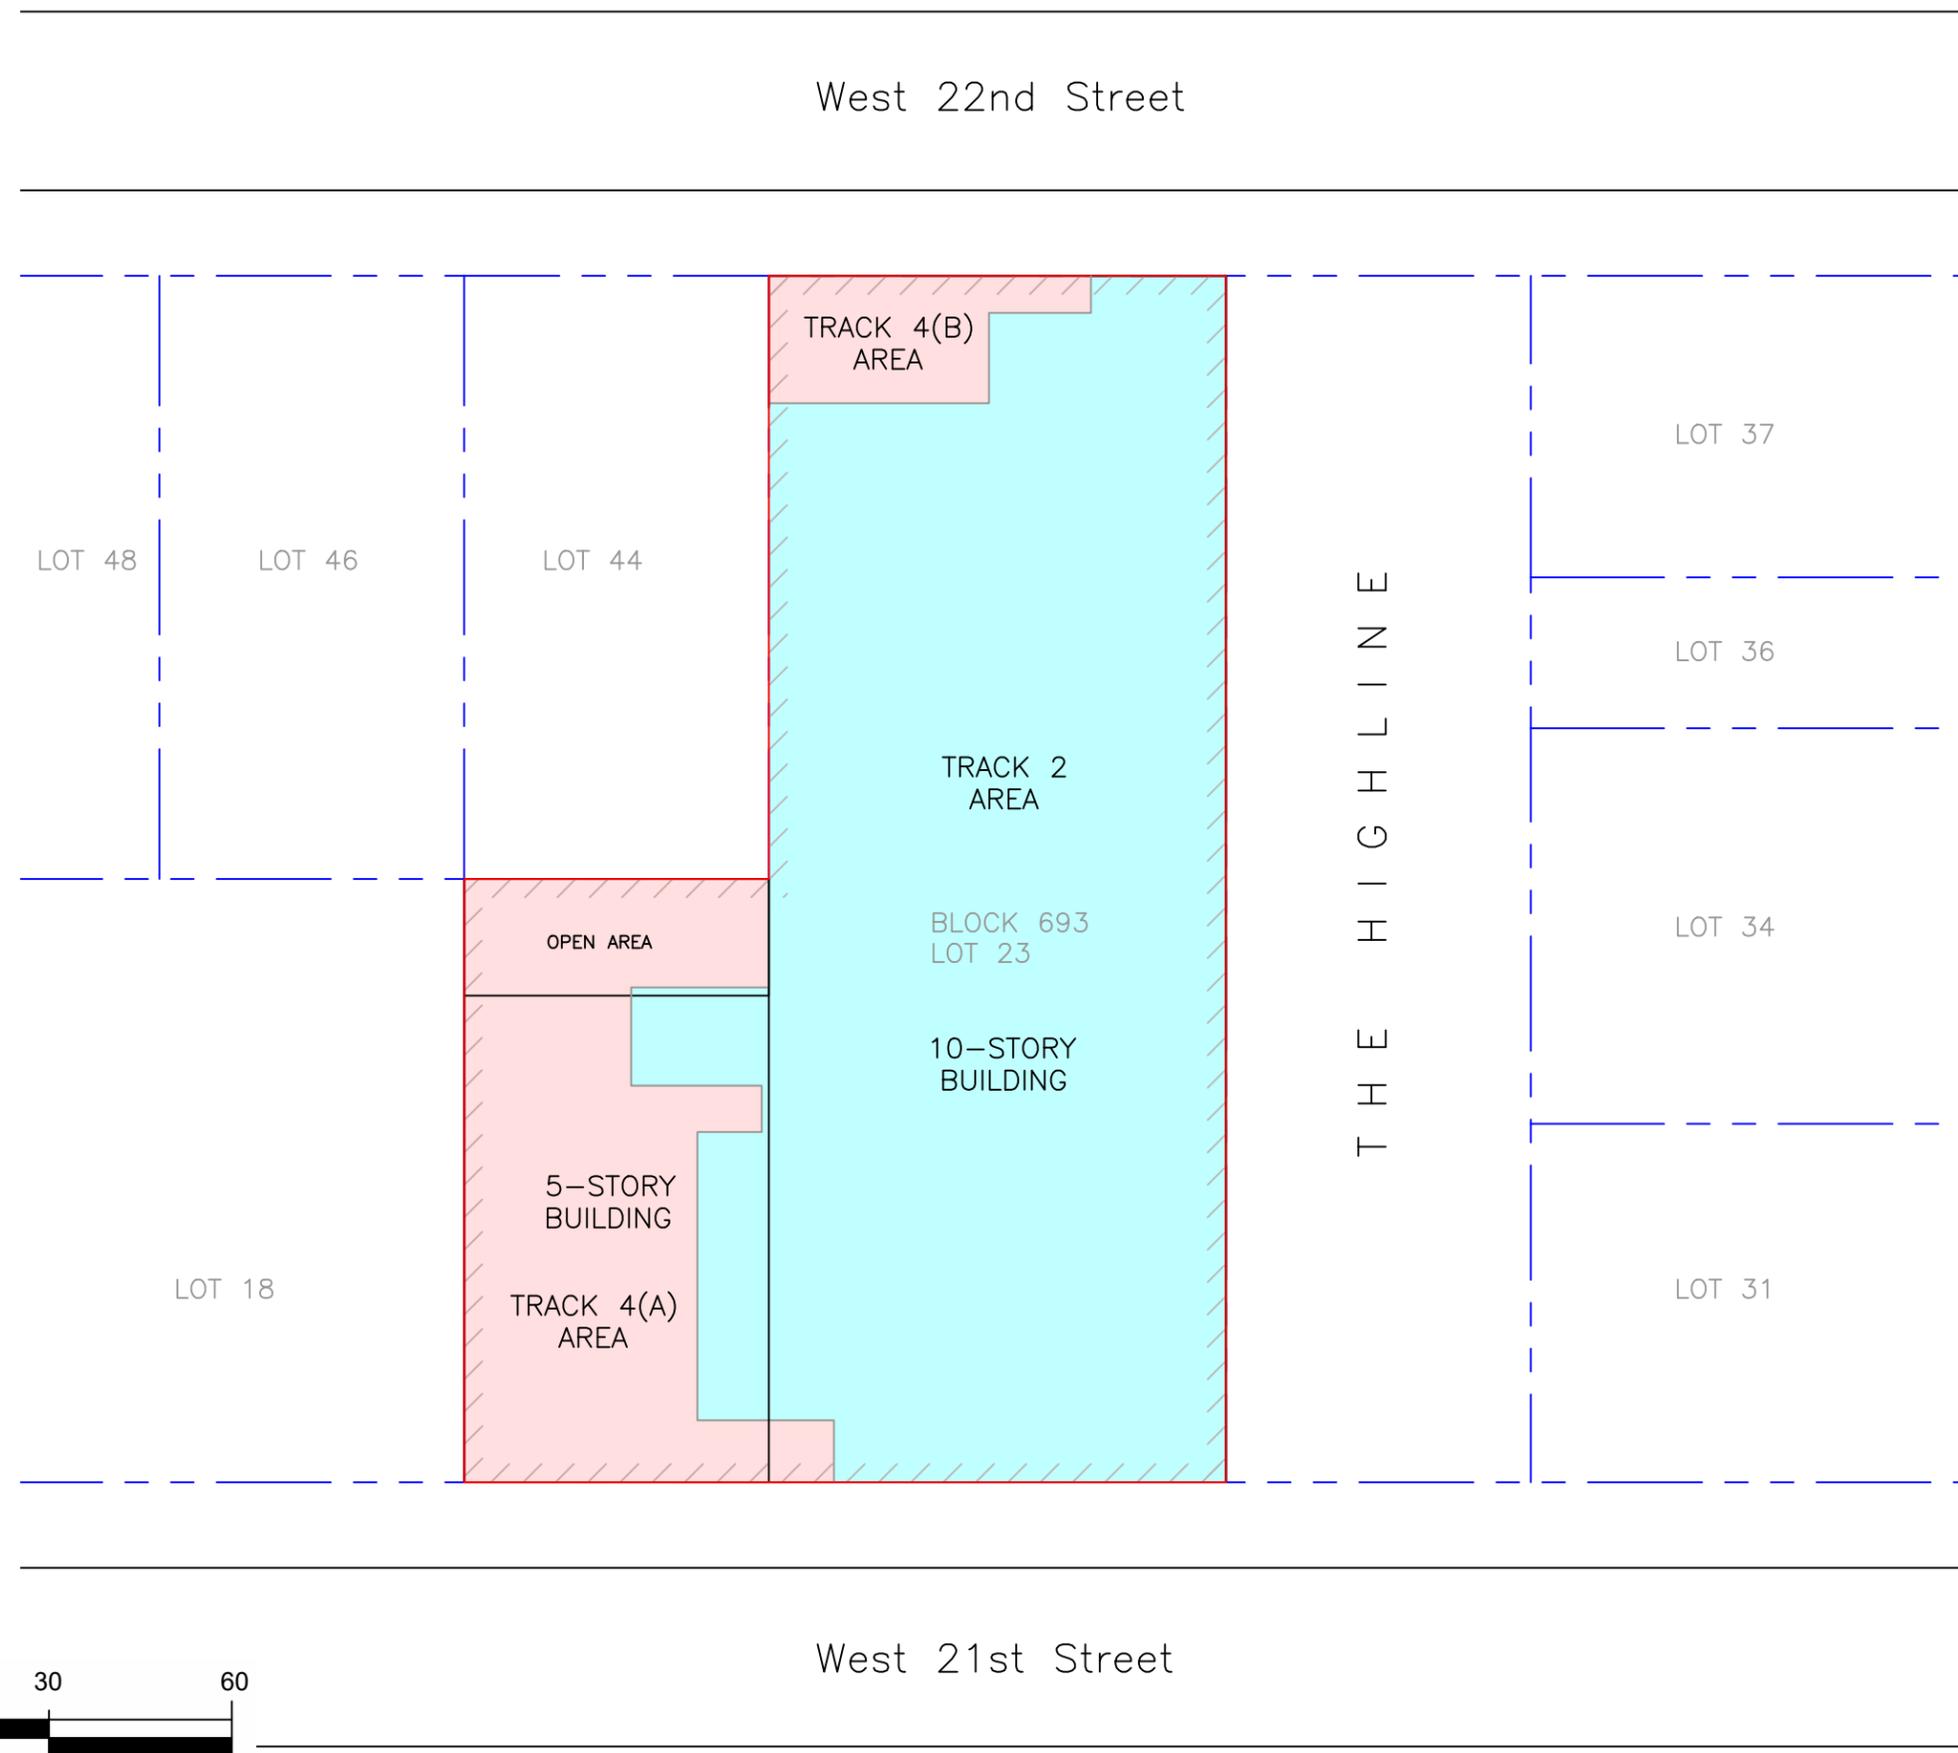
FIGURE 2

The development on the Site includes a 13-story commercial building. The development footprint is a lot line-to-lot line building as shown in Figure 2.

SITE LAYOUT

The majority of the existing groundwater monitoring wells were demolished during building construction, and two new monitoring wells (MW-1 and MW-3) were installed. Former MW-6 was repaired and developed by a licensed environmental driller and has been designated MW-2. As outlined in the SMP, quarterly groundwater monitoring (later reduced to semi-annual sampling in September 2019) was conducted to confirm natural attenuation of VOCs in groundwater. On September 4, 2020, NYSDEC approved reduction of the monitoring well network to include only MW-3. Monitoring wells MW-1 and MW-2 remain in place and continue to be gauged as a part of groundwater elevation data collection. The groundwater monitoring well locations are shown on Figure 2.

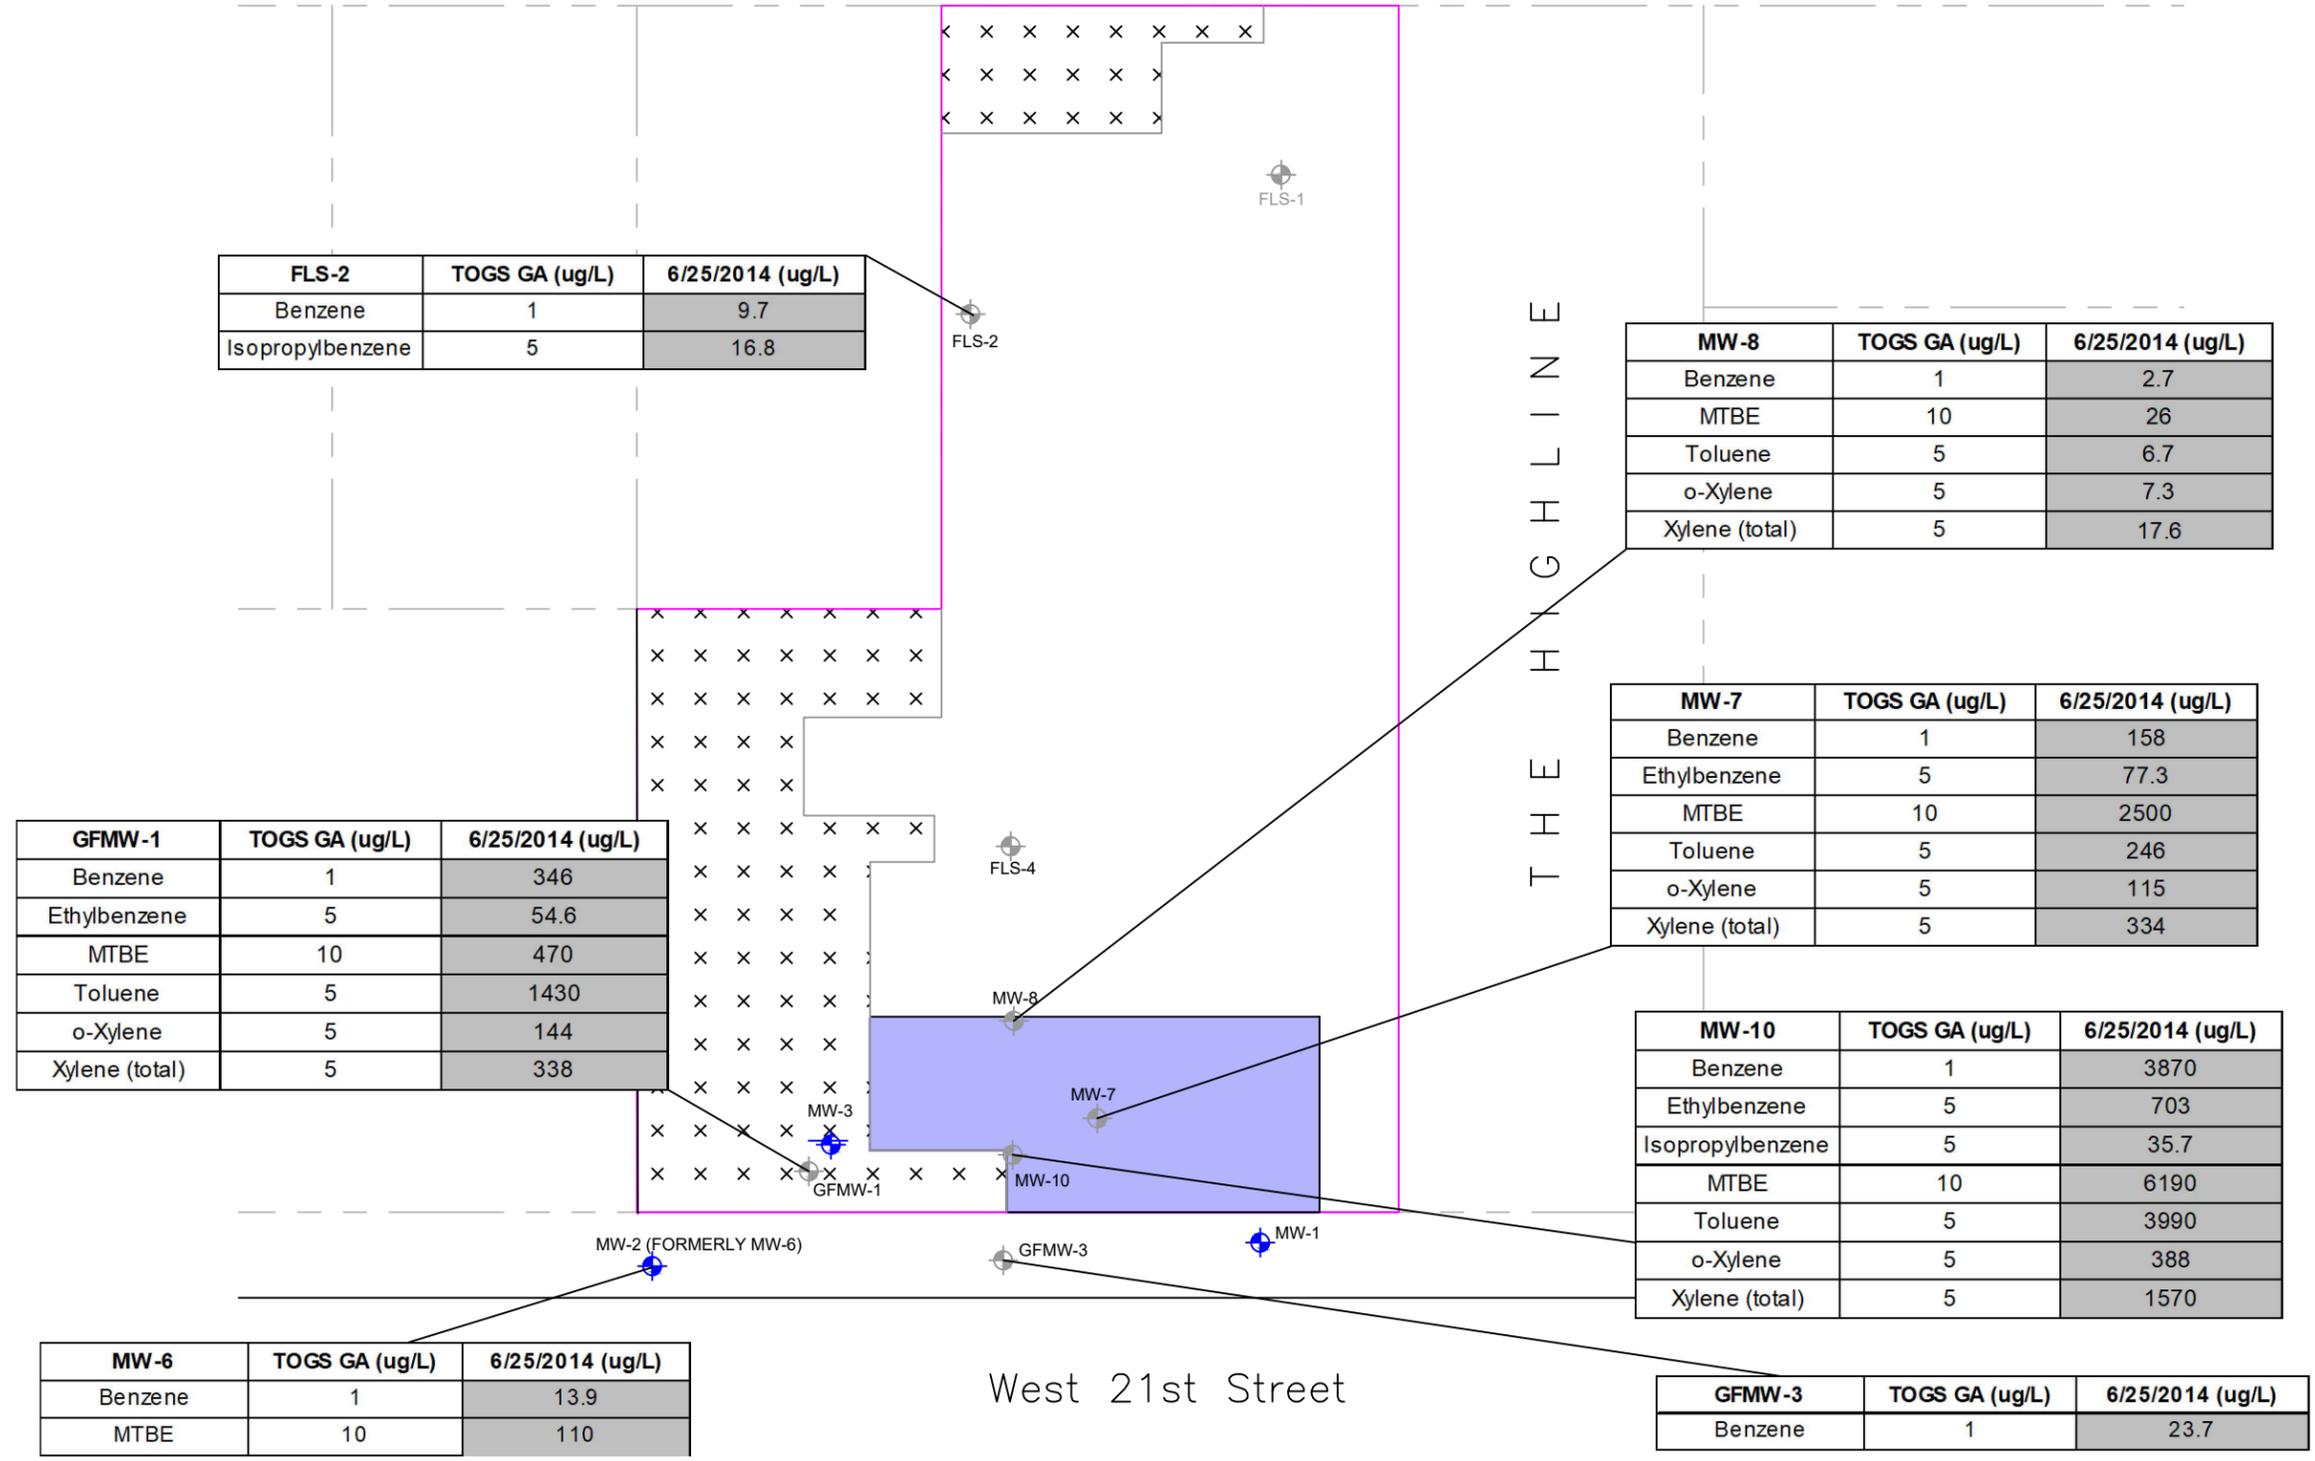
Figure 3A

FLS-2	TOGS GA (ug/L)	6/25/2014 (ug/L)
Benzene	1	9.7
Isopropylbenzene	5	16.8

MW-8	TOGS GA (ug/L)	6/25/2014 (ug/L)
Benzene	1	2.7
MTBE	10	26
Toluene	5	6.7
o-Xylene	5	7.3
Xylene (total)	5	17.6

MW-7	TOGS GA (ug/L)	6/25/2014 (ug/L)
Benzene	1	158
Ethylbenzene	5	77.3
MTBE	10	2500
Toluene	5	246
o-Xylene	5	115
Xylene (total)	5	334

GFMW-1	TOGS GA (ug/L)	6/25/2014 (ug/L)
Benzene	1	346
Ethylbenzene	5	54.6
MTBE	10	470
Toluene	5	1430
o-Xylene	5	144
Xylene (total)	5	338

MW-10	TOGS GA (ug/L)	6/25/2014 (ug/L)
Benzene	1	3870
Ethylbenzene	5	703
Isopropylbenzene	5	35.7
MTBE	10	6190
Toluene	5	3990
o-Xylene	5	388
Xylene (total)	5	1570

MW-6	TOGS GA (ug/L)	6/25/2014 (ug/L)
Benzene	1	13.9
MTBE	10	110

GFMW-3	TOGS GA (ug/L)	6/25/2014 (ug/L)
Benzene	1	23.7

PRE-REMEDIAL EXCEEDANCES OF VOCs IN GROUNDWATER

NYSDEC spill number #00-10394 was opened when petroleum contamination was discovered in 2000. Remedial investigations at the Site between May 2007 and October 2014 found Underground Storage Tanks and soils with elevated levels of volatile organic compounds (VOC), semi-volatile organic compounds (SVOC) and metals. Groundwater and soil vapor indicated elevated concentrations of gasoline-related chemical constituents. Offsite investigations downgradient identified concentrations of VOCs in groundwater attributable to the on-Site spill. Spill number #00-10394 was subsequently closed by NYSDEC in October 2018. Pre-remediation groundwater and soil vapor sample locations with summary of elevated analytical data are depicted on Figures 3A and 4A. Pre-remediation VOC analytical data are summarized in Tables 1 and 3.

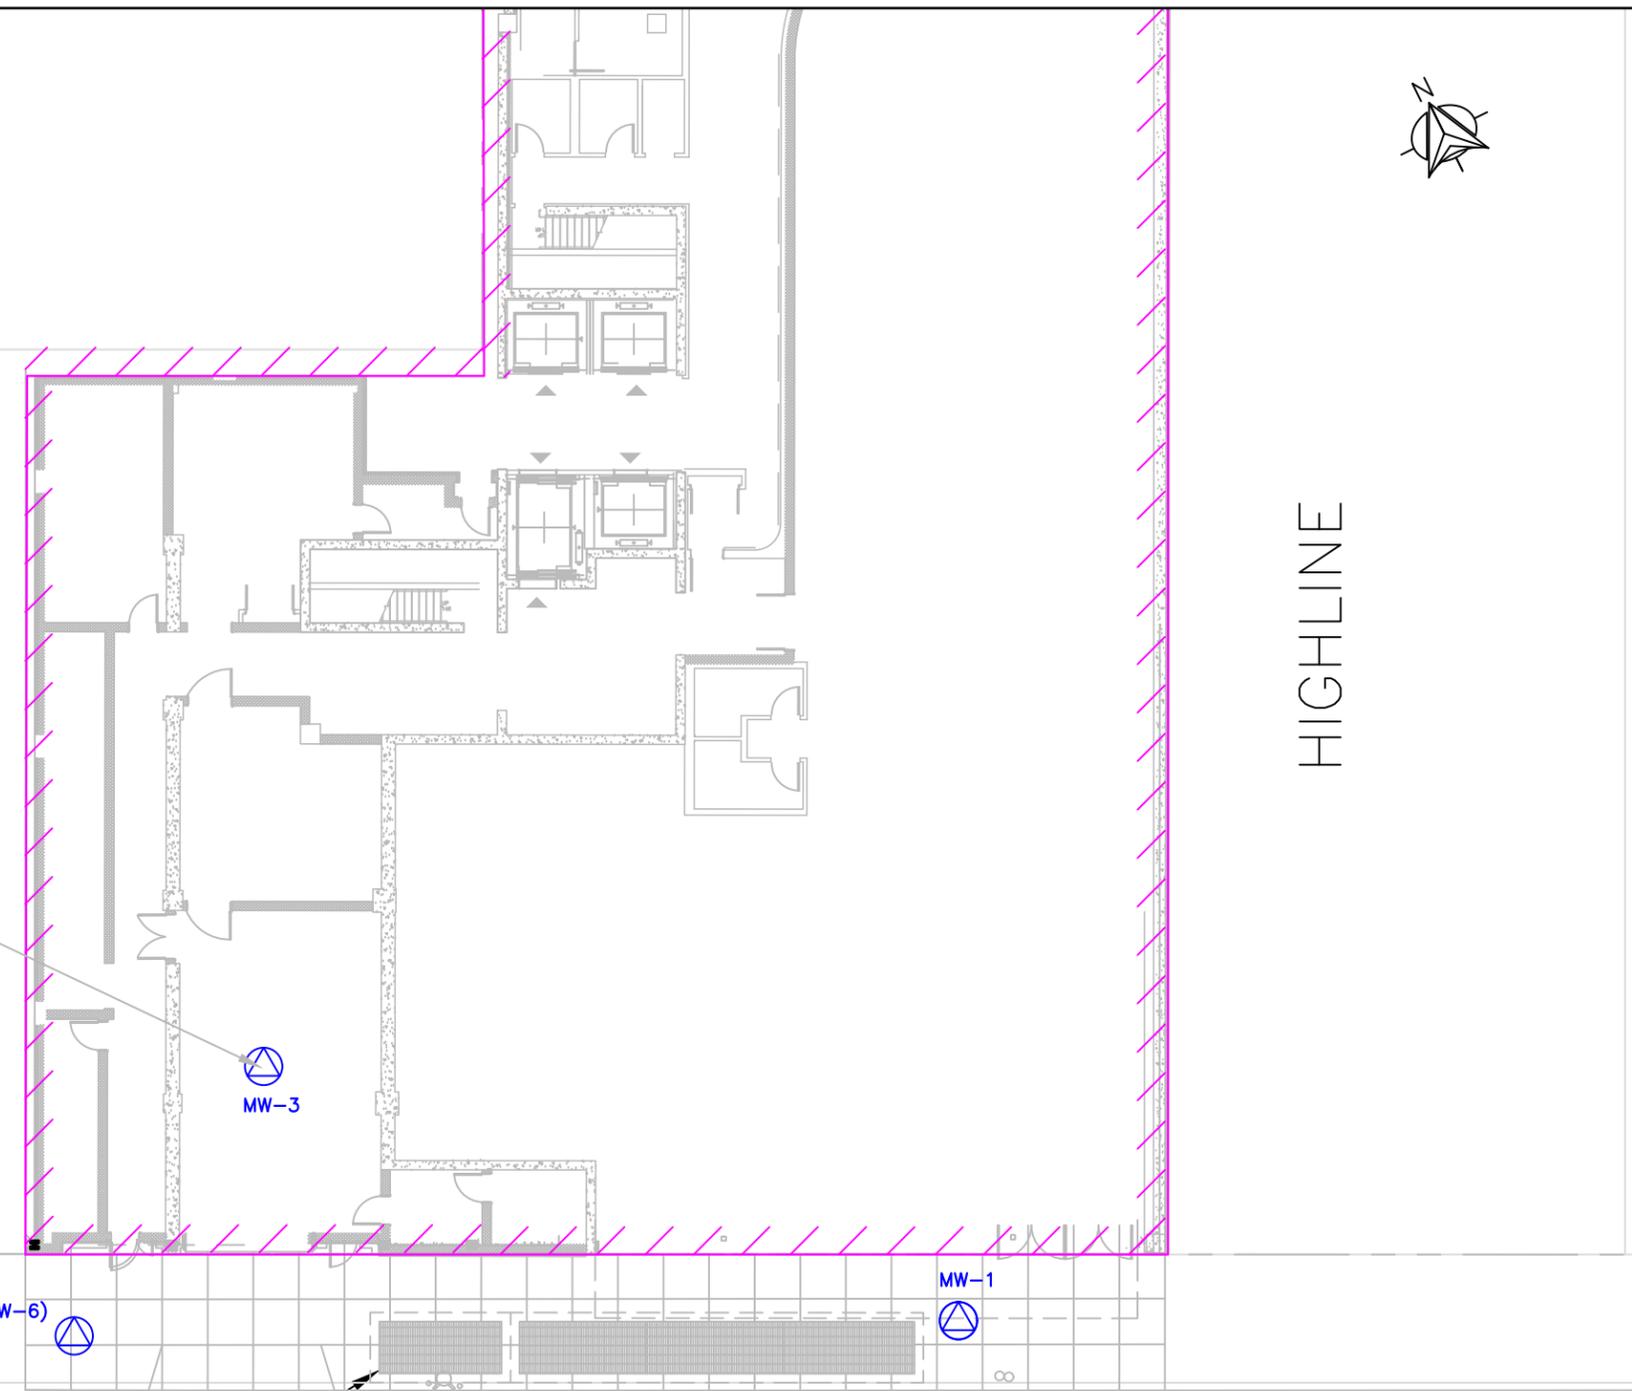
Figure 3B

**Post-Remediation
Semi-Annual
Groundwater
Sampling Results**

MW-3	3/12/2020	9/15/2020
Benzene	12.0	10.9
Toluene	30.4	30.6
Ethylbenzene	2.2	1.9
Xylene (total)	13.4	11.9
MTBE	260	191
	3/12/2021	9/21/2021
Benzene	2.4	12.6
Toluene	6.4	40.5
Ethylbenzene	ND (0.60)	2.3
Xylene (total)	2.4	14.1
MTBE	40.7	142

Notes:
Groundwater results and TOGS values in ug/L.
Samples were collected 9/21/2021.
Results qualified J are estimated.
Highlighted Results show Target Compound List (Method 8260) VOCs above TOGs class GA AWQS.
Technical Operational Guidance Services (TOGS)
Ambient Water Quality Standards and Guidance Values (AWQS)

During the reporting period, groundwater samples were collected from MW-3 in September 2021. See Figures 3A and B for post-remediation monitoring well locations. Groundwater analytical results for the most recent sampling events are summarized in Table 2. Groundwater data indicates that concentrations under the Site have decreased by over an order of magnitude from pre-remediation contaminant concentrations. Additional data from the most recent groundwater monitoring event is presented in Section 4.2. Typically, a second semi-annual groundwater sampling event is conducted in March, however, following the results of the September 2021 sampling event, FLS recommended to discontinue the groundwater monitoring program on Site. At the time of this report, NYSDEC and the New York State Department of Health (NYSDOH) have not yet finalized a determination regarding this request. However, NYSDEC did approve a request to postpone additional groundwater sampling until a final decision had been made. A copy of this approval is included in Appendix B.

The most recent groundwater samples were collected in September 2021 and were analyzed for VOCs by SGS Laboratories using EPA Method 8260. Results, analysis and recommendations are presented in the 2021 Semi-Annual Groundwater Monitoring Report dated December 2021. Contaminants of concern were detected in location MW-3 at concentrations above the NYSDEC Division of Water Technical and Operational Guidance Series 1.1.1 Ambient Water Quality Standards and Guidance Values (TOGS), including benzene, toluene, xylene, and methyl-tert-butyl ether (MTBE). However, these concentrations remain well below pre-remediation groundwater concentrations:

- As detailed in the September 2021 Semi-Annual Groundwater Report, based on evidence of sustained low-level asymptotic data trends for contaminants of concern on Site, FLS recommends to discontinue the groundwater monitoring program on Site. As approved by NYSDEC, FLS will postpone groundwater sampling activities until a determination is reached.
- All ECs and ICs at the Site will continue in operation and monitoring in 2022.
- The SSDS will continue to operate passively to mitigate potential soil vapor intrusion into the building.

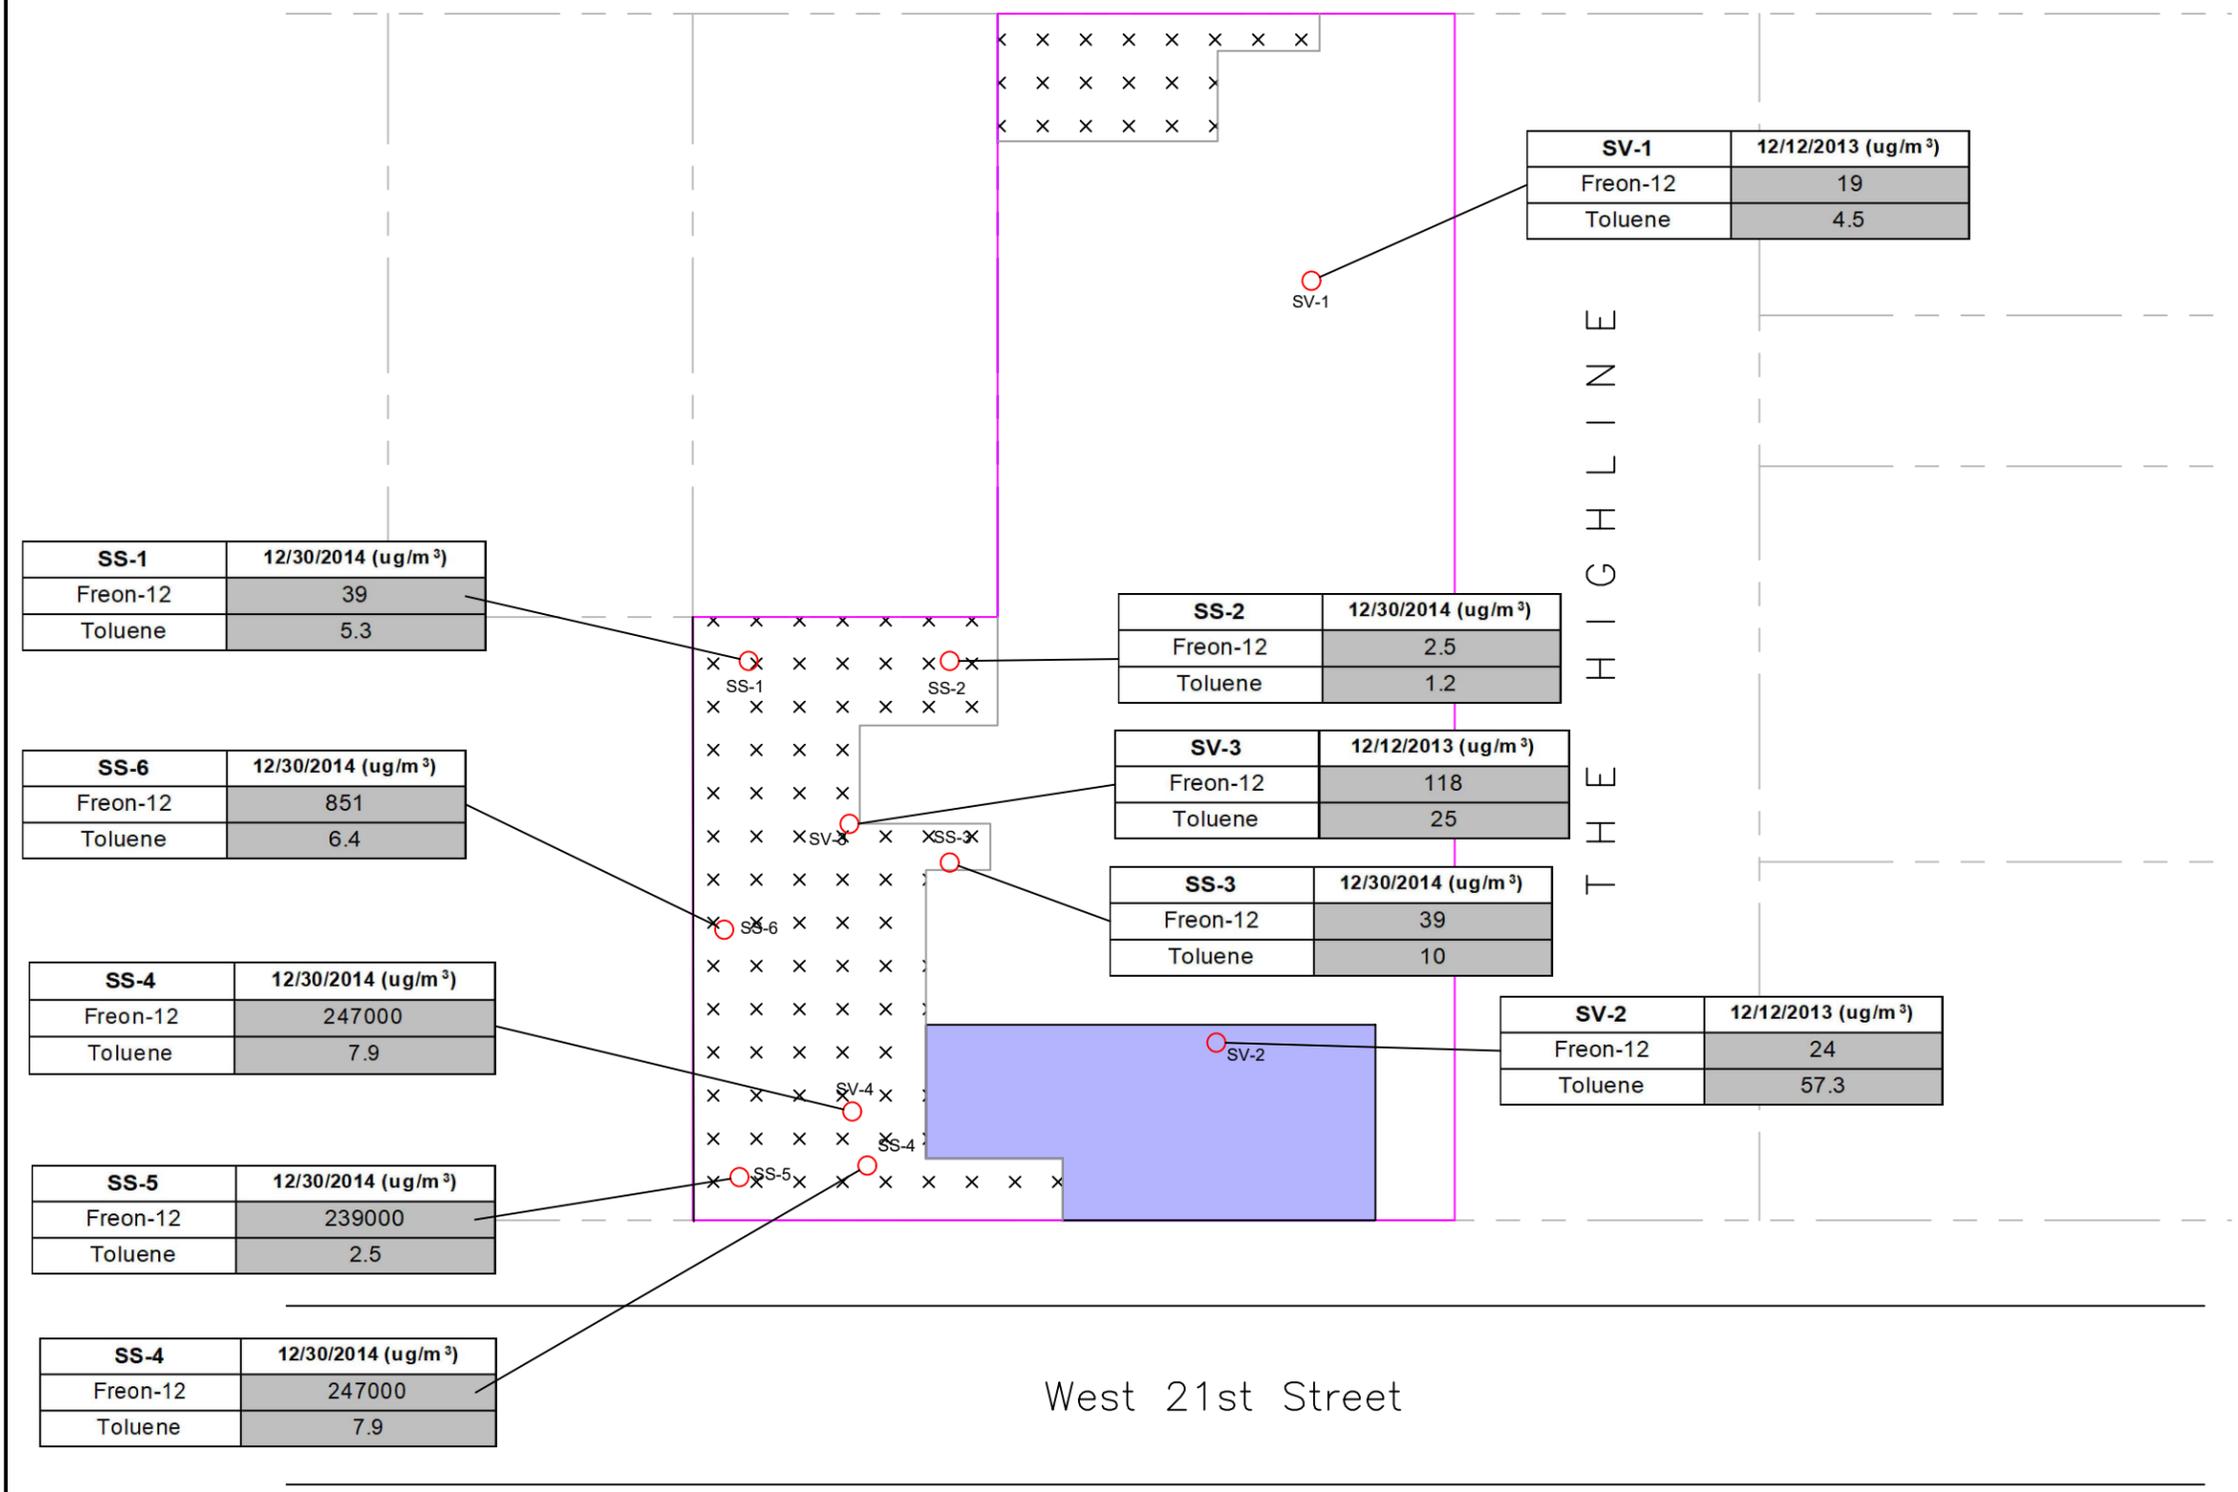
Figure 4A

PRE-REMEDIATION VOCS IN SUB-SLAB VAPOR

IA-1	1/17/2020 (ug/m ³)
Benzene	0.7
Freon-12	2.4
Ethanol	8.5
Ethylbenzene	0.33 J
Toluene	6.4
Xylene (total)	1.4

IA-2	1/17/2020 (ug/m ³)
Benzene	0.64
Freon-12	2.3
Ethanol	14
Ethylbenzene	0.43 J
Toluene	6.8
Xylene (total)	2

AA-2	1/17/2020 (ug/m ³)
Benzene	0.51
Freon-12	2.2
Ethanol	3.8
Ethylbenzene	ND (0.69)
Toluene	5.3
Xylene (total)	0.42 J

The SMP initially required soil vapor intrusion (SVI) sampling to be conducted within the Track 4(A) area during the heating season (November 15 – March 15). Two SVI sampling investigations were conducted on Site in February 2019 and January 2020. Analytical results were compared on-to the Guidance for Evaluating Soil Vapor Intrusion in the State of New York (October 2006) Decision Matrices (updated May 2017). Key contaminants of concern to NYSDEC and NYSDOH for the Site (Freon-12, BTEX, hexane, ethanol chlorinated solvents etc.) were either reduced or remained at low-level concentrations. Considering these findings, in the February 2020 SVI Investigation Summary Report, FLS recommended to discontinue further monitoring of sub-slab vapor and indoor air, and to leave the SSDS as a passive system. On March 26, 2020, NYSDEC approved these measures, and concluded no further monitoring of the sub-slab vapor and indoor air was necessary (Appendix B). As such, no further sub-slab vapor or indoor air monitoring occurred during this reporting period.

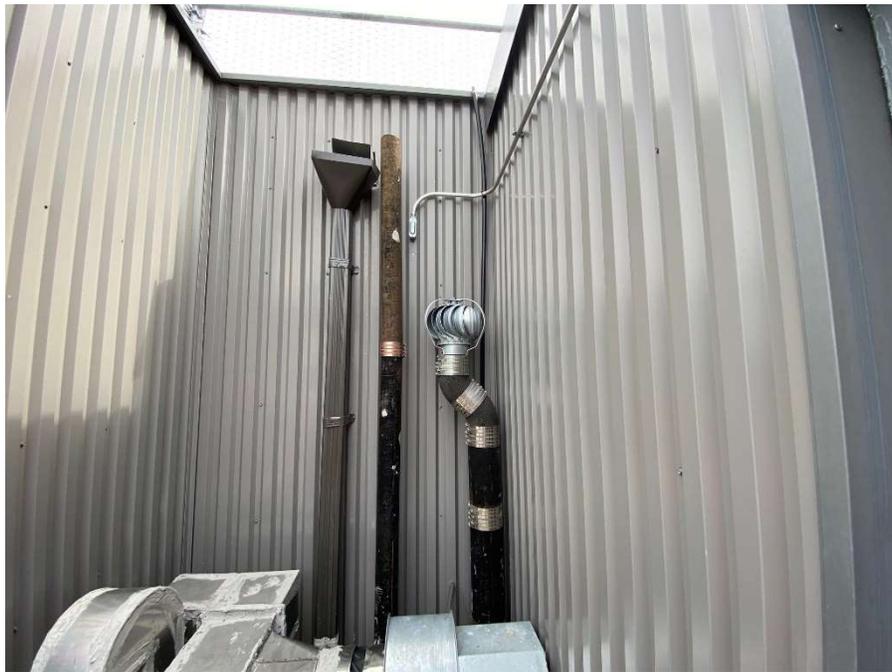
Photo 8: SSDS riser area

The SSDS was inspected and flow rate at the vertical riser was measured as 2.75 CFM, 74.6 % relative humidity, and a temperature of 70.7°F. The riser appeared in good condition and was free of obstruction.
