REMEDIAL INVESTIGATION WORK PLAN

**U-Haul Site
555 West 22nd Street
New York, New York 10011
NYSDEC BCP No. C231101**

FINAL
October 2016

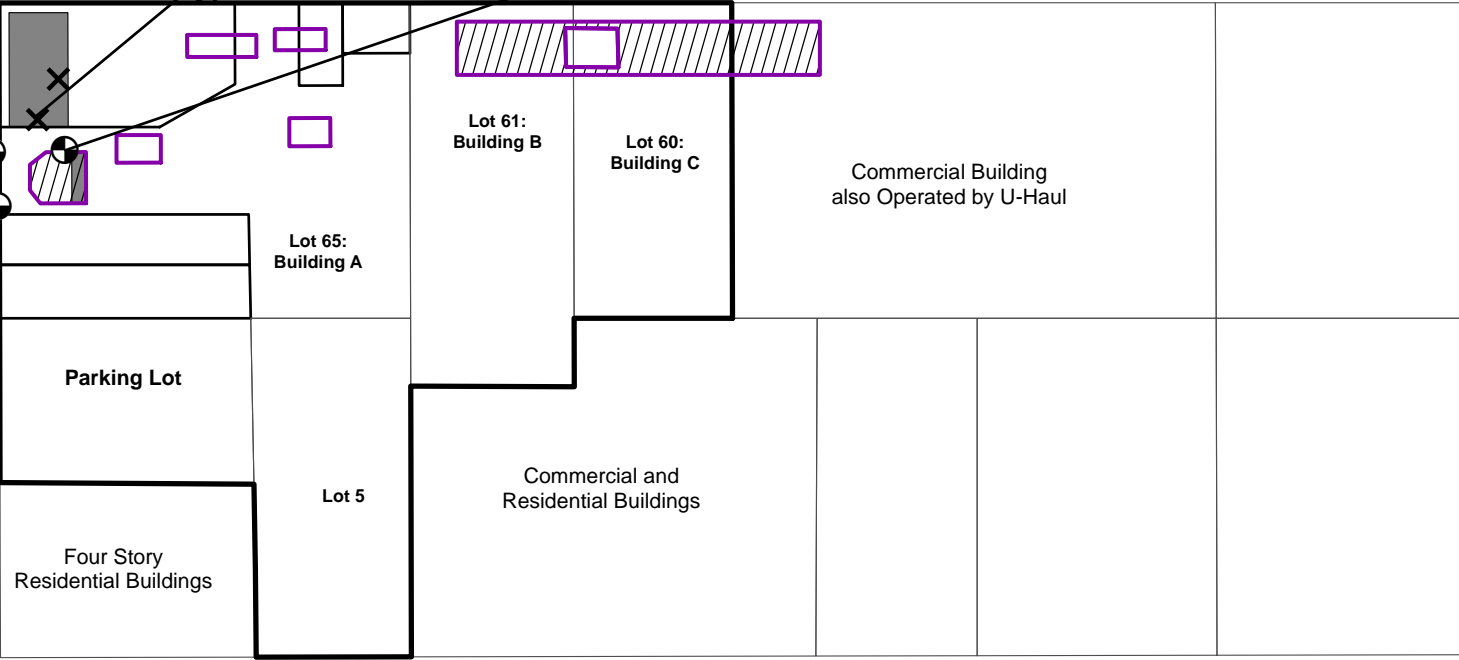
Figure 5.
Soil Sample Results - VOCs and SVOCs
1997 Site Assessment Report
Remedial Investigation Work Plan
555 West 22nd Street, New York, NY 10011

MW-1			
5/31/1997	5 ft	10 ft	15 ft
Volatile Organics			
Benzene	ND	ND	ND
n-Butylbenzene	ND	ND	ND
sec-Butylbenzene	ND	ND	ND
tert-Butylbenzene	ND	ND	ND
Methyl tert butyl ether	8.2	1.7	2.9
Ethylbenzene	ND	ND	ND
Napthalene	ND	ND	16
n-Propylbenzene	ND	ND	ND
Toluene	ND	ND	ND
1,3,5-Trimethylbenzene	ND	ND	ND
Total Xylenes	ND	ND	ND
Semivolatile Organics			
Anthracene	ND	ND	2500
Benzo(a)anthracene	ND	ND	1600
Benzo(a)pyrene	ND	ND	1300
Benzo(b)fluoranthene	ND	ND	900
Benzo(g,h,i)perylene	ND	ND	ND
Benzo(k)fluoranthene	ND	ND	1000
Indeno(1,2,3-cd)pyrene	ND	ND	ND
Chrysene	ND	ND	1400
Dibenzo(a,h)anthracene	ND	ND	ND
Fluoranthene	ND	ND	3600
Fluorene	ND	ND	1200
Napthalene	ND	ND	940
Phenanthrene	ND	ND	3800
Pyrene	ND	ND	3200

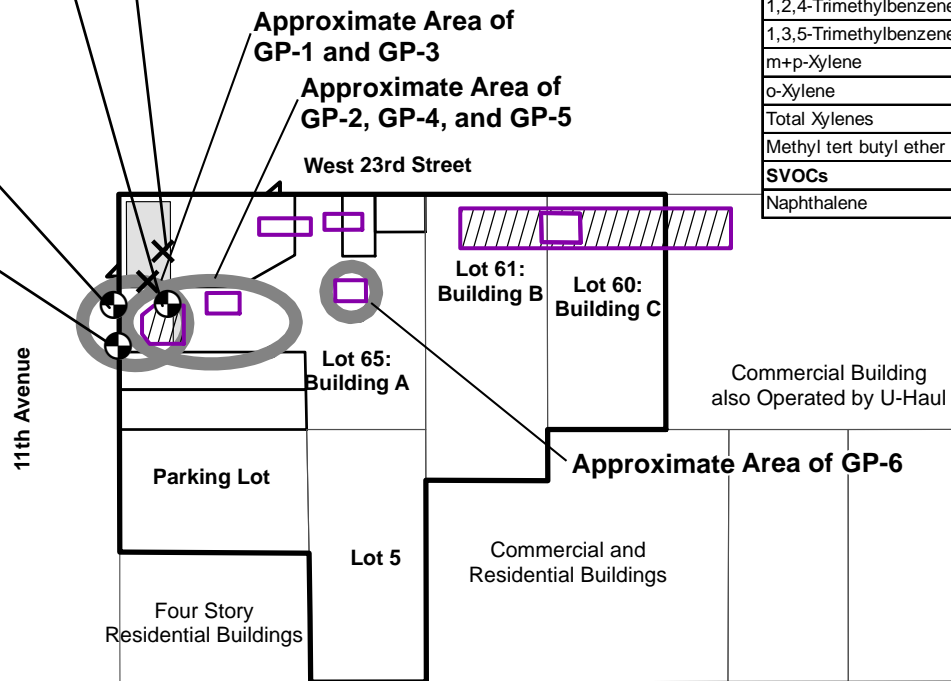
Figure 6.
Groundwater Sample Results
1997-1999 Site Assessment Reports and 2001 Site Investigation Report
Remedial Investigation Work Plan
555 West 22nd Street, New York, NY 10011

GPW-6	
Date	5/15/2001
VOCs	
Benzene	24.1
n-Butylbenzene	62.1
sec-Butylbenzene	444
tert-Butylbenzene	483
Ethylbenzene	147
Isopropylbenzene	ND
p-Isopropyltoluene	ND
Napthalene	85
n-Propylbenzene	43.4
Toluene	ND
1,2,4-Trimethylbenzene	363
1,3,5-Trimethylbenzene	98.1
m+p-Xylene	249
o-Xylene	165
Total Xylenes	-
Methyl tert butyl ether	ND
SVOCs	
Napthalene	21.2

Assumed Groundwater Flow Direction

On May 15, 2001, ATC collected additional soil and groundwater samples to delineate the contamination around former boring B-4 to characterize the subsurface conditions along the western boundary of Building A (Lot 65), and to evaluate subsurface conditions down gradient of the abandoned 1,000-gallon fuel oil UST. Laboratory analysis indicated petroleum related VOCs were present in groundwater at concentrations exceeding TOGS AWQS. Available soil and groundwater results from this investigation are shown on Figures 3 and 6, respectively.

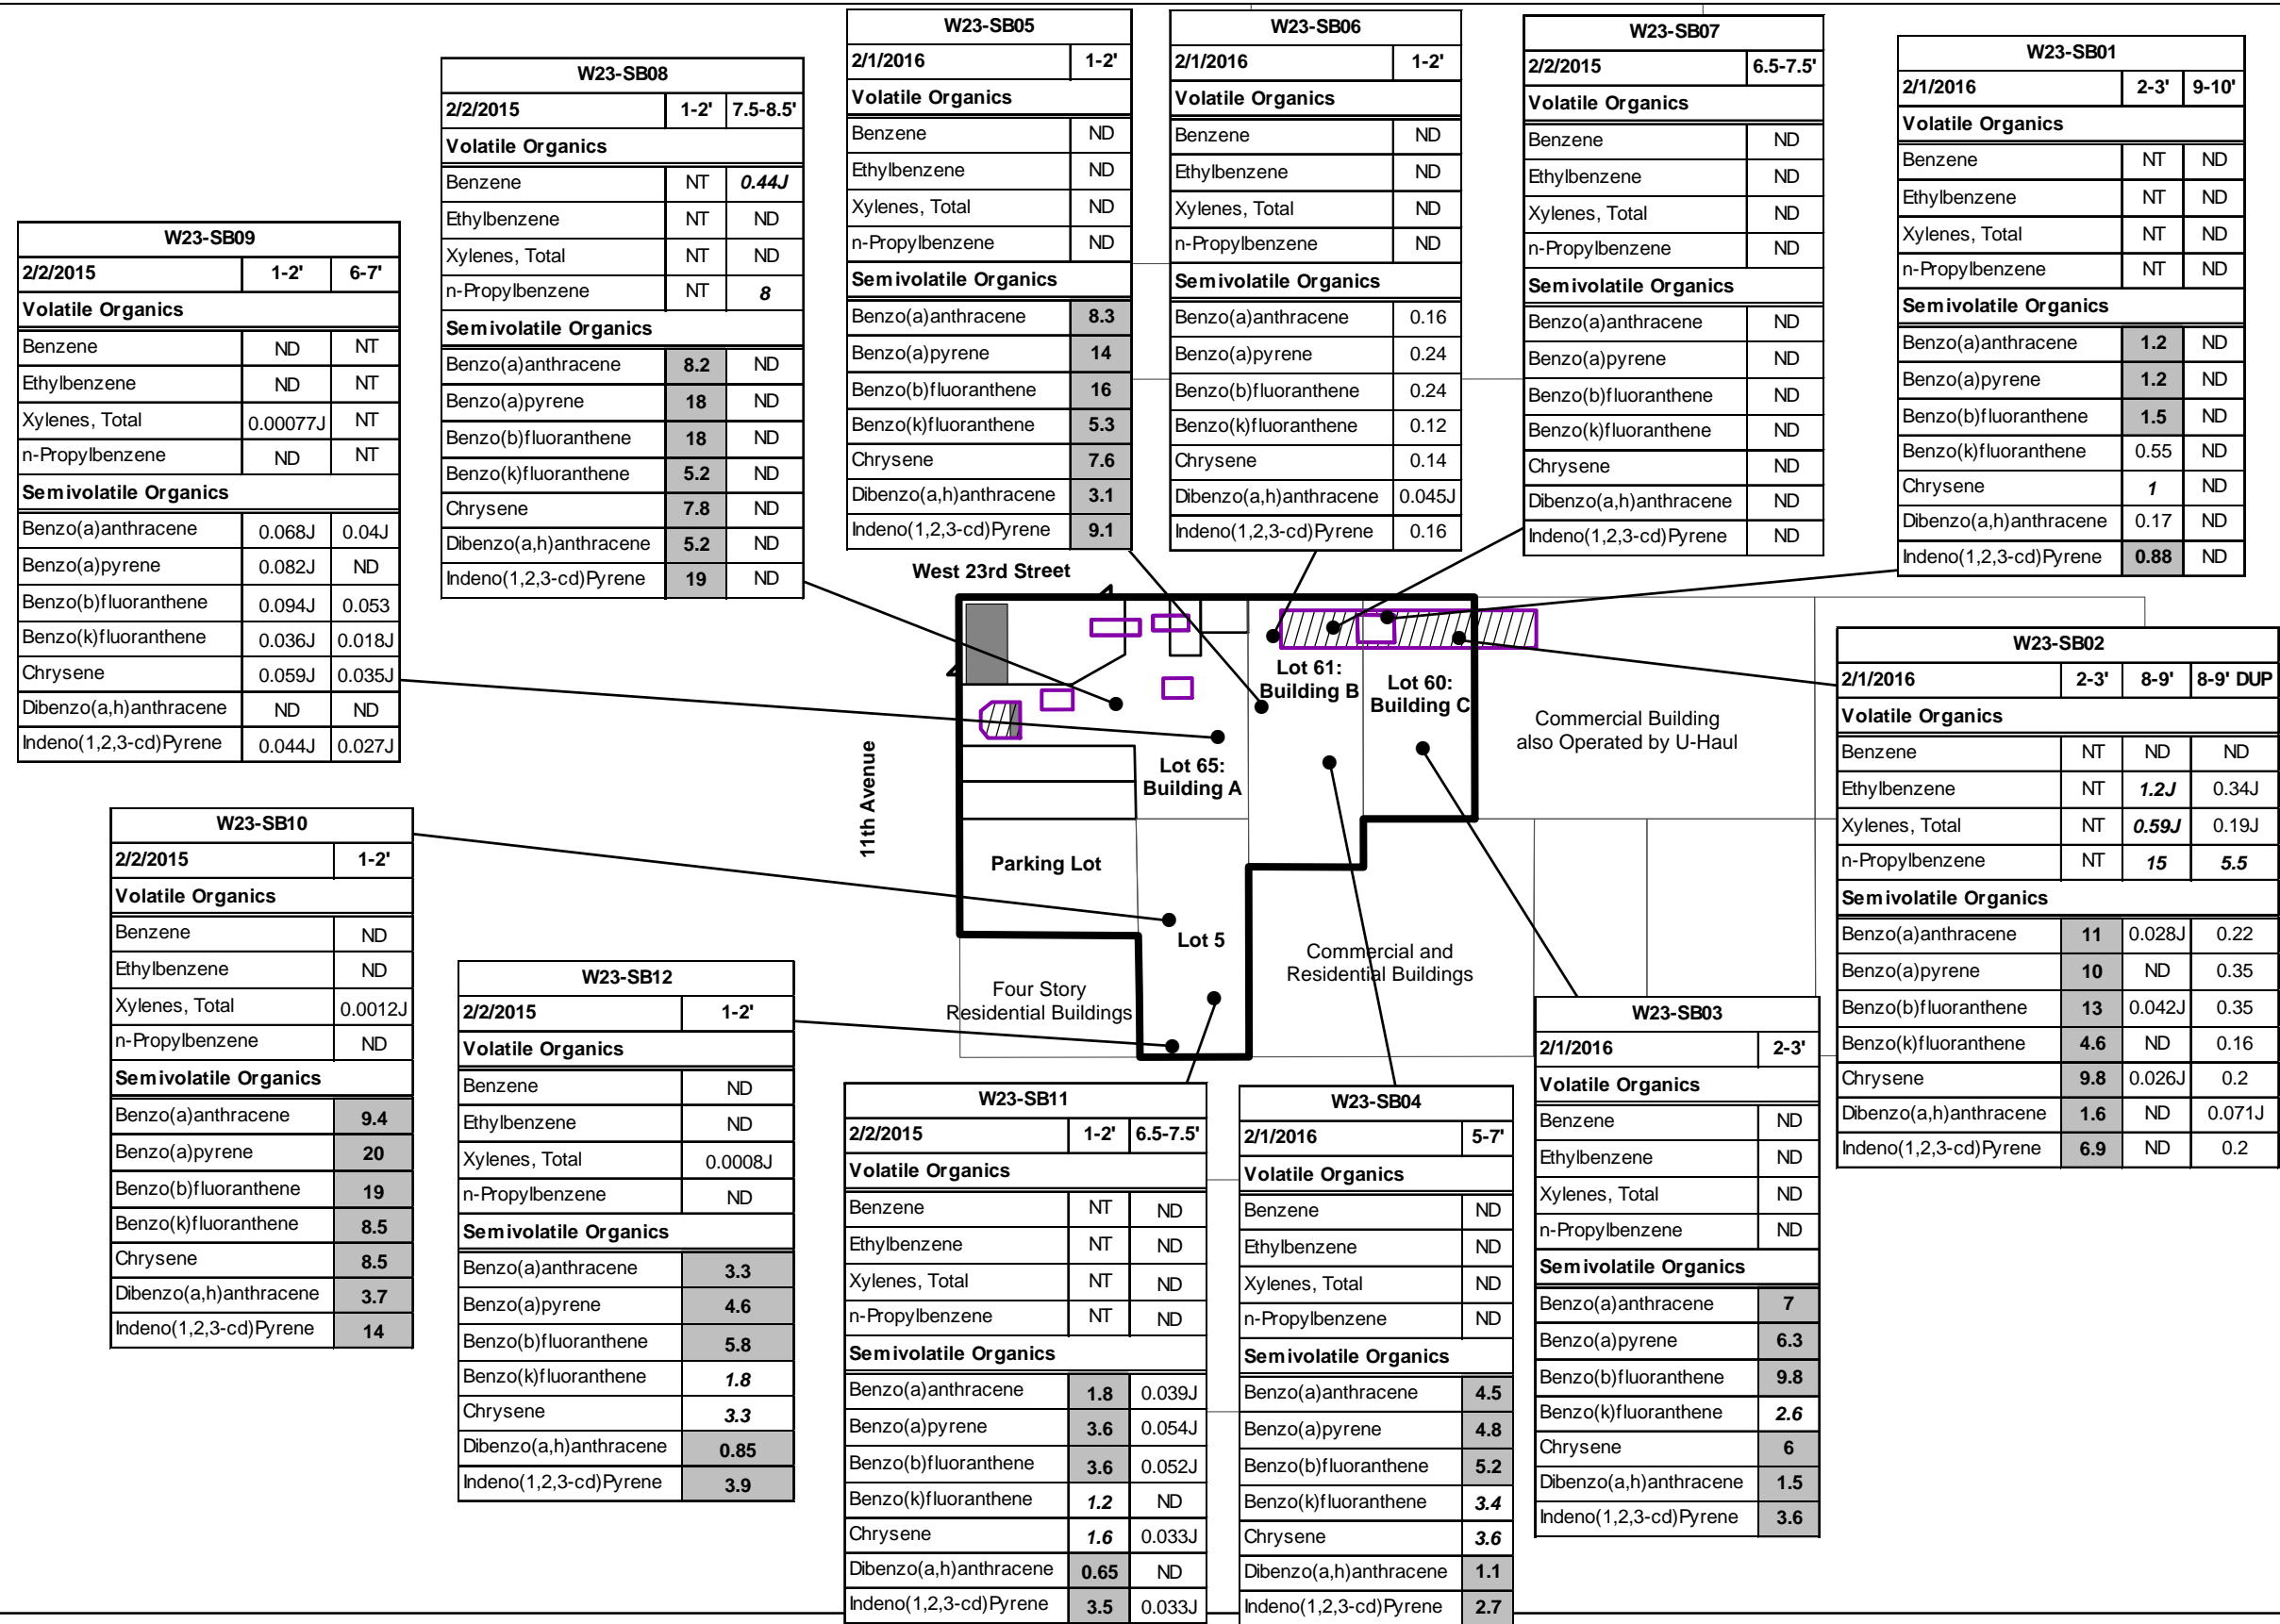
Sample ID		
Date	**NY-RESRR	*NY-UNRES
Depth		
Analyte	mg/kg	mg/kg
Volatile Organics		
Benzene	4.8	0.06
Ethylbenzene	41	1
Xylenes, Total	100	0.26
n-Propylbenzene	100	3.9
Semivolatile Organics		
Benzo(a)anthracene	1	1
Benzo(a)pyrene	1	1
Benzo(b)fluoranthene	1	1
Benzo(k)fluoranthene	3.9	0.8
Chrysene	3.9	1
Dibenzo(a,h)anthracene	0.33	0.33
Indeno(1,2,3-cd)Pyrene	0.5	0.5

Minor exceedances of petroleum related VOCs above Unrestricted Use SCOs were detected in soil samples collected from 2 borings: SB-08 [7.5-8.5] and SB-02 [8-9]. Low levels of petroleum related compounds were found in soils below Lot 65 and Lot 60 and are consistent with areas of former onsite petroleum storage (Figure 8).

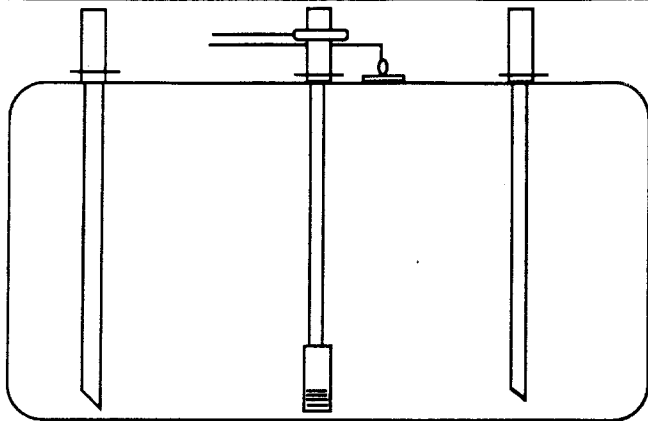
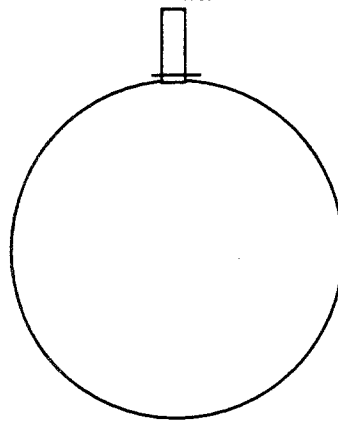
Tank Condition Reports

On the above tank diagram, an "X" marks the exact location of leak point(s) or areas of corrosion.

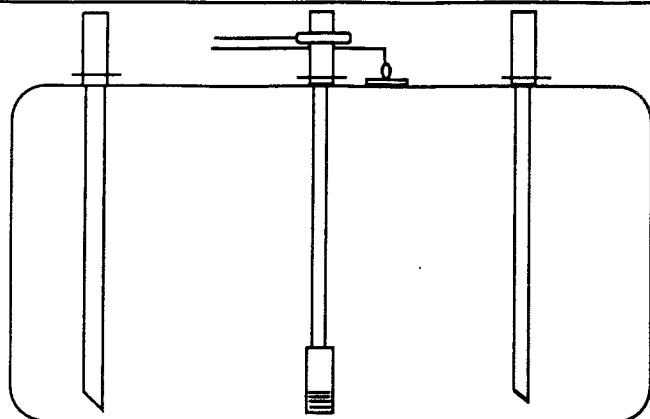
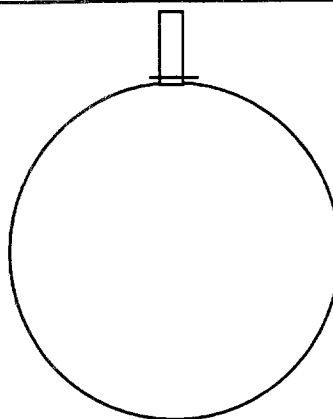
On the above tank diagram, an "X" marks the exact location of leak point(s) or areas of corrosion.

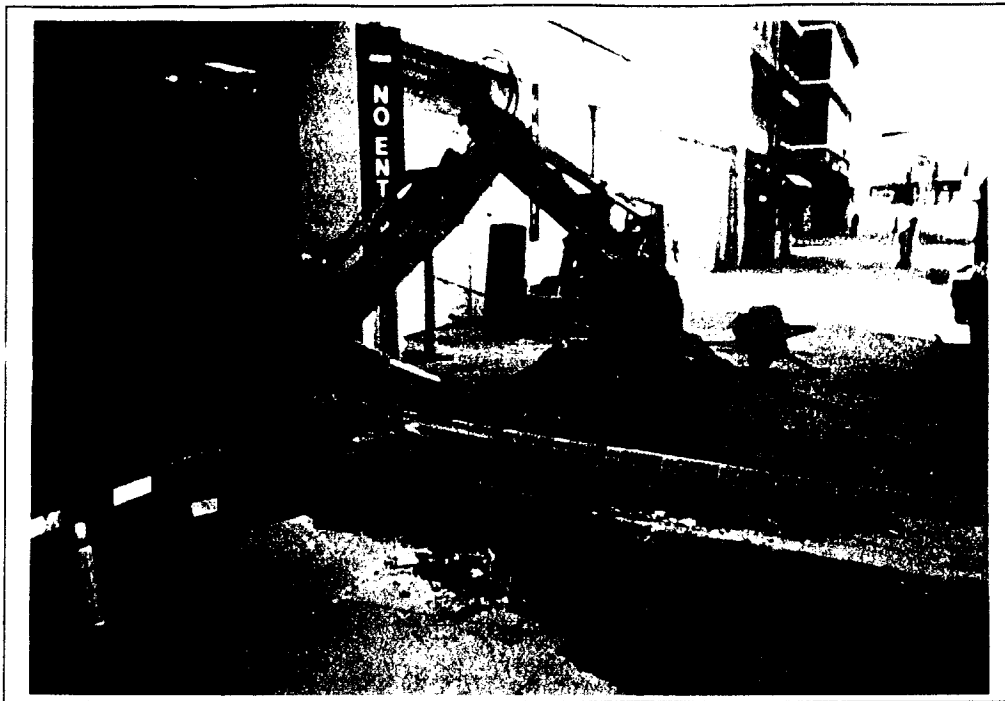
VIEW OF FILL LINE EXCAVATION

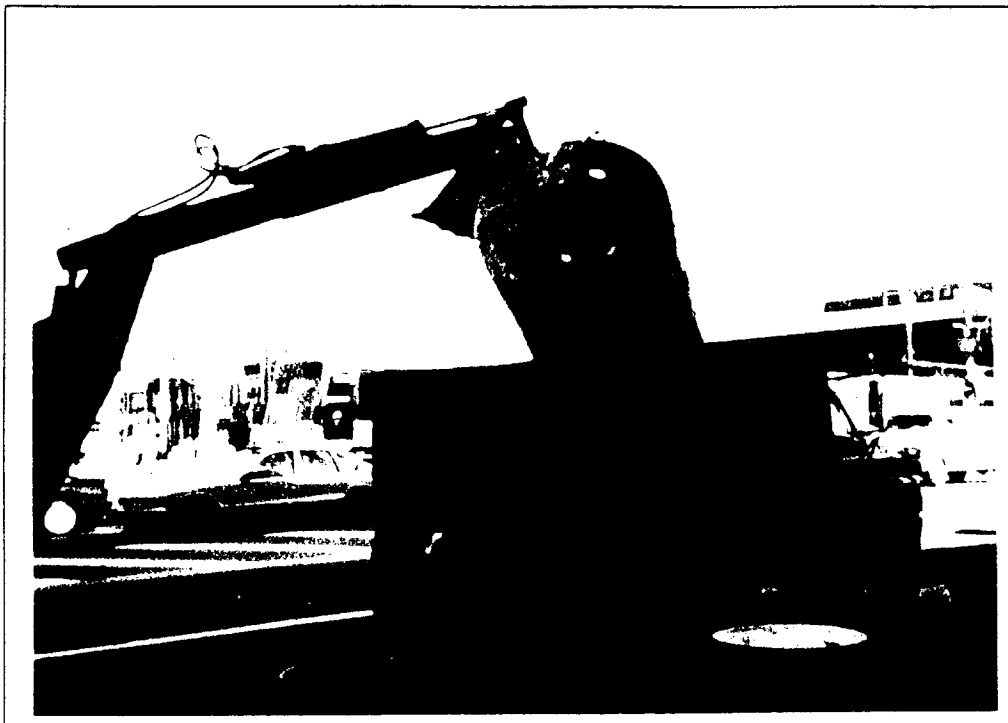
VIEW OF TANK BEING CUT, CLEANED
AND READY FOR TRANSPORT

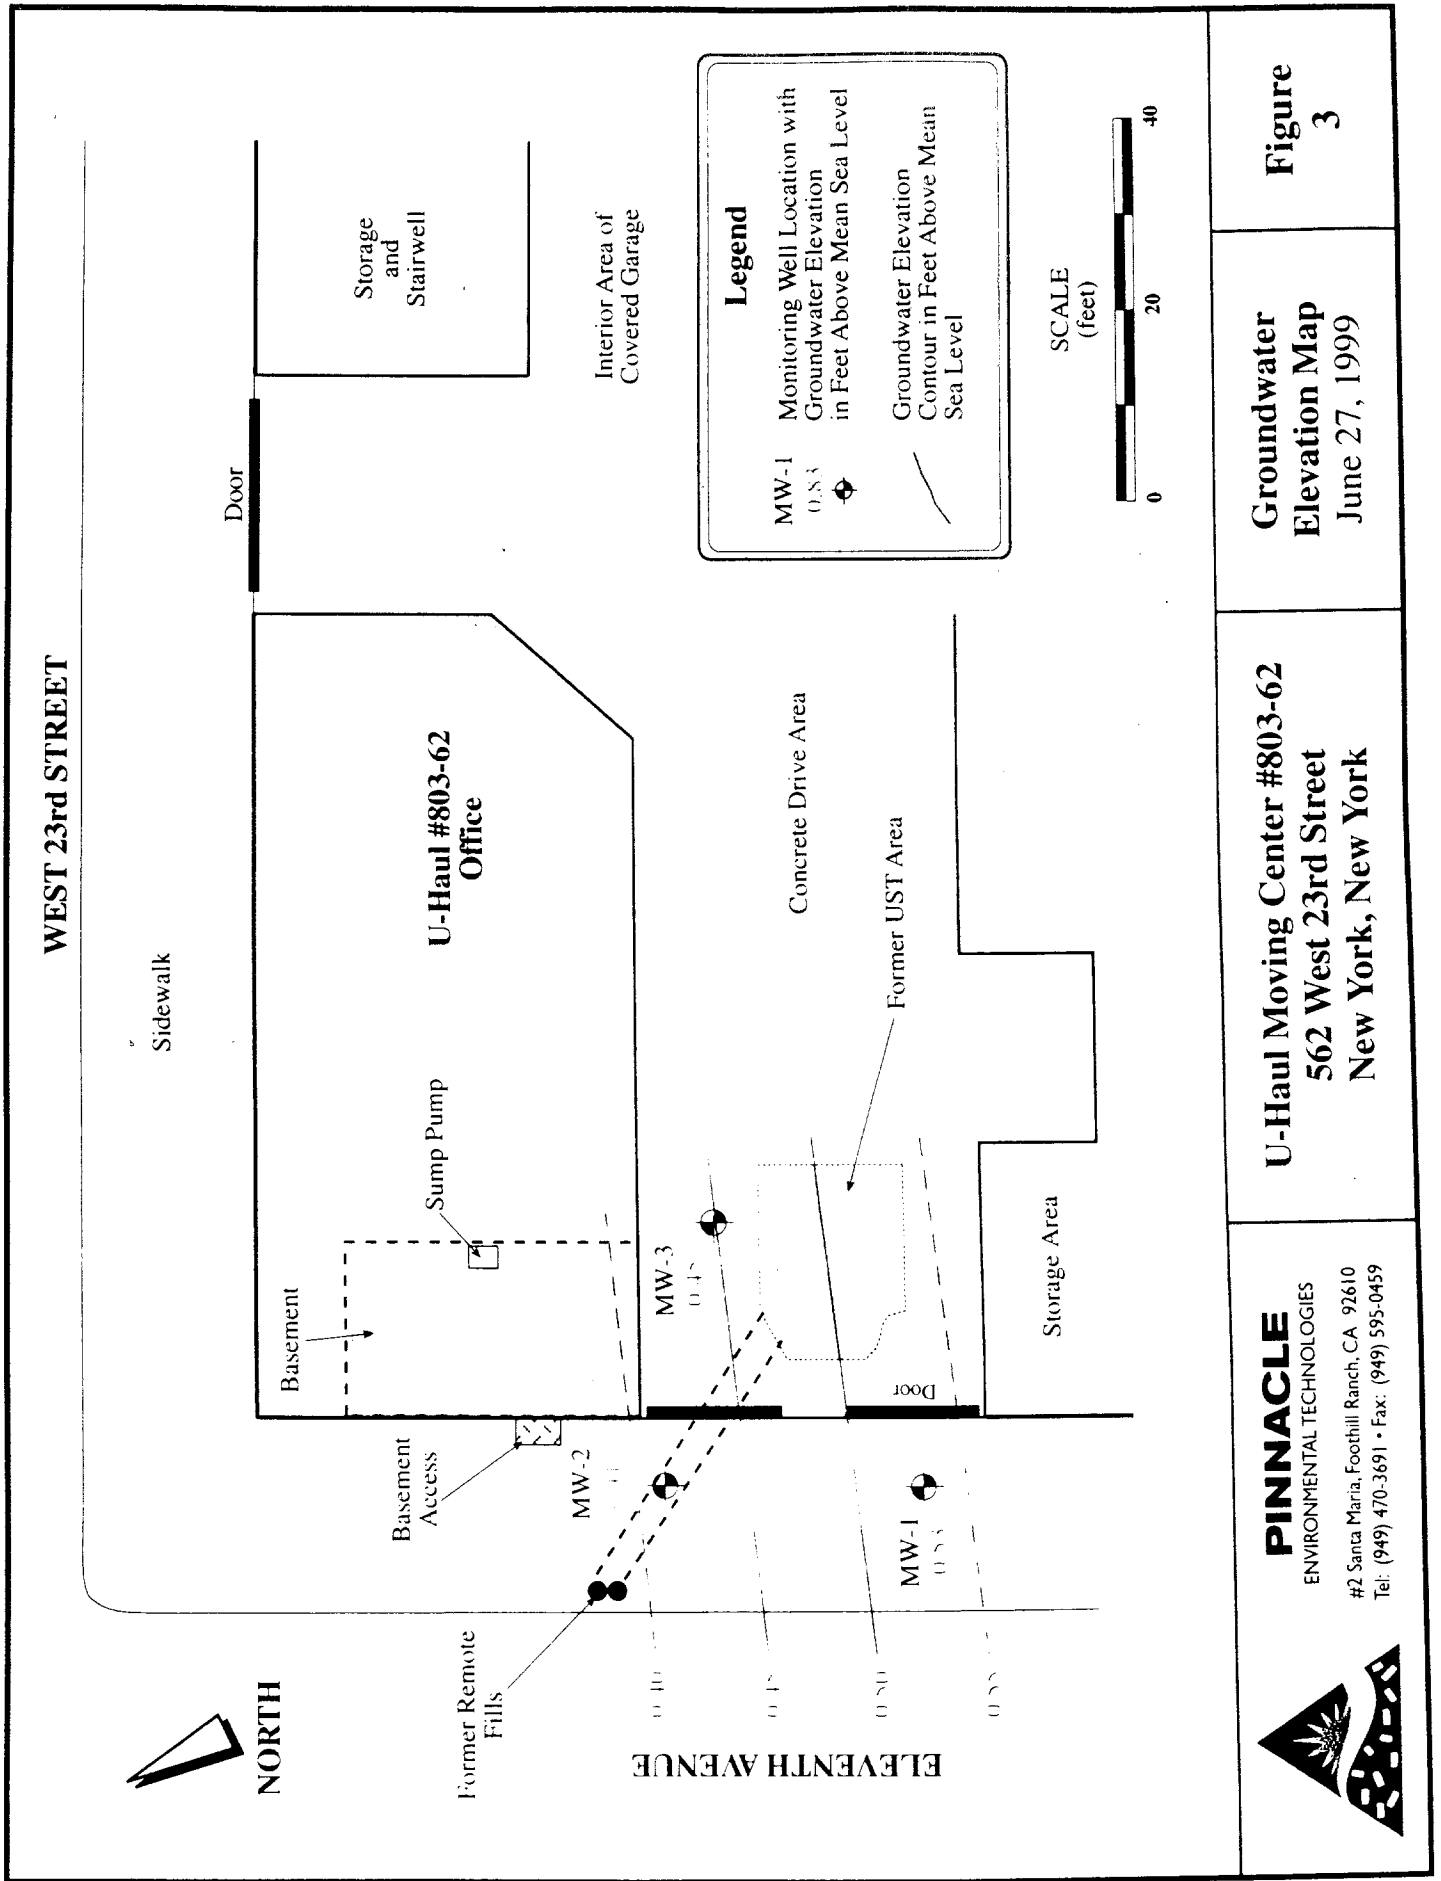
Figure 3

Groundwater Elevation Map
June 27, 1999

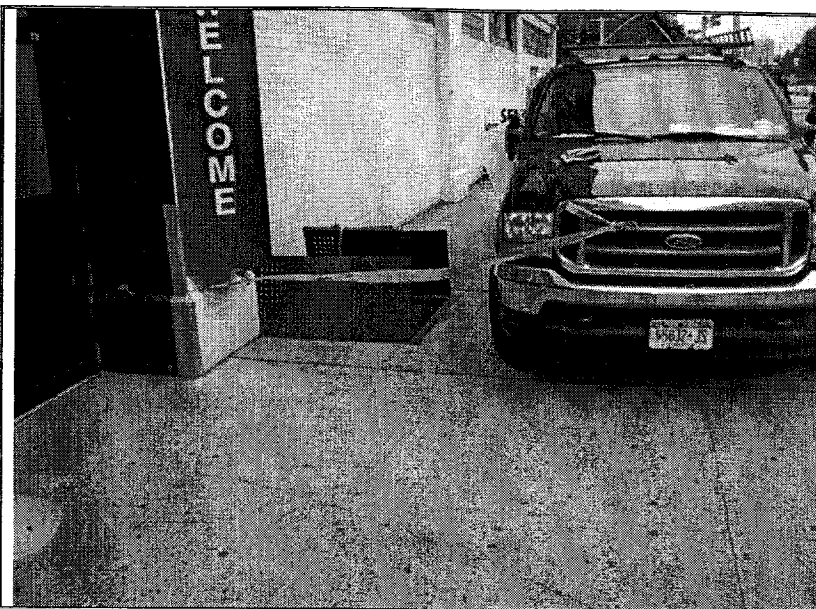
4. Picture of safety precautions near entrance to the basement.

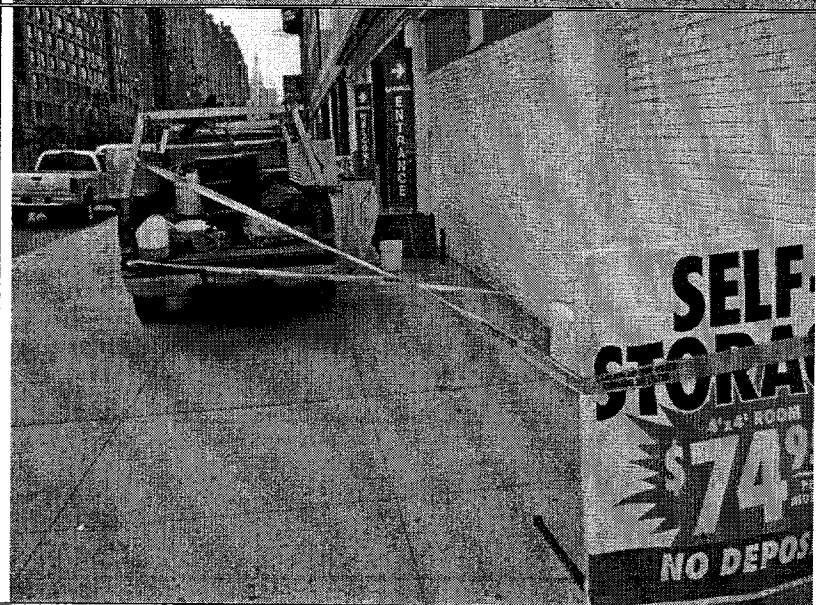
5. Picture of safety precautions taken during tank closure activities.

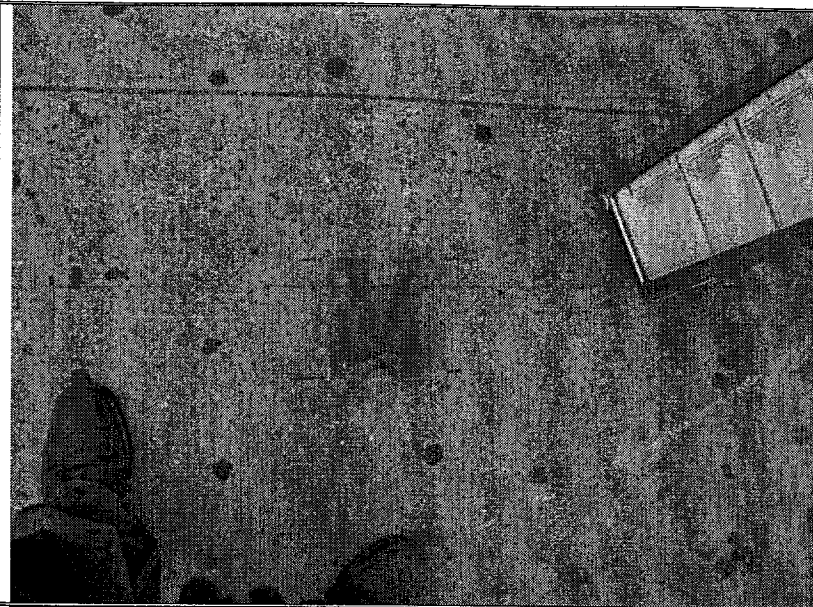
7. Picture of curb fill plugged with concrete.

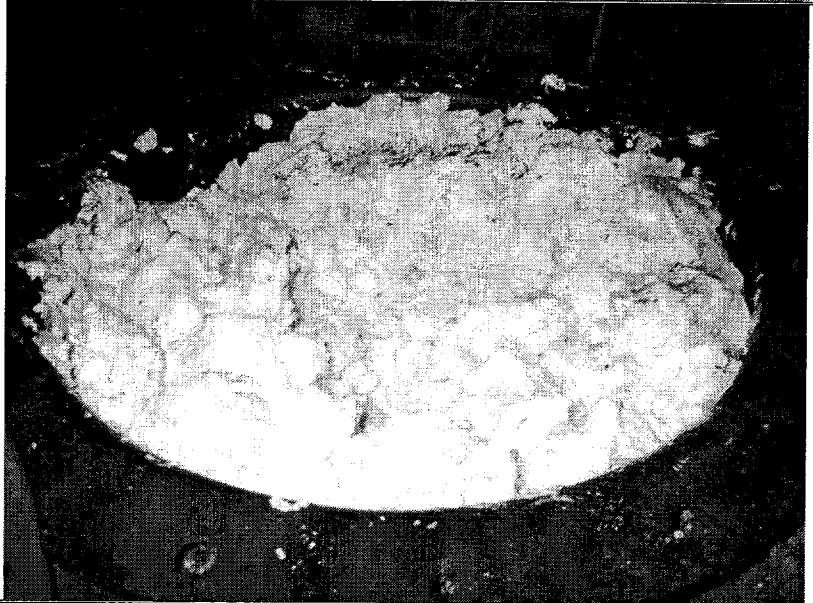
9. Picture of tank filled with foam.

Integral observed the presence of (1) 5,000-gallon abandoned AST and its associated vent pipes, during the 2015 Phase I ESA. According to Site reports, this AST was closed in place in 2006 (foam filled) within the former boiler room. No significant signs of petroleum release were noted during a visual inspection of the AST area. A concrete block wall encompasses the lower half of the AST obstructing any observation of the condition of the underside of the tank.
