SITE OBSERVATION REPORT

PROJECT No.: 170381202 PROJECT: 250 Water Street LOCATION: New York, NY BCP SITE ID: C231127	CLIENT: 250 Seaport District, LLC	DATE: Saturday, February 12, 2022 WEATHER: Partly Cloudy, 53.4-59.3 °F Wind: SSW @ 1.1-6.0 mph TIME: 6:30 am – 7:00 pm
CONTRACTOR: AARCO Environmental Services Corp. (AARCO)		LANGAN REP. : Michael Au
EQUIPMENT: Bobcat E35i Excavator Jerome J405 Jerome J505 RKI GX-6000 PID MiniRAE 3000 PID DustTrak II	PRESENT AT SITE: Remedial Design Investigation Day 1 Langan Mimi Raygorodetsky, Paul McMahon, Michael Au, Gabriel Enriquez Castro AARCO Brian Wyble, Will Scheiner, Juan Torres Excel Environmental Resources, Inc. (Excel) Abby Lodge	
OBSERVATIONS, DISCUSSIONS, TEST RESULTS, ETC.: Langan began implementation of the New York State Department of Environmental Conservation (NYSDEC)-approved February 11, 2022 Remedial Design Investigation Work Plan (RDIWP) at the 250 Water Street site (NYSDEC Brownfield Cleanup Program [BCP] Site No. C231127). Site Activities <ul style="list-style-type: none"> • AARCO used a Bobcat E35i excavator to excavate four test pits in the north-central, central and southwestern parts of the site. Langan conducted ambie

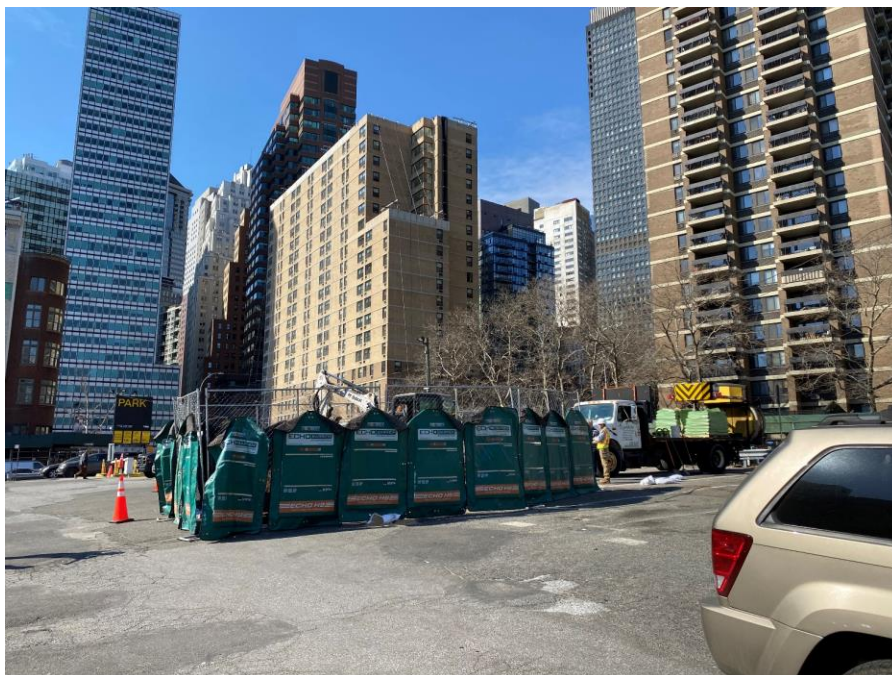
Photo 2: View of typical work zone fencing with chain-link fence and Echo Barrier H9™ acoustic curtains (facing northwest).

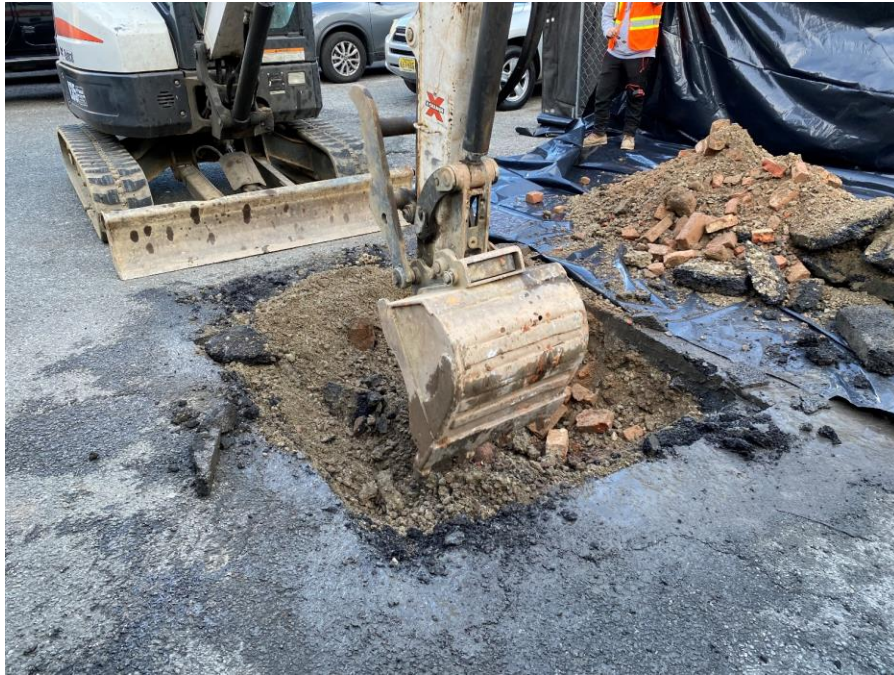
- TP03 (about 5 feet long by 5 feet wide) was excavated to a maximum depth of about 8 feet bgs.
 - Excavated material consisted of an about 1-foot-thick layer of gravel followed by historic fill with varying amounts of brick, wood, and abandoned utility piping to about 8 feet bgs (the test pit termination depth).

Photo 3: View of AARCO excavating test pit TP03 and stockpiling excavated soil/fill on polyethylene sheeting (facing southeast).

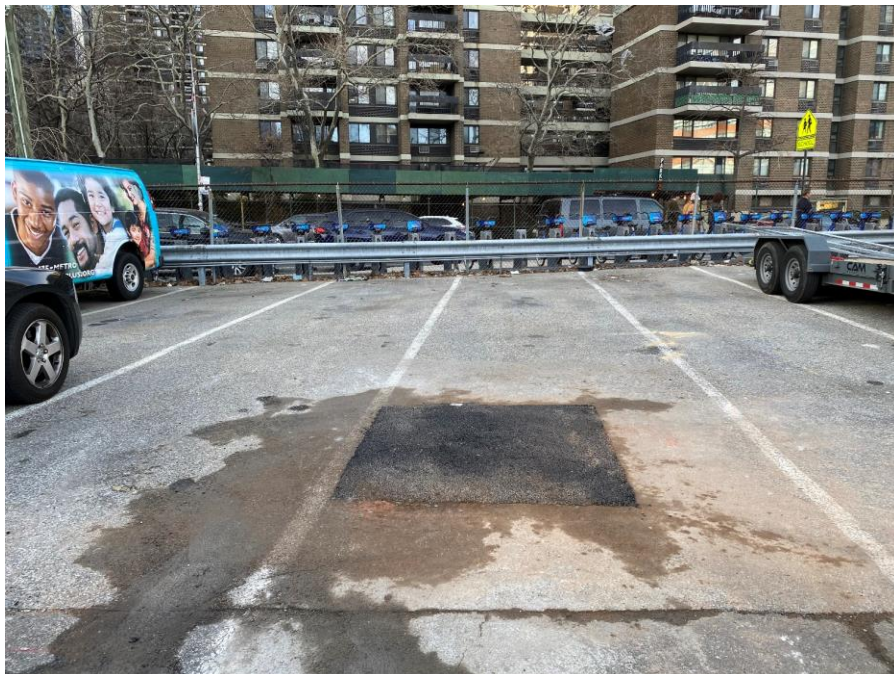
- TP05 (about 5 feet long by 5 feet wide) was excavated to a maximum depth of about 8 feet bgs.
 - Excavated material consisted of historic fill, primarily consisting of brick, to about 4 feet bgs followed by an apparent native layer consisting of medium- to fine-grained brown sand with varying amounts of silt and gravel to about 8 feet bgs (the test pit termination depth).

Photo 4: View of test pit TP05, restored to the surrounding grade using cold patch asphalt (facing north).

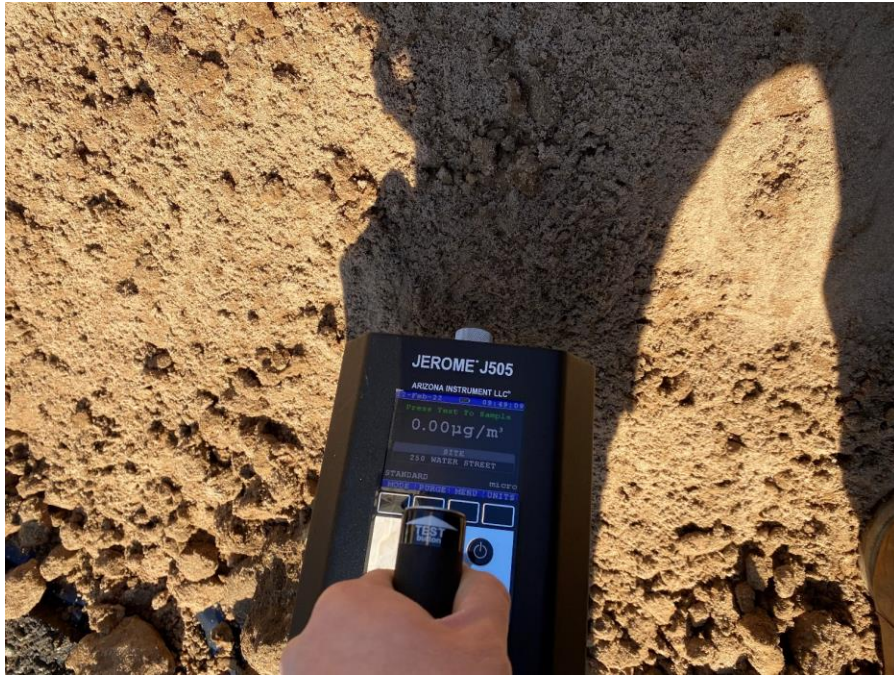
Photo 5: View of Langan screening excavated soil/fill from test pit TP01 using a Jerome® J505 mercury analyzer.
