## SITE OBSERVATION REPORT

<b>PROJECT No.:</b> 170381202  <b>PROJECT:</b> 250 Water Street  <b>LOCATION:</b> New York, NY  <b>BCP SITE ID:</b> C231127	<b>CLIENT:</b> 250 Seaport District, LLC	<b>DATE:</b> Friday, April 22, 2022  <b>WEATHER:</b> Clear, 55.2 – 69.4 °F Wind: E @ 1.0 – 7.7 mph  <b>TIME:</b> 6:00 AM – 3:30 PM  <b>MONITOR:</b> Lauren Roper, Ellie Seery	
<b>EQUIPMENT:</b> MiniRAE 3000 PID DustTrak II Jerome J405® Jerome J505® Hand tools	<b>PRESENT AT SITE:</b> <span style="float: right;"><b>Day 2</b></span> <b>Langan</b> (Environmental) – Lauren Roper, Ellie Seery <b>UBS</b> (Fence installation Contractor) – Eddie Perez		
<b>OBSERVATIONS, DISCUSSIONS, TEST RESULTS, ETC.:</b>  Langan was present to document remediation and construction activities in accordance with the New York State Department of Environmental Conservation (NYSDEC)-approved November 2021 Remedial Action Work Plan (RAWP) at the 250 Water Street site (NYSDEC Brownfield Cleanup Program [BCP] Site No. C231127).  <b>Site Activities</b> <ul style="list-style-type: none"> <li>UBS continued installing perimeter construction fencing along the northern boundary of the site (along Pearl Street). Perimeter construct

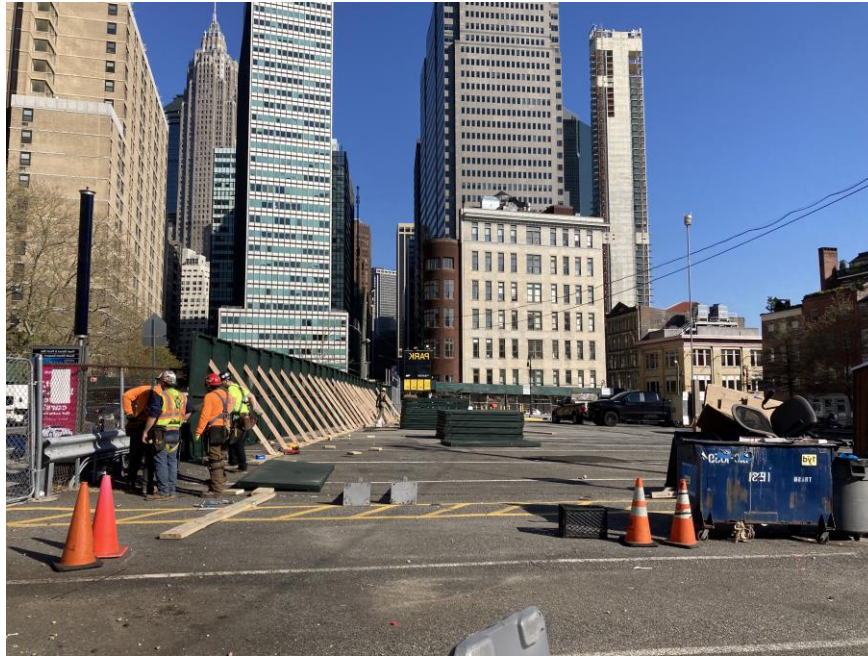
Photo 1: View of perimeter construction fencing installed along the northern boundary of the site (facing west).

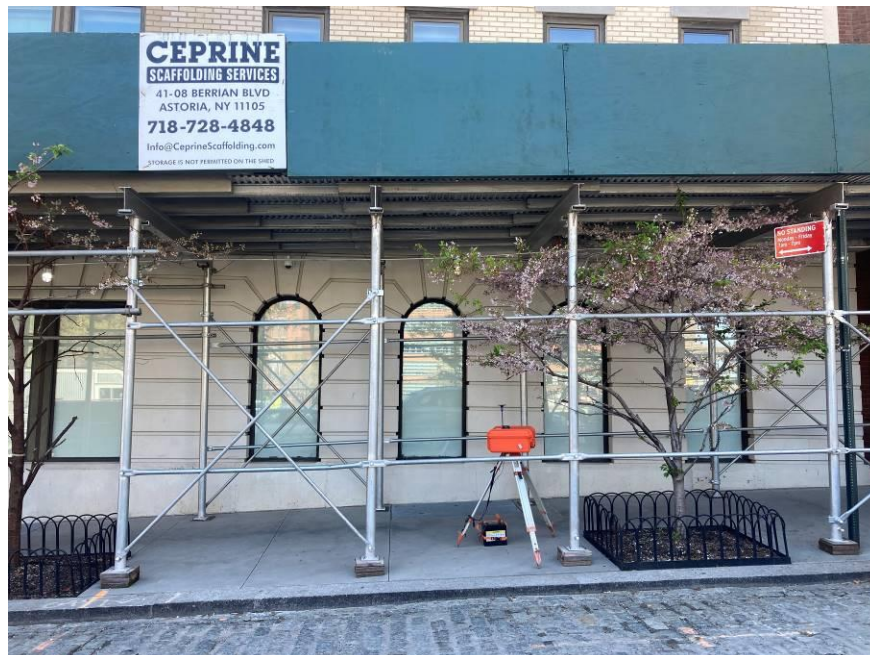
Photo 2: View of perimeter CAMP station PM-2, relocated to the eastern sidewalk of Beekman Street (facing west)

- Perimeter air monitoring station PM-2 was relocated to the western sidewalk of Beekman Street from 12:04 PM to 1:30 PM during installation of the perimeter construction fence along Pearl Street.
