## SITE OBSERVATION REPORT

<b>PROJECT No.:</b> 170381202  <b>PROJECT:</b> 250 Water Street  <b>LOCATION:</b> New York, NY  <b>BCP SITE ID:</b> C231127	<b>CLIENT:</b> 250 Seaport District, LLC	<b>DATE:</b> Monday, April 25, 2022  <b>WEATHER:</b> Clear, 49.8 – 58.4 °F Wind: SSW @ 0.8 – 6.9 mph  <b>TIME:</b> 6:00 AM – 4:00 PM  <b>MONITOR:</b> Lauren Roper, Maye Yassin	
<b>EQUIPMENT:</b> MiniRAE 3000 PID DustTrak II Jerome J405® Jerome J505® Hand tools	<b>PRESENT AT SITE:</b> <span style="float: right;"><b>Day 4</b></span> <b>Langan</b> (Environmental) – Lauren Roper, Maye Yassin <b>UBS</b> (Fence installation Contractor)		
<b>OBSERVATIONS, DISCUSSIONS, TEST RESULTS, ETC.:</b>  Langan was present to document remediation and construction activities in accordance with the New York State Department of Environmental Conservation (NYSDEC)-approved November 2021 Remedial Action Work Plan (RAWP) at the 250 Water Street site (NYSDEC Brownfield Cleanup Program [BCP] Site No. C231127).  <b>Site Activities</b> <ul style="list-style-type: none"> <li>UBS continued installing perimeter construction fencing along the northern, western, and southern boundaries of the site (along Pearl Street, Beekman

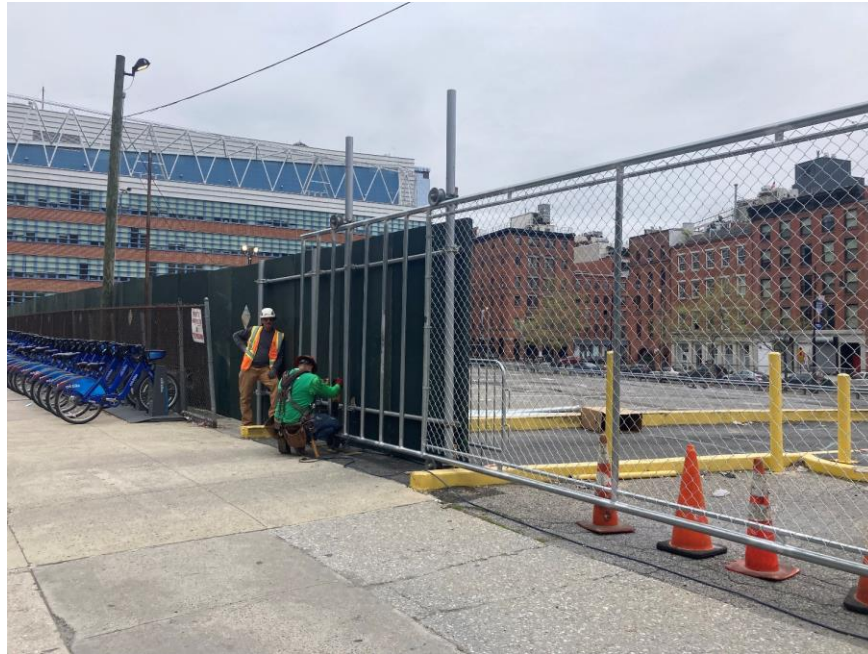
Photo 1: View of perimeter construction fencing installed along the northern boundary of the site (facing southeast).

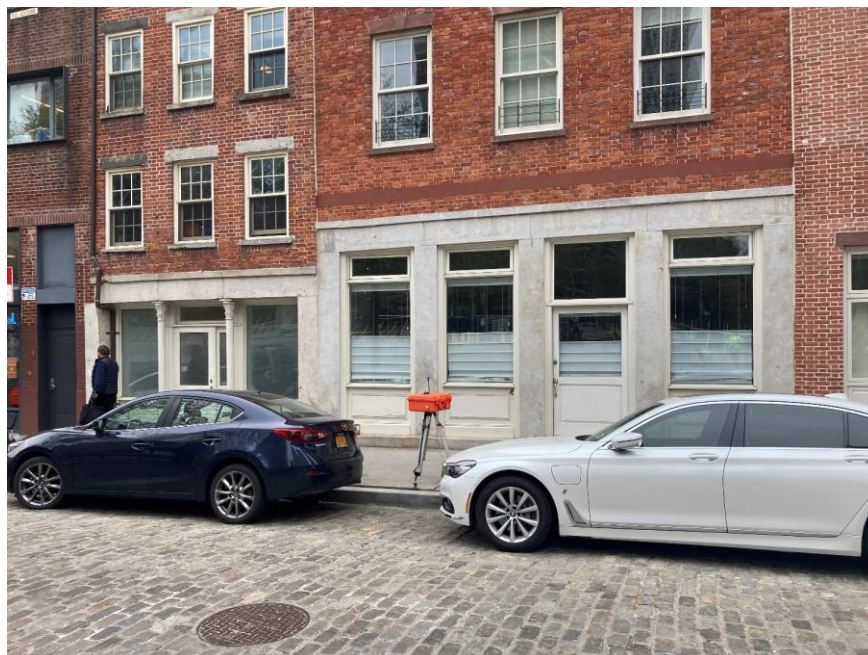
Photo 2: View of perimeter CAMP station PM-3, relocated to the southern sidewalk of Water Street (facing south)

- Perimeter air monitoring station PM-3 was relocated to the southern sidewalk of Water Street from 10:10am to 2:50pm during installation of the perimeter construction fence along Water Street.
