## SITE OBSERVATION REPORT

<p><b>PROJECT No.:</b> 170381202</p> <p><b>PROJECT:</b> 250 Water Street</p> <p><b>LOCATION:</b> New York, NY</p> <p><b>BCP SITE ID:</b> C231127</p>	<p><b>CLIENT:</b> 250 Seaport District, LLC c/o The Howard Hughes Corporation</p>	<p><b>DATE:</b> Thursday, May 12, 2022</p> <p><b>WEATHER:</b> Overcast, 61.8 – 70.7 °F Wind: N @ 0.8 – 7.6 mph</p> <p><b>TIME:</b> 6:00 AM – 3:30 PM</p> <p><b>MONITOR:</b> Lauren Roper, Brian Kenneally</p>
<p><b>EQUIPMENT:</b> MiniRAE 3000 PID DustTrak II Jerome J405® Jerome J505® Hand tools Comacchio MC28 Drill Rig CAT 374F Excavator</p>	<p><b>PRESENT AT SITE:</b> <span style="float: right;"><b>Day 12</b></span>  <b>Langan</b> (Environmental) – Lauren Roper, Brian Kenneally  <b>LendLease</b> (Construction Manager) – Marty Cohen  <b>Civetta Cousins JV, LLC (CCJV)</b> (Foundation Contractor) – George Washburn  <b>New York State Department of Environmental Conservation (NYSDEC)</b> – Aaron Fischer</p>

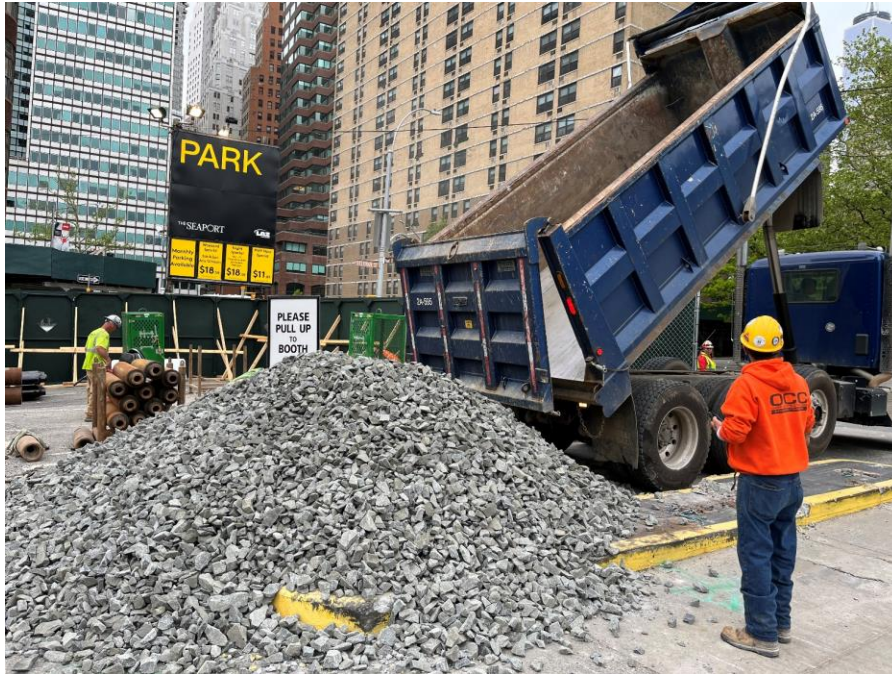
Photo 1: CCJV importing one truckload of 2.5-inch virgin stone for installation of a tracking pad in the northwestern portion of the site (facing northwest)

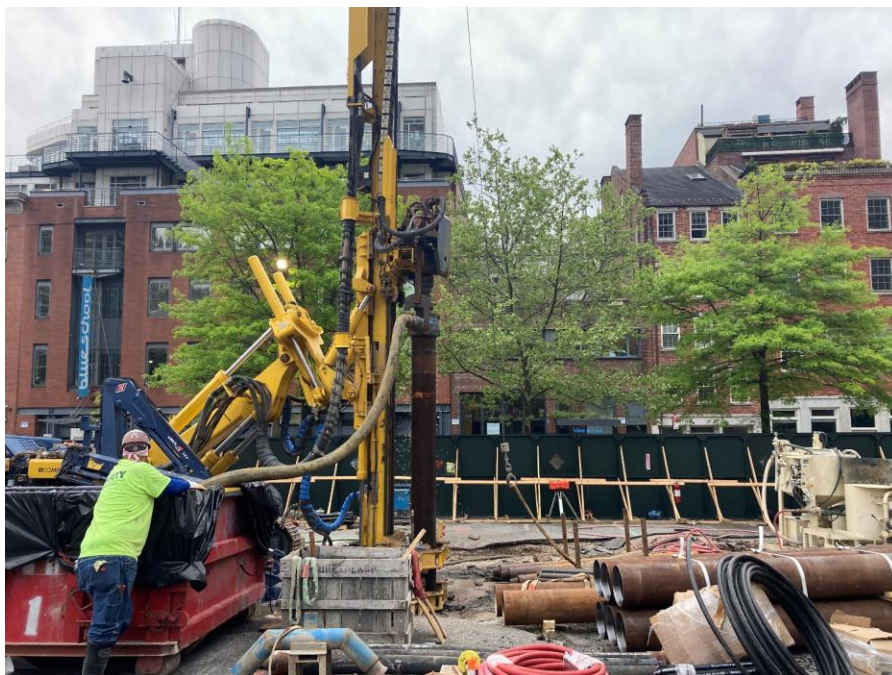
Photo 2: View of CCJV advancing a pile in the southwestern portion of the site (facing south)
