SITE OBSERVATION REPORT

PROJECT No.: 170381202	CLIENT: 250 Seaport District, LLC c/o The Howard Hughes Corporation	DATE: Friday, May 13, 2022
PROJECT: 250 Water Street		WEATHER: Overcast, 60.2 – 71.6 °F Wind: NNE @ 1.0 – 8.0 mph
LOCATION: New York, NY		TIME: 6:00 AM – 2:30 PM
BCP SITE ID: C231127		MONITOR: Lauren Roper, Brian Kenneally

Langan was present to document remediation and construction activities in accordance with the NYSDEC-approved November 2021 Remedial Action Work Plan (RAWP) at the 250 Water Street site (NYSDEC Brownfield Cleanup Program [BCP] Site No. C231127).

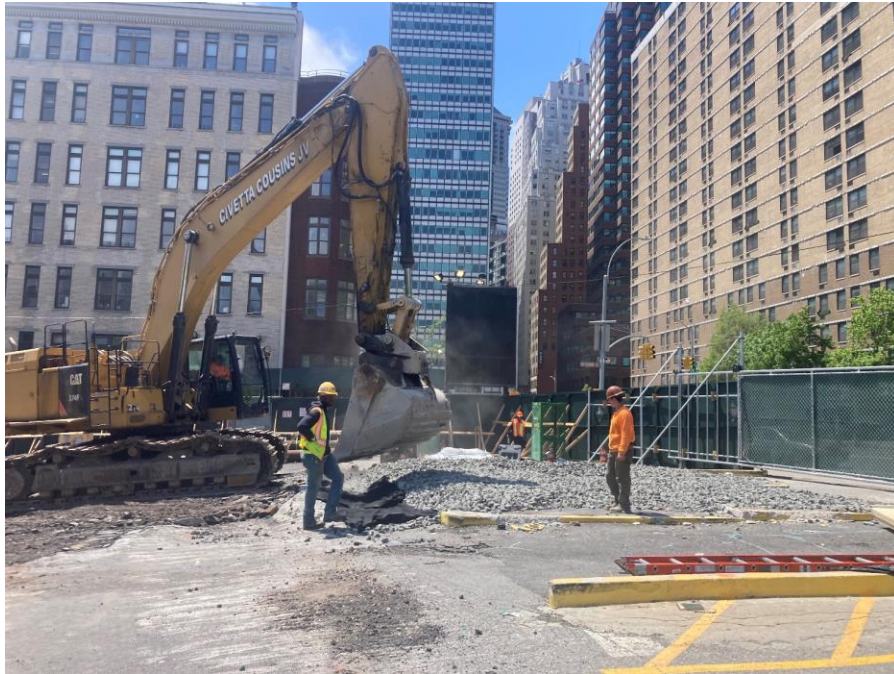
Photo 1: View of CCJV grading previously imported 2.5-inch virgin stone for maintenance of the tracking pad in the northwestern portion of the site (facing west)

- CCJV graded previously imported 2.5-inch virgin stone for maintenance of the tracking pad in the northwestern portion of the site.

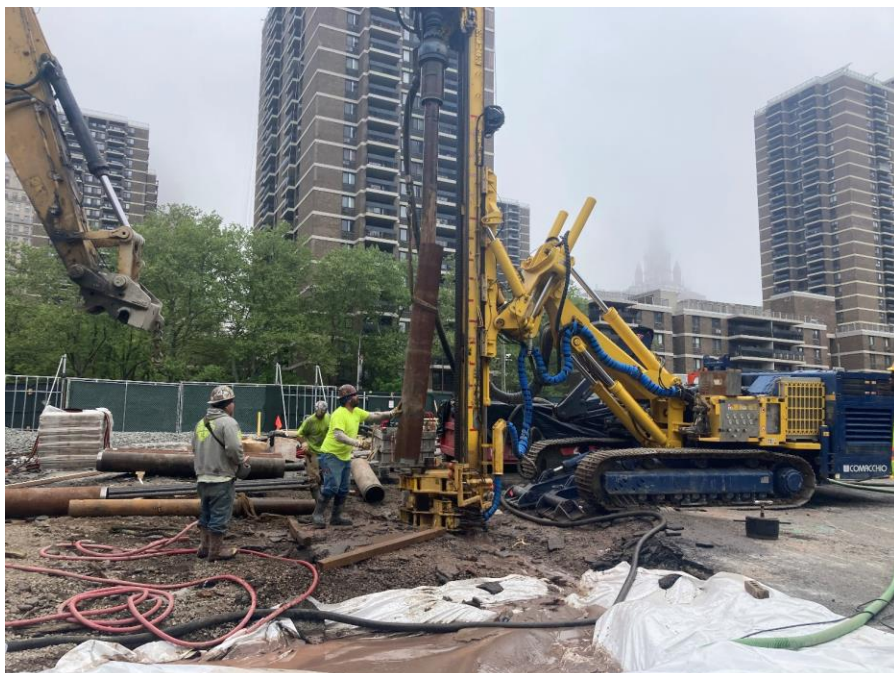
Photo 2: View of CCJV advancing a foundation pile in the southwestern portion of the site (facing southwest)

- CCJV continued advancing a foundation pile from about 20 feet to 80 feet below grade surface (bgs) in the southwestern portion of the site using a Comacchio MC28 drill rig. Municipally-supplied water was used during drilling activities and recirculated to facilitate installation of the pile and was temporarily containerized in a settling tank. Excess water generated during drilling activities was collected into a temporary sump, lined with polyethylene sheeting, and then pumped into the settling tank.

- CCJV began advancement of a foundation pile from surface grade to about 20 feet bgs in the southwestern portion of the site using a Comacchio MC28 drill rig. Municipally-supplied water was used during drilling activities and recirculated to facilitate installation of the pile and was temporarily containerized in a settling tank. Excess water generated during drilling activities was collected into a temporary sump, lined with polyethylene sheeting, and then pumped into the settling tank.
