SITE OBSERVATION REPORT

PROJECT No.: 170381202	CLIENT: 250 Seaport District, LLC c/o The Howard Hughes Corporation	DATE: Saturday, May 14, 2022
PROJECT: 250 Water Street		WEATHER: Overcast, 63.0 – 67.0 °F Wind: ESE @ 1.2 – 2.5 mph
LOCATION: New York, NY		TIME: 7:00 AM – 2:00 PM
BCP SITE ID: C231127		MONITOR: Lexi Haley, Audrey Seery

Langan was present to document remediation and construction activities in accordance with the NYSDEC-approved November 2021 Remedial Action Work Plan (RAWP) at the 250 Water Street site (NYSDEC Brownfield Cleanup Program [BCP] Site No. C231127).

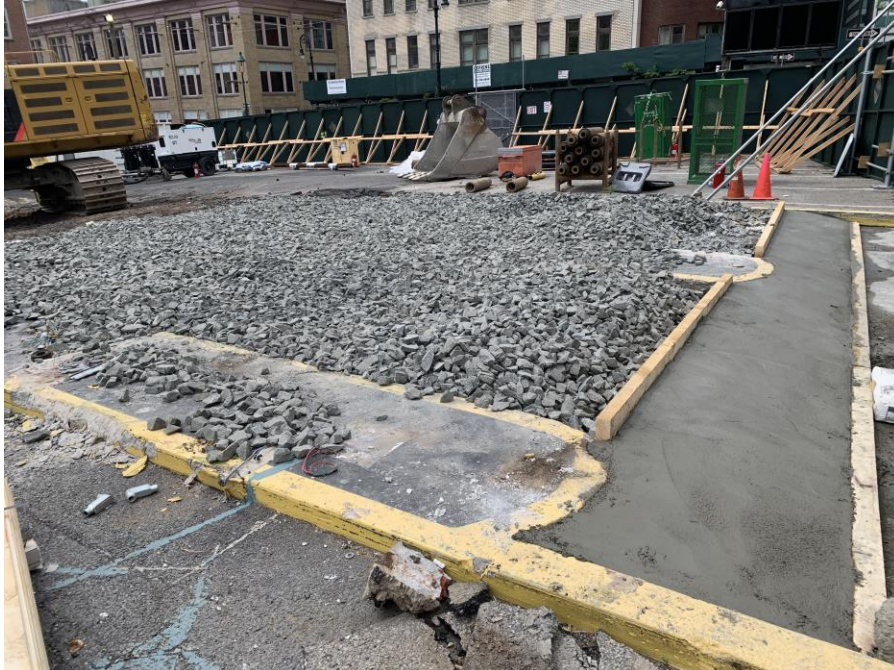
Photo 1: View of concrete placed along the northern edge of the tracking pad (facing southwest).

- CCJV graded previously imported 2.5-inch virgin stone for maintenance of the tracking pad in the northwestern portion of the site.
- CCJV placed concrete in an about 20-foot-long by 2-foot-wide area along the northern edge of the tracking pad to create an access ramp for vehicular access.
