SITE OBSERVATION REPORT

PROJECT No.: 170381202

DATE: Monday, May 23, 2022

250 Water Street

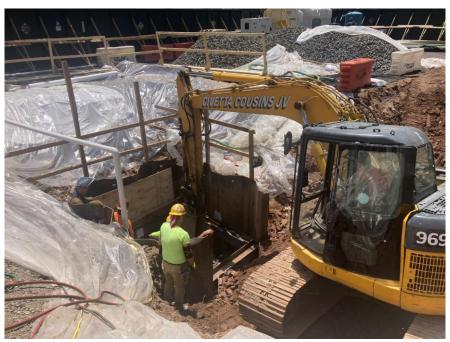
Photo 1: View CCJV excavating soil/fill between previously installed foundation piles in the southwestern portion of the site (facing southwest)

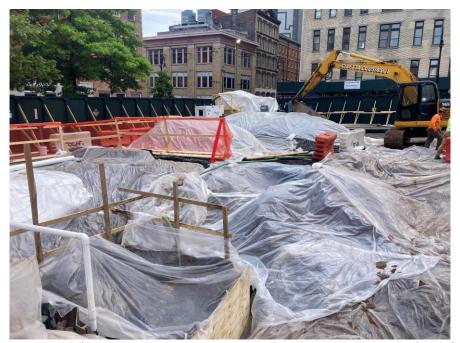
Photo 2: View of exposed soil/fill and imported virgin stone stockpiles covered at end of day (facing southwest).
