SITE OBSERVATION REPORT

<p>PROJECT No.: 170381202</p> <p>PROJECT: 250 Water Street</p> <p>LOCATION: New York, NY</p> <p>BCP SITE ID: C231127</p>	<p>CLIENT: 250 Seaport District, LLC c/o The Howard Hughes Corporation</p>	<p>DATE: Monday, October 10, 2022</p> <p>WEATHER: Sunny, 64 – 66 °F Wind: N @ 2.5 mph</p> <p>TIME: 11:20 AM – 12:40 PM</p> <p>MONITOR: Brian Kenneally</p>
<p>EQUIPMENT: MiniRAE 3000 PID DustTrak II Jerome J405® Jerome J505® Hand tools CAT 374F Komatsu 969 Komatsu 228 Takeuchi TB290 JCB 110W Hydradig Wacker Neuson RTSC3 Wacker Neuson OPU6555</p>	<p>PRESENT AT SITE: Day 125 Langan (Environmental/Geotechnical) – Brian Kenneally Civetta Cousins JV, LLC (CCJV) (Foundation Contractor) – Jack Dettra</p>	
<p>OBSERVATIONS, DISCUSSIONS, TEST RESULTS, ETC.:</p> <p>Langan was present to document remediation activities in accordance with the NYSDEC-approved November 2021 Remedial Action Work Plan (RAWP) at the 250 Water Street site (NYSDEC Brownfield Cleanup Program [BCP] Site No. C231127).</p> <p>Site Activities</p> <ul style="list-style-type: none"> CCJV covered exposed soil/fill that has not been confirmed to meet Track 2 remediation criteria and construction and demolition

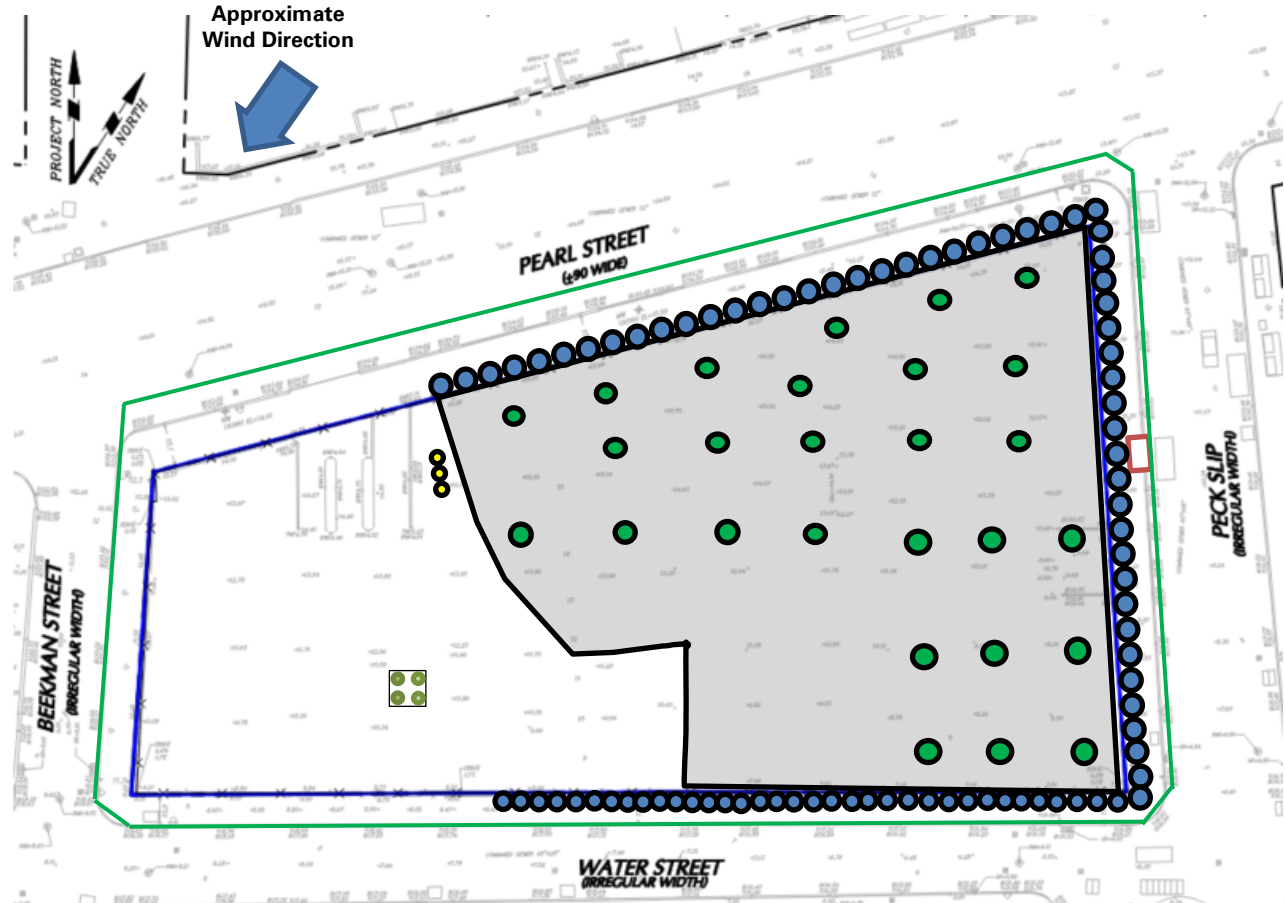
Site Map

1) Locations of air monitoring stations are approximate.

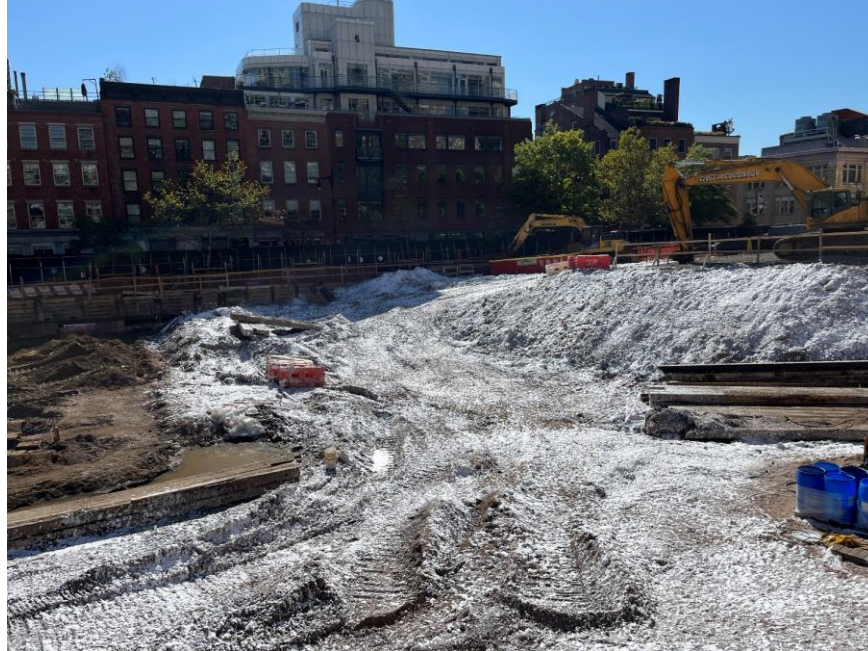
Photo 1: Atmos® AC-645 dust/vapor suppressing foam applied to exposed soil/fill for the temporary overnight cover (facing southwest)
