## SITE OBSERVATION REPORT

<p><b>PROJECT No.:</b> 170381202</p> <p><b>PROJECT:</b> 250 Water Street</p> <p><b>LOCATION:</b> New York, NY</p> <p><b>BCP SITE ID:</b> C231127</p>	<p><b>CLIENT:</b> 250 Seaport District, LLC c/o The Howard Hughes Corporation</p>	<p><b>DATE:</b> Thursday, October 20, 2022</p> <p><b>WEATHER:</b> Clear, 45.3 – 60.0 °F Wind: W @ 0.8 – 6.7 mph</p> <p><b>TIME:</b> 6:00 AM – 4:15 PM</p> <p><b>MONITOR:</b> Brian Kenneally</p>
<p><b>EQUIPMENT:</b> MiniRAE 3000 PID DustTrak II Jerome J405® Jerome J505® Hand tools CAT 374F Komatsu 969 Komatsu 228 Takeuchi TB290 JCB 110W Hydradig Wacker Neuson RTSC3 Wacker Neuson OPU6555</p>	<p><b>PRESENT AT SITE:</b> <span style="float: right;"><b>Day 135</b></span>  <b>Langan</b> (Environmental/Geotechnical) – Brian Kenneally  <b>Civetta Cousins JV, LLC (CCJV)</b> (Foundation Contractor) – Donald Amenaj  <b>Lendlease</b> (General Contractor) – Marty Cohen  <b>New York State Department of Environmental Conservation (NYSDEC)</b> – Rafi Alam</p>

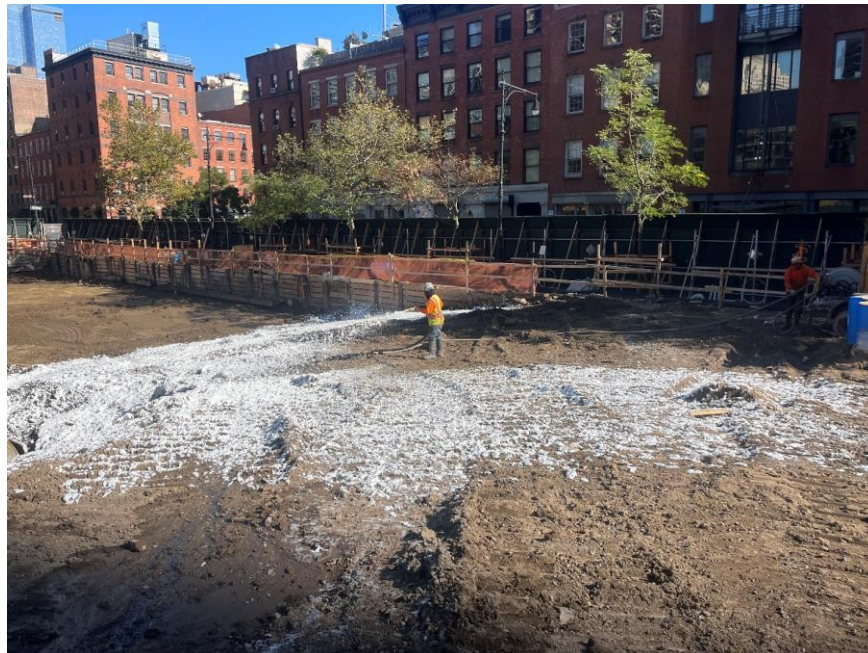
**Photo 2:** CCJV applying Atmos® AC-645 dust/vapor suppressing foam to exposed soil/fill for the temporary overnight cover (facing southwest)
