Day 155

SITE OBSERVATION REPORT

250 Water Street

Langan was present to document remediation activities in accordance with the NYSDEC-approved November 2021 Remedial Action Work Plan (RAWP) at the 250 Water Street site (NYSDEC Brownfield Cleanup Program [BCP] Site No C231127).

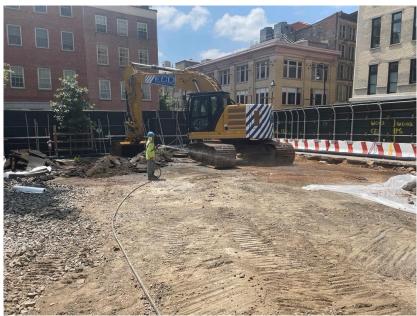
Photo 1: ECD excavating soil/fill in the southwestern part of the site (facing southwest)

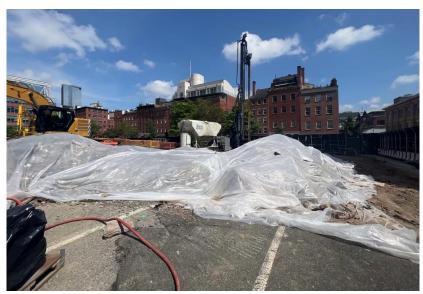
Photo 2: Soil/fill stockpile on and covered with polyethylene sheeting in the northwestern part of the site (facing south)
