SITE OBSERVATION REPORT

PROJECT No.: 170381202

250 Water Street

Langan was present to document remediation activities in accordance with the NYSDEC-approved November 2021 Remedial Action Work Plan (RAWP) at the 250 Water Street site (NYSDEC Brownfield Cleanup Program [BCP] Site No C231127).

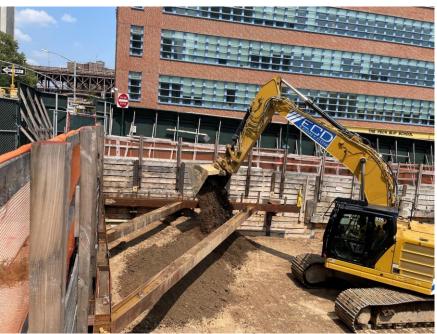
Photo 1: ECD using imported general fill to create a temporary ramp in the northeastern corner of the site (facing east)

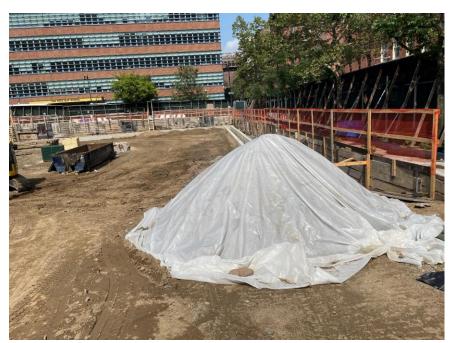
Photo 2: Soil/fill stockpile on and covered with polyethylene sheeting in the southern part of the site (facing east)
