#### SITE OBSERVATION REPORT

**PROJECT No.:** 170381202

250 Water Street

Langan was present to document remediation activities in accordance with the NYSDEC-approved November 2021 Remedial Action Work Plan (RAWP) at the 250 Water Street site (NYSDEC Brownfield Cleanup Program [BCP] Site No C231127).

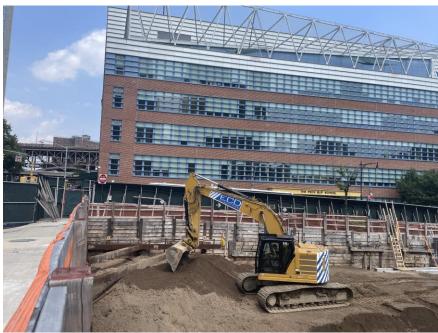
Photo 1: ECD using imported general fill to create a temporary ramp in the northeastern corner of the site (facing east)

- ECD placed imported general fill in an about 90-foot-long by 35-foot-wide area in the northeastern part of the site (Pearl Street and Peck Slip) to create a temporary ramp for equipment access.
- ECD continued constructing wooden formwork in preparation for concrete guide wall installation in the southern part of the site (Water Street). The concrete guide wall will be used to facilitate installation of SOE along the perimeter of the site.

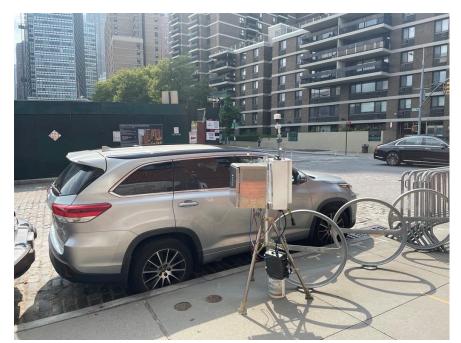
Photo 2: CAMP station WZ-3 on the eastern sidewalk of Peck Slip (facing northwest)

- CAMP station WZ-1 was placed on the western sidewalk of Beekman Street from 6:36am to 2:16pm.
- CAMP station WZ-2 was placed on the southern sidewalk of Water Street from 6:39am to 2:21pm.
- CAMP station WZ-3 was placed on the eastern sidewalk of Peck Slip from 6:44am to 3:50pm.
- CAMP station WZ-4 was placed on the northern sidewalk of Pearl Street from 6:47am to 3:39pm.
