SITE OBSERVATION REPORT

<p>PROJECT No.: 170381202</p> <p>PROJECT: 250 Water Street</p> <p>LOCATION: New York, NY</p> <p>BCP SITE ID: C231127</p>	<p>CLIENT: 250 Seaport District, LLC c/o The Howard Hughes Corporation</p>	<p>DATE: Tuesday, August 1, 2023</p> <p>WEATHER: Sunny, 77 – 81° F Wind: W @ 0.2 – 3.0 mph</p> <p>TIME: 5:30am – 4:00pm</p> <p>MONITOR Jack Millman</p>	
<p>EQUIPMENT: CAT 335 Excavator Komatsu PC138 Excavator ABI Mobilram Drill Rig Jerome J505 Mercury Vapor Analyzer RKI GX-6000 Photoionization Detector (PID) Aeroqual ASQ1 Air Monitoring Station</p>	<p>PRESENT AT SITE: Day 172 Langan (Environmental/Geotechnical) Jack Millman, Gabriella DeGennaro, Tom Keane Suffolk Construction (Suffolk) (General Contractor) Anthony Galu East Coast Drilling, Inc. (ECD) (Foundation Contractor) Danny Rodgers New York State Department of Environmental Conservation (NYSDEC) Jared Donaldson</p>		
<p>OBSERVATIONS, DISCUSSIONS, TEST RESULTS, ETC.:</p> <p>Langan was present to document remediation activities in accordance with the NYSDEC-approved November 2021 Remedial Action Work Plan (RAWP) at the 250 Water Street site (NYSDEC Brownfield Cleanup Program [BCP] Site No C231127).</p> <p>Site

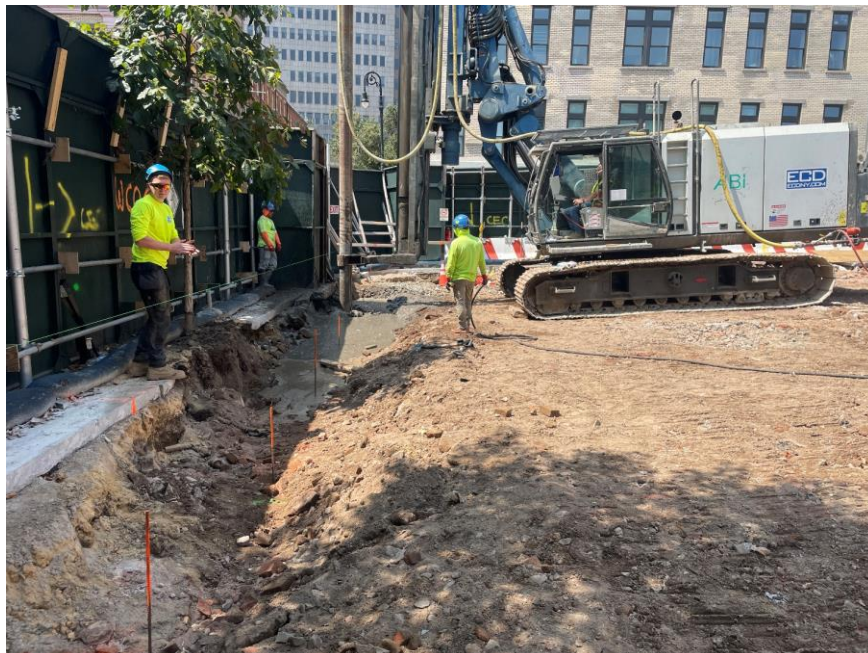
Photo 2: ECD advancing a soil mix column in the southwestern part of the site (facing west)
