## SITE OBSERVATION REPORT

<b>PROJECT No.:</b> 170381202	<b>CLIENT:</b> 250 Seaport District, LLC c/o The Howard Hughes Corporation	<b>DATE:</b> Wednesday, August 2, 2023
<b>PROJECT:</b> 250 Water Street		<b>WEATHER:</b> Sunny, 77 – 81° F Wind: SW @ 0.2 – 2.3 mph
<b>LOCATION:</b> New York, NY		<b>TIME:</b> 5:45am – 4:00pm
<b>BCP SITE ID:</b> C231127		<b>MONITOR</b> Jack Millman

Langan was present to document remediation activities in accordance with the NYSDEC-approved November 2021 Remedial Action Work Plan (RAWP) at the 250 Water Street site (NYSDEC Brownfield Cleanup Program [BCP] Site No C231127).

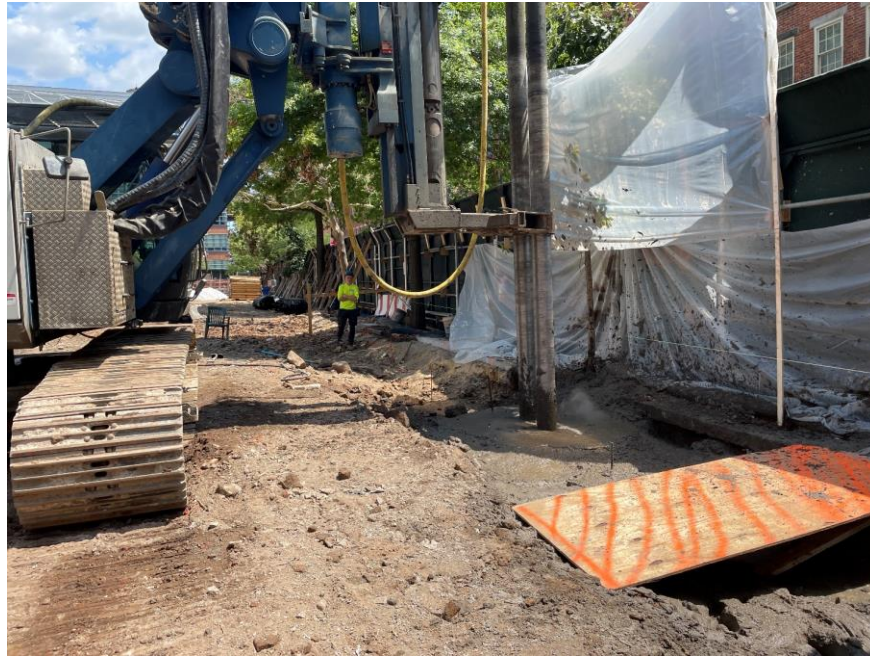
**Photo 1:** ECD advancing a soil mix column in the southwestern part of the site (facing southeast)

- ECD used an ABI Mobilram drill rig to install four soil mix columns to about 35 feet below grade surface (bgs) for support of excavation (SOE) installation in the southwestern part of the site (Water Street). ECD's drill rig advanced steel rods with a soil mixing paddle at the bottom of the rods, while concurrently injecting grout through the top of the paddle and spinning and advancing the paddle downward.

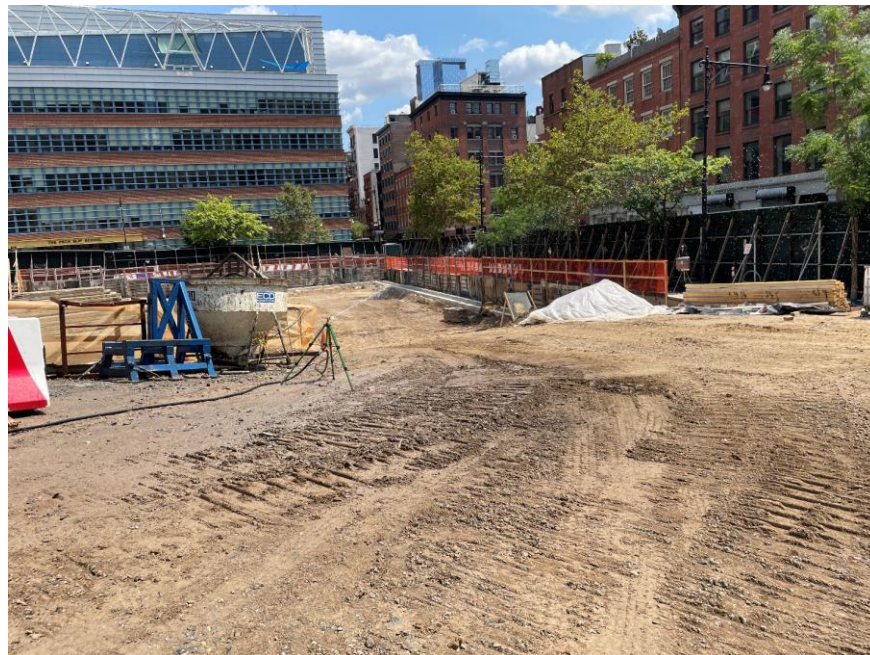
**Photo 2:** Dust suppression in the central part of the site (facing southeast)
