## SITE OBSERVATION REPORT

<b>PROJECT No.:</b> 170381202	<b>CLIENT:</b> 250 Seaport District, LLC c/o The Howard Hughes Corporation	<b>DATE:</b> Monday, August 21, 2023
<b>PROJECT:</b> 250 Water Street		<b>WEATHER:</b> Sunny, 72 – 86° F Wind: N @ 0.14 – 1.62 mph
<b>LOCATION:</b> New York, NY		<b>TIME:</b> 5:30am – 5:30pm
<b>BCP SITE ID:</b> C231127		<b>MONITOR</b> Jack Millman

Langan was present to document remediation activities in accordance with the NYSDEC-approved November 2021 Remedial Action Work Plan (RAWP) at the 250 Water Street site (NYSDEC Brownfield Cleanup Program [BCP] Site No C231127).

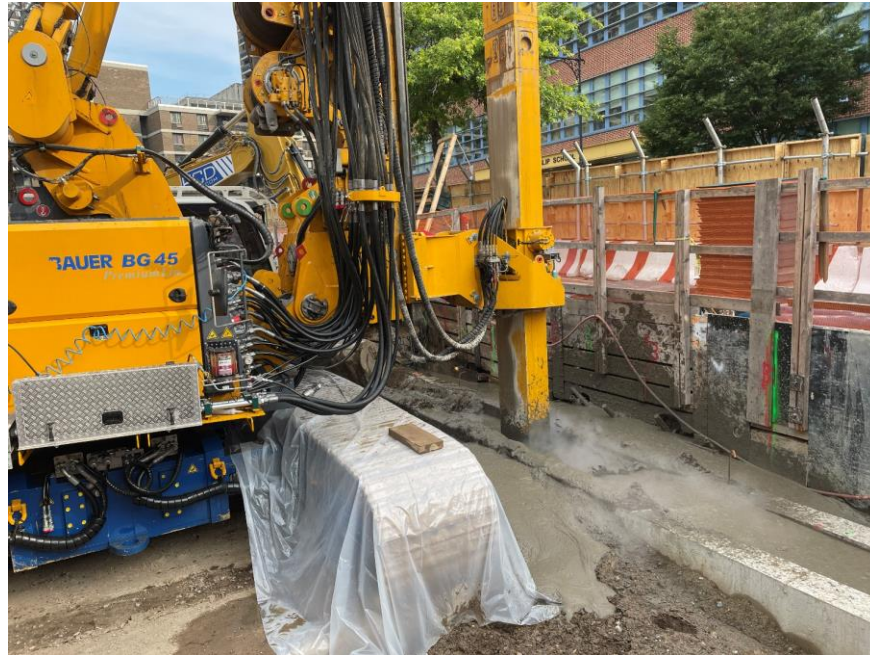
**Photo 1:** ECD installing a soil mix column in the eastern part of the site (facing northeast)

- ECD used a Bauer BG45 drill rig to install a deep soil mix column for SOE installation in the eastern part of the site (along Peck Slip). ECD’s drill rig advanced a steel rod with two cutter blades at the bottom of the rod, while concurrently injecting grout through the cutting head and spinning and advancing the blades downward to about 70 feet bgs. The soil mix column will be completed at a later date.

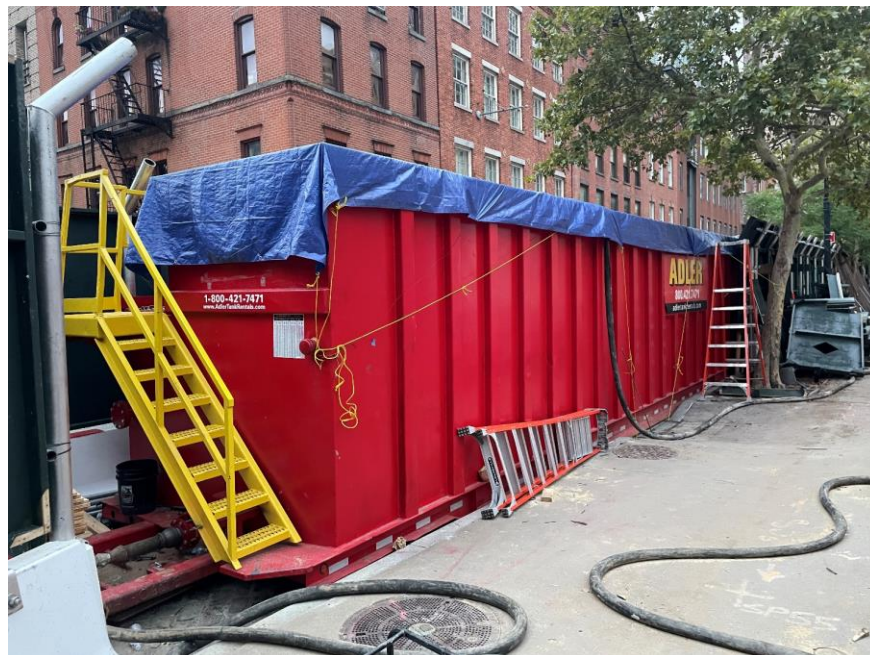
**Photo 2:** Dewatering tank staged in the southeast part of the site (facing southwest)

- ECD continued mobilizing and staging equipment for the site dewatering system in the southeast part of the site (along Water Street).
