## SITE OBSERVATION REPORT

**PROJECT No.:** 170381202

250 Water Street

Langan was present to document remediation activities in accordance with the NYSDEC-approved November 2021 Remedial Action Work Plan (RAWP) at the 250 Water Street site (NYSDEC Brownfield Cleanup Program [BCP] Site No C231127).

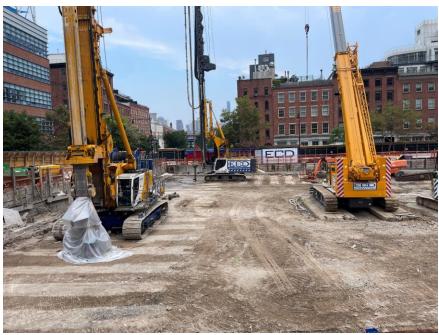
Photo 1: General view of site (facing south)

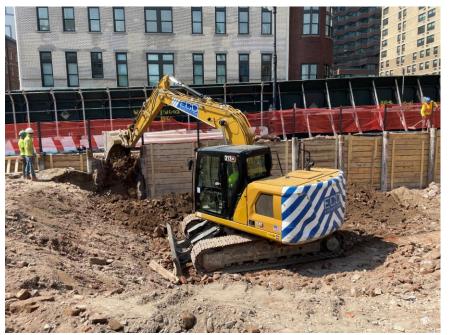
- ECD excavated an about 15-foot-long by 1-foot-wide area to a maximum depth of about 7 feet below grade surface (bgs) in the western part of the site (waste characterization cells WC02 and WC03) to install timber lagging for the support-of-excavation (SOE) system.

Photo 2: ECD excavating soil/fill in the western part of the site (facing west)
