## SITE OBSERVATION REPORT

<b>PROJECT No.:</b> 170381202  <b>PROJECT:</b> 250 Water Street  <b>LOCATION:</b> New York, NY  <b>BCP SITE ID:</b> C231127	<b>CLIENT:</b> 250 Seaport District, LLC c/o The Howard Hughes Corporation	<b>DATE:</b> Tuesday, September 12, 2023  <b>WEATHER:</b> Partly Sunny, 70 – 82° F Wind: SE @ 0.1 – 1.5 mph  <b>TIME:</b> 5:45am – 5:30pm  <b>MONITOR</b> Jack Millman	
<b>EQUIPMENT:</b> CAT 335 Excavator CAT 328 Excavator Komatsu PC138 Excavator Delmag Drill Rig Bauer RTG RG 27S Bauer BG45 Drill Rig Jerome J505 Mercury Vapor Analyzer RKI GX-6000 Photoionization Detector (PID) Aeroqual ASQ1 Air Monitoring Station	<b>PRESENT AT SITE: Day 201</b> <b>Langan</b> (Environmental/Geotechnical) Jack Millman, JN Stanley, Pradeep Pandey <b>Suffolk Construction (Suffolk)</b> (General Contractor) Anthony Galu, Wyatt Favia <b>East Coast Drilling, Inc. (ECD)</b> (Foundation Contractor) Danny Rodgers <b>New York State Department of Environmental Conservation (NYSDEC)</b> Meghan Medwig

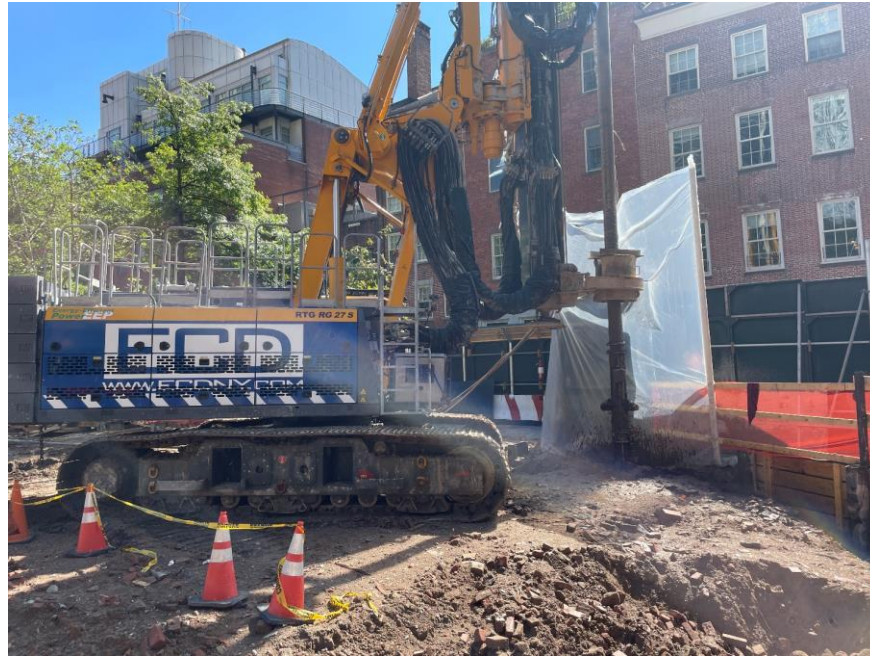
**Photo 1:** ECD advancing a soil mix column in the southwest part of the site (facing south)

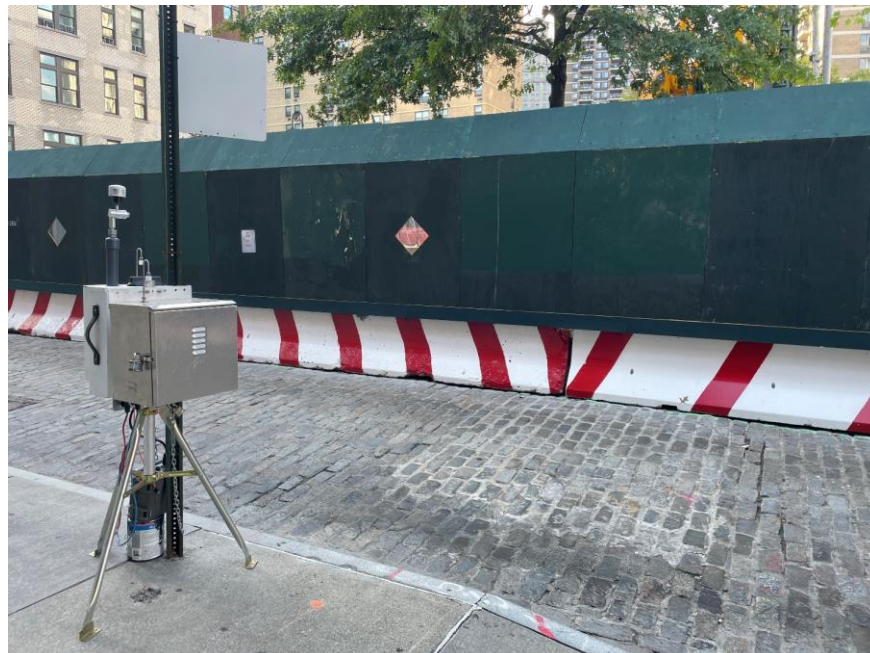
**Photo 2:** CAMP station WZ-2 on the southern sidewalk of Water Street (facing northwest)

- CAMP station WZ-1 was placed on the western sidewalk of Beekman Street from about 6:36am to 4:40pm.
- CAMP station WZ-2 was placed on the southern sidewalk of Water Street from about 6:37am to 4:47pm.
- CAMP station WZ-3 was placed on the eastern sidewalk of Peck Slip from about 6:40am to 4:57pm.
- CAMP station WZ-4 was placed on the northern sidewalk of Pearl Street from about 6:42am to 5:07pm.
