SITE OBSERVATION REPORT

<p>PROJECT No.: 170381202</p> <p>PROJECT: 250 Water Street</p> <p>LOCATION: New York, NY</p> <p>BCP SITE ID: C231127</p>	<p>CLIENT: 250 Seaport District, LLC c/o The Howard Hughes Corporation</p>	<p>DATE: Wednesday, October 18, 2023</p> <p>WEATHER: Sunny, 55 – 63° F Wind: NW @ 0.1 – 1.2 mph</p> <p>TIME: 5:45 am – 6:30 pm</p> <p>MONITOR Gabriella DeGennaro</p>
<p>EQUIPMENT: CAT 335 Excavator CAT 328 Excavator Komatsu PC210 Excavator Delmag Drill Rig Bauer RTG RG 27S Bauer BG45 Drill Rig Casagrande M6A-1 Tieback Drill Rig Jerome J505 Mercury Vapor Analyzer RKI GX-6000 Photoionization Detector (PID) Aeroqual ASQ1 Air Monitoring Station</p>	<p>PRESENT AT SITE: Day 227 Langan (Environmental/Geotechnical) Gabriella DeGennaro, Michael Cole, Pradeep Pandey Suffolk Construction (Suffolk) (General Contractor) Wyatt Favia East Coast Drilling, Inc. (ECD) (Foundation Contractor) Danny Rodgers New York State Department of Environmental Conservation (NYSDEC) Shawn Roberts Earth Efficient (Soil Broker) Yinette Batista AKRF, Inc. (Archaeologist) Theresa Imbriolo Innovative Recycling Technologies, Inc. (IRT) (UST Cleaning/Removal Contractor)</p>

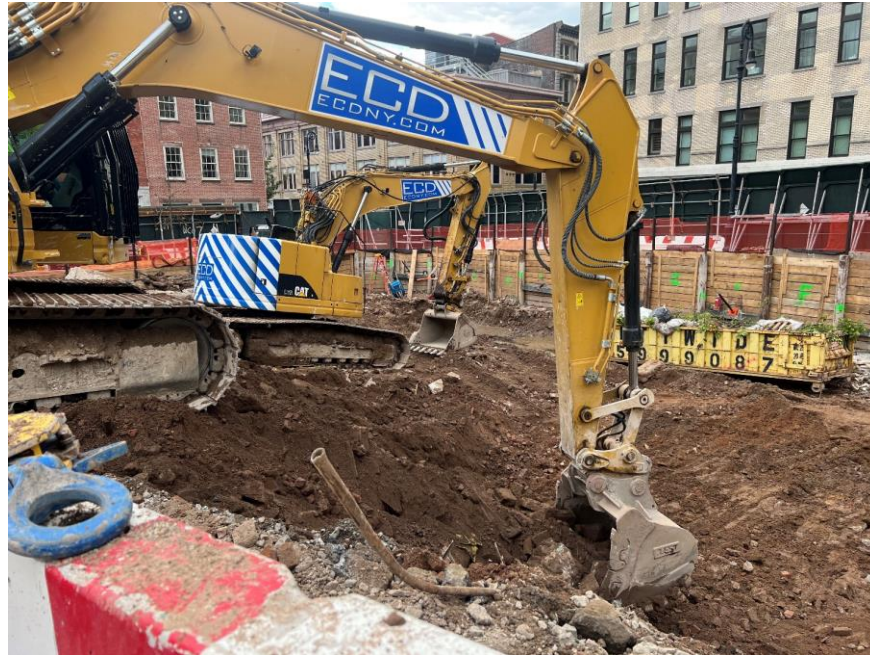
- ECD excavated an about 40-foot-long by 5-foot-wide area to a maximum depth of about 2 feet below the existing grade (about 9 feet below sidewalk grade [bsg]) in the southern part of the site (waste characterization cell WC03 and WC06) to install timber lagging for the SOE system.

- Excavated soil/fill was screened for odors, staining, organic vapors, and mercury vapor using a handheld PID and handheld Jerome® J505 mercury vapor analyzer, respectively. Evidence of impacts was not observed and the excavated soil/fill was separated from C&D debris using a sifting bucket. The C&D debris was either stockpiled adjacent to the excavation area or was live-loaded into securely covered tri-axle dump trucks for off-site disposal. Following removal of the C&D debris and installation of the timber lagging, the excavated soil/fill was temporarily backfilled into the excavation area for off-site disposal at a later date.

Photo 1: ECD excavating soil/fill in the western part of the site (facing southeast)

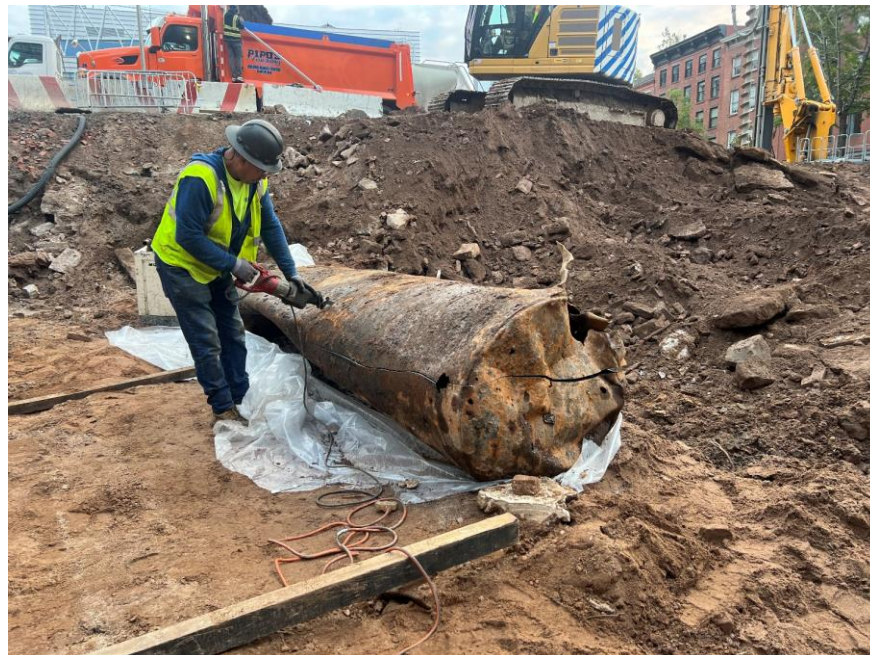
- IRT decommissioned the underground storage tank (UST) staged in the southern part of the site. Decommissioning activities included cutting a hole in the UST to render it unusable and removing residual tank contents. Following removal of the tank bottoms, the interior of the tank was cleaned using absorbent pads. The spent absorbent pads and the residual tank contents (petroleum-related sludge) were containerized in 55-gallon United Nations/Department of Transportation (UN/DOT)-approved 55-gallon steel drums for off-site disposal. No odors or PID readings were observed during decommissioning of the UST.

Photo 2: IRT decommissioning a UST prior to off-site disposal (facing southeast)

- IRT exported the UST carcass for off-site disposal as scrap metal at the Gershow Recycling facility, located in Brooklyn, NY.
- IRT exported three UN/DOT-approved 55-gallon drum containing spent absorbent pads for off-site disposal at the Republic Environmental Systems facility, located in Hatfield, PA.
- ECD exported 12 truckloads (about 240 cubic yards [CY]) of C&D debris for off-site disposal at the Earth Efficient MSM facility located in East Stroudsburg, PA.
- ECD exported one truckload (about 20 CY) of soil/fill for off-site disposal at the Middlesex County Landfill (MCUA) facility in East Brunswick, NJ.
- No material was imported to the site.
