SITE OBSERVATION REPORT

PROJECT No.: 170381202

Saturday, November 11, 2023

250 Water Street

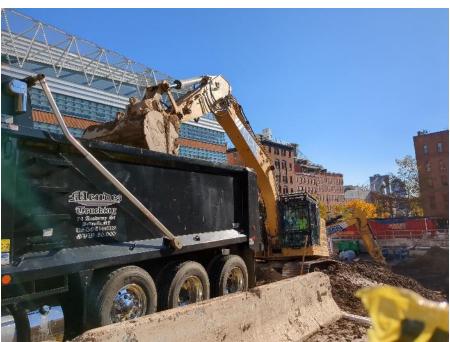
Photo 1: ECD loading a truck with non-hazardous soil/fill for off-site disposal (facing southeast)

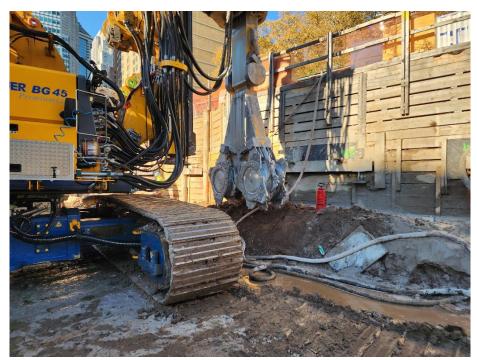
- ECD used a Bauer BG45 drill rig to install one deep soil mix column for the support-of-excavation (SOE) system installation in the northern part of site (along Pearl Street). ECD's drill rig advanced a steel rod with two cutter blades at the bottom of the rod, while concurrently injecting grout through the cutting head and spinning and advancing the blades downward to a depth of about 108 feet below grade surface (bgs).

Photo 2: ECD installing a soil mix column in the northern part of the site (facing northwest)
