FOCUSED SUBSURFACE SITE INVESTIGATION (FSSI)

**92-98 NAGLE AVENUE
AKA 2-12 SICKLES STREET
NEW YORK, NEW YORK 10040**

MECC PROJECT NO. M17389

RE: Focused Subsurface Site Investigation (FSSI)
92-98 Nagle Avenue
AKA: 2-12 Sickles Street
New York, New York

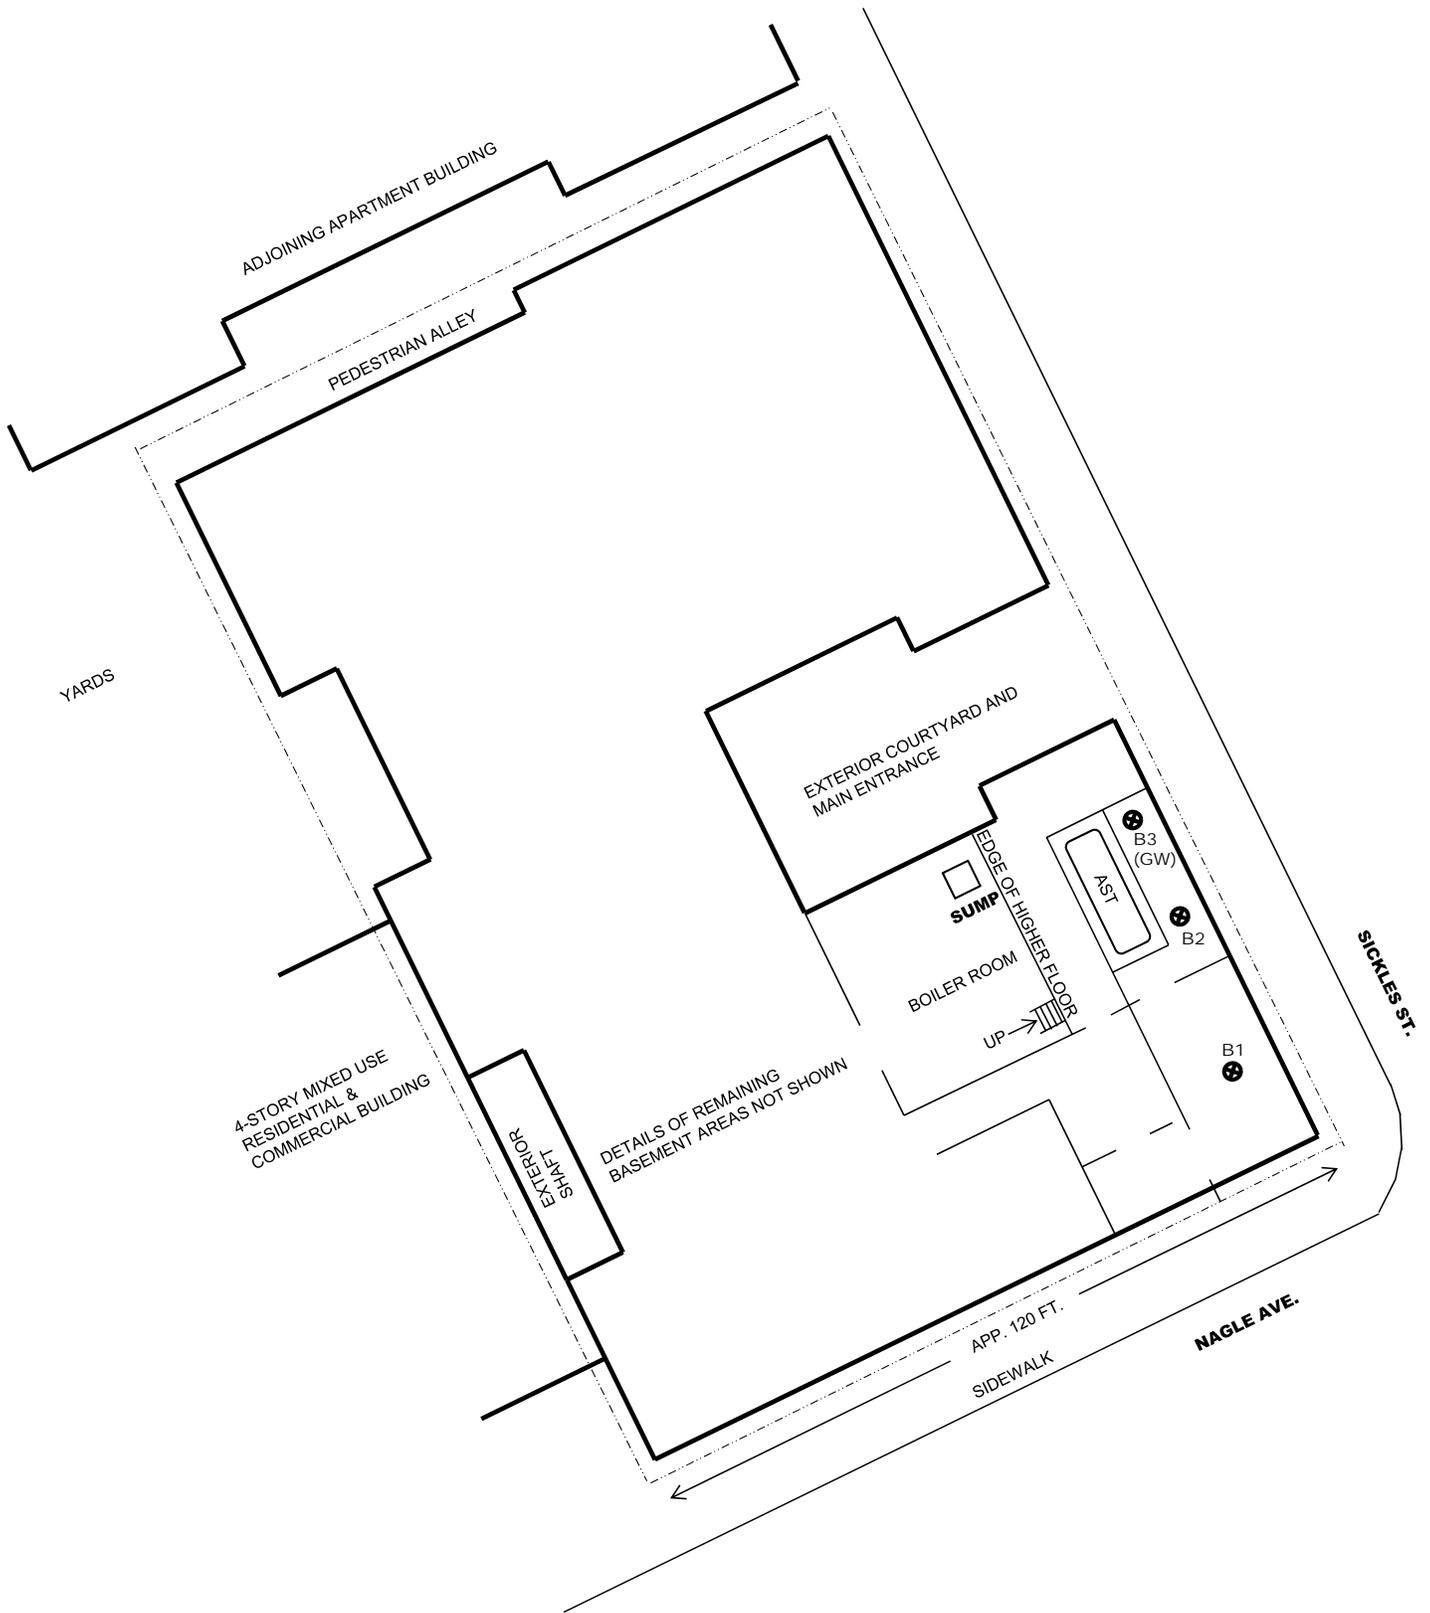
SITE SKETCH: 92 TO 98 NAGLE AVE.
NOT TO SCALE NY, NY

SUMMARY OF VOCs DETECTED IN THE SUMP & GROUNDWATER SAMPLES (IN UG/L):

B3GW:	SUMP:
PCE: 39000	PCE: 46
TCE: 100	TCE: 1.7
CIS-1,2-DCE: 180	CIS-1,2-DCE: 7.8

NOTE:
INTERIOR DETAILS SHOW A PORTION OF THE BASEMENT LEVEL ONLY

ESTIMATED DIRECTION OF LOCAL
GROUNDWATER FLOW

PATTERNED LINES ENCLOSE THE SITE
 ⊕ DENOTES SOIL BORING LOCATIONS
 ("GW" DESIGNATION INDICATES GROUNDWATER SAMPLE LOCATIONS)

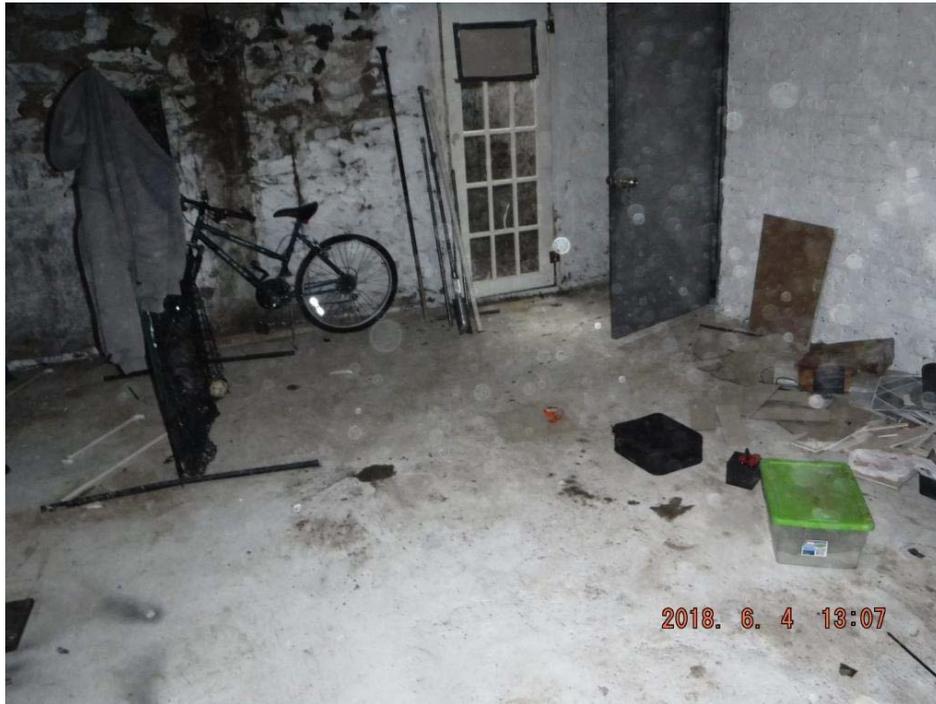
Photograph 1: Location of B1 at the south end of the former dry cleaner space (patched area in floor)

MECC employed an electrically-powered hammer drill to create three openings into the basement floor of the former dry cleaner space. Two of these openings were installed into a narrow space between the aboveground storage tank vault (it appears that this storage tank and vault were installed in the former dry cleaner space in the recent past). Mr. Frank Galdun, Project Geologist with MECC, conducted all drilling and field sampling activities. All field work was completed on June 4, 2018. A hand auger was used to complete all borings. Soil Boring Nos. B1 and B2 encountered refusal within two feet below the basement floor. Soil Boring B3 was finished to a depth of six feet below the floor.

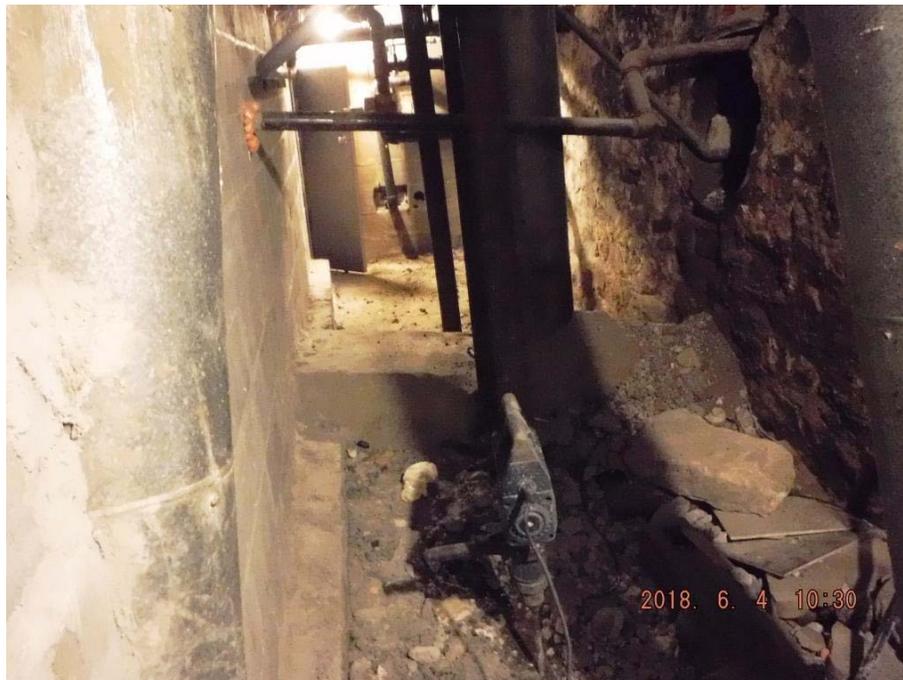
The focus of this study was specifically within the basement of the vacant dry cleaner space within the Site building. Currently, the basement under the former dry cleaner contains storage of miscellaneous resident-owned items and the aboveground heating oil storage tank vault. Support columns reaching from the basement floor to the ceiling in the former dry cleaner basement were observed; such columns are typical installations to support the weight of a dry cleaning machine on the ground floor.

Photograph 2: Locations of B2 and B3. B3 was installed at far end of room. Tank vault at left. Dry cleaning machine support columns shown

Laboratory analysis of these samples shows PCE at a concentration in groundwater as high as 39000 ug/l in B3GW. The regulatory limit for PCE in groundwater is 5 ug/l. PCE degradation products were also detected in the samples (cis-1,2-DCE, TCE). The data does show evidence indicating that the sump is drawing in some portion of the contaminated groundwater.

This FSSI has identified PCE in groundwater at a concentration of 39,000 micrograms per liter (ug/l). The applicable regulatory limit for PCE in groundwater is 5.0 ug/l and MECC qualifies the detected PCE concentration in groundwater at the Site as severe. Other evidence shows that contaminated groundwater is being drawn towards the sump pit, but not to a great degree as shown by the relatively low contaminant concentrations. Based on local surface topography, the estimated direction of groundwater flow is northeast. The former dry cleaner space is at the northeast end of the Site building and, therefore, it is possible that a contaminant plume has developed beyond Site borders to the northeast. Further investigation needs to be conducted to determine the extent of the contamination and to assess the potential of a vapor intrusion condition. Due to the discovered severity of the PCE contamination in groundwater, MECC recommends regulatory agency reporting.

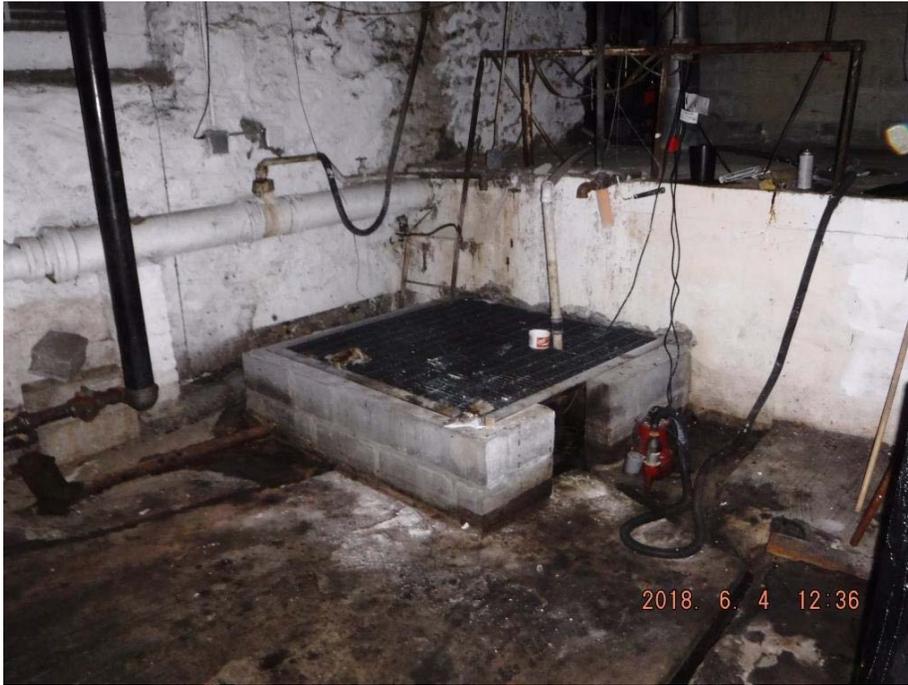
The boiler room is located in the basement of the Site building and the floor of this area is approximately four feet lower in elevation than the remainder of the basement floors. A large sump pit is present in the boiler room and it is clear that the sump is capturing groundwater for discharge to the local sewer system. MECC observed open runnels along the bottoms of the boiler room perimeter walls and water was observed to be flowing within these runnels towards the sump. The sump structure is approximately four feet long, four feet wide and roughly two feet deep and is lined with concrete.

Photograph 1: Sump pit in the basement boiler room.
