Re: 644 East 14th Street, Manhattan, NY

**Block 396 Lot 29**

Environmental Business Consultants (EBC) performed a Limited Phase II subsurface investigation at the above referenced property on March 13, 2014, confirm the presence of a possible No. 2 fuel oil underground storage tank within the small yard on the south side of the property, and determine if the historic use of the Site as an automotive service facility has negatively impacted subsurface soil and/or groundwater.

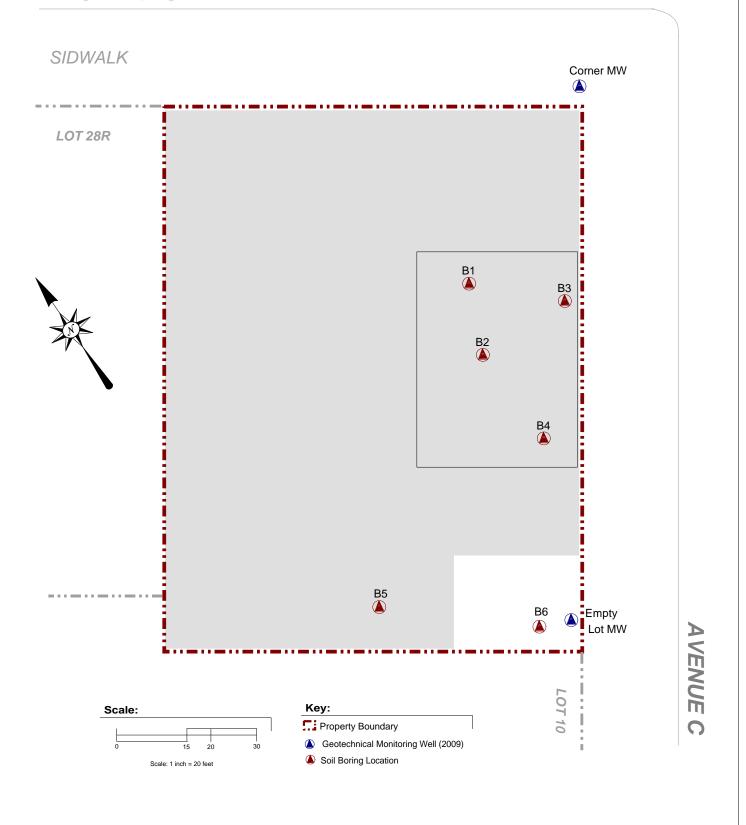
Figure	No.
1

Six soil boring locations (B1 through B6) were selected as shown on **Figure 1.** Four of the soil borings (B1 through B4) were performed within the area identified on the Sanborn maps as being utilized for auto repair, on soil boring was performed within the small yard on the south side of the building (B6), and one soil boring was performed within the one-story addition accessed from the rear yard (B5) because spray painted words on the interior walls of the building indicated this area was also utilized for automotive repair or bulk petroleum storage.

Two groundwater samples were collected at the Site in the locations shown on **Figure 1**. Groundwater sample "Corner MW" was collected from the existing geotechnical monitoring located within the sidewalk at the northeast corner of the building. Groundwater sample "Empty Lot MW" was collected
