DAILY FIELD REPORT 003

Prepared By: LANGAN

BCP Project No:	C231153	Date:	June 1, 2023
Project Name:	Kasser Scrap Metal and Rector Cleaners Site	Time:	7:00 am to 3:30 pm
Consultant: Langan Engineering, Environmental, Surveying, Landscape Architecture and Geology, D.P.C. (Langan)		Langan Field Personnel: Caitlyn Dempsey (Environmental)	
Construction Manager: Consigli Construction Co., Inc. (Consigli)			
Foundation Contractor: Urban Foundation/Engineering (Urban)

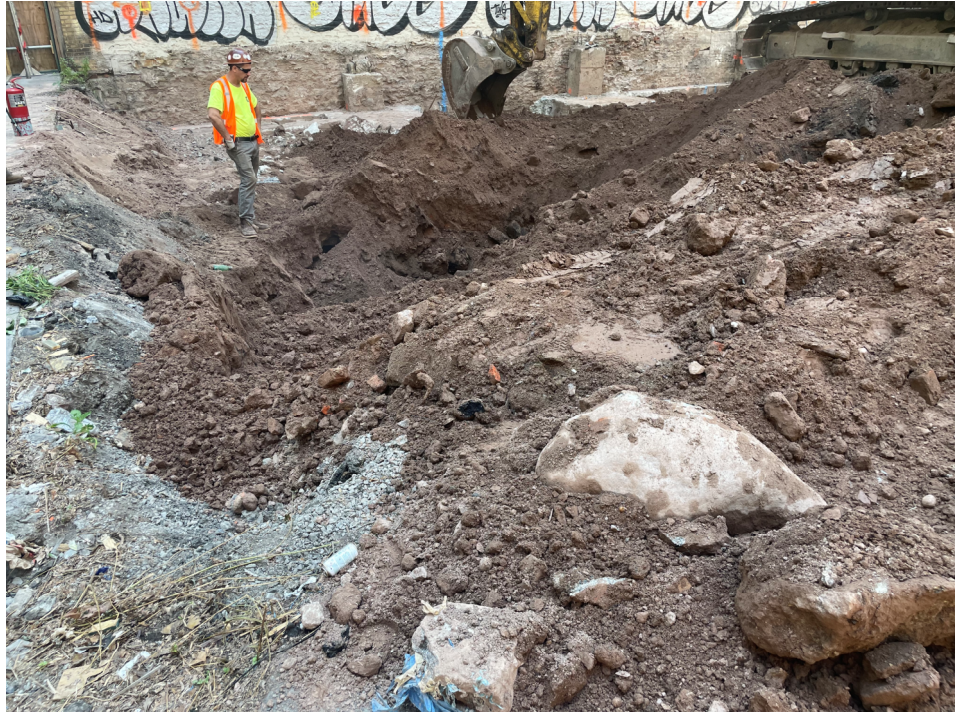
- Urban excavated an about 5-foot-long by 20-foot-wide area and an about 5-foot-long by 10-foot-wide area to about 5-feet below grade surface (bgs) in the northern part of waste characterization grid WC03_0-5. Excavated soil/fill was stockpiled and graded adjacent to the excavation pending off-site disposal.

- All excavated soil/fill consisted of non-native soil; odors, staining, elevated PID readings, or other evidence of a petroleum or chemical release were not observed.

Photo 1: Urban excavating in the northern part of WC03_0-5 (facing east).

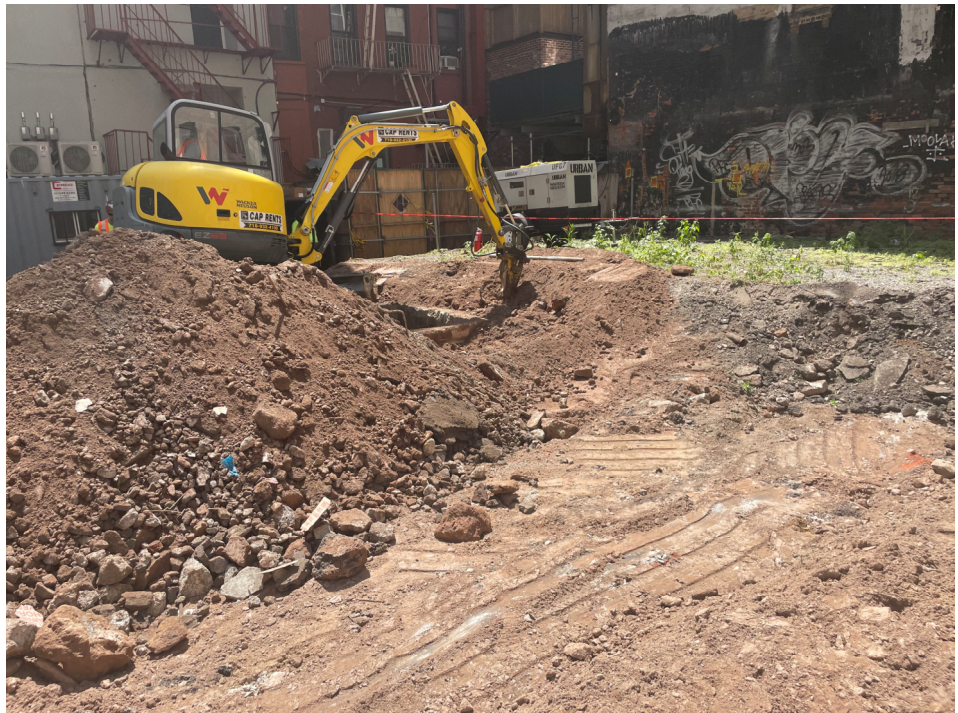
- Urban excavated an about 5-foot-long by 10-foot-wide area to about 4 feet bgs in the southern part of waste characterization grids WC04_0-5 and WC05_0-5 in an attempt to determine the full extent of the closed-in-place 3,000-gallon underground storage tank (UST) and its concrete encasement. Excavated soil/fill was temporarily stockpiled adjacent to the excavation before being replaced into the excavation area. Impacts, including odors, staining, or elevated photoionization detector (PID) readings were not observed. The full extents of the UST and concrete encasement were not determined. Additional attempts will be made to determine the full extent of the closed-in-place UST.

- Urban removed concrete in the northern and eastern parts of waste characterization grids WC03 and WC05. The concrete and demolition debris (C&D) was separated and stockpiled in the western part of waste characterization grid WC04.

Photo 2: View of Urban removing concrete in the eastern part of WC05_0-5 (left) and the top of the UST concrete encasement (right).
