DAILY FIELD REPORT 004

Prepared By: LANGAN

BCP Project No:	C231153	Date:	June 2, 2023
Project Name:	Kasser Scrap Metal and Rector Cleaners Site	Time:	7:00 am to 3:30 pm
Consultant: Langan Engineering, Environmental, Surveying, Landscape Architecture and Geology, D.P.C. (Langan)		Langan Field Personnel: Caitlyn Dempsey (Environmental)	
Construction Manager: Consigli Construction Co., Inc. (Consigli)			
Foundation Contractor: Urban Foundation/Engineering (Urban)

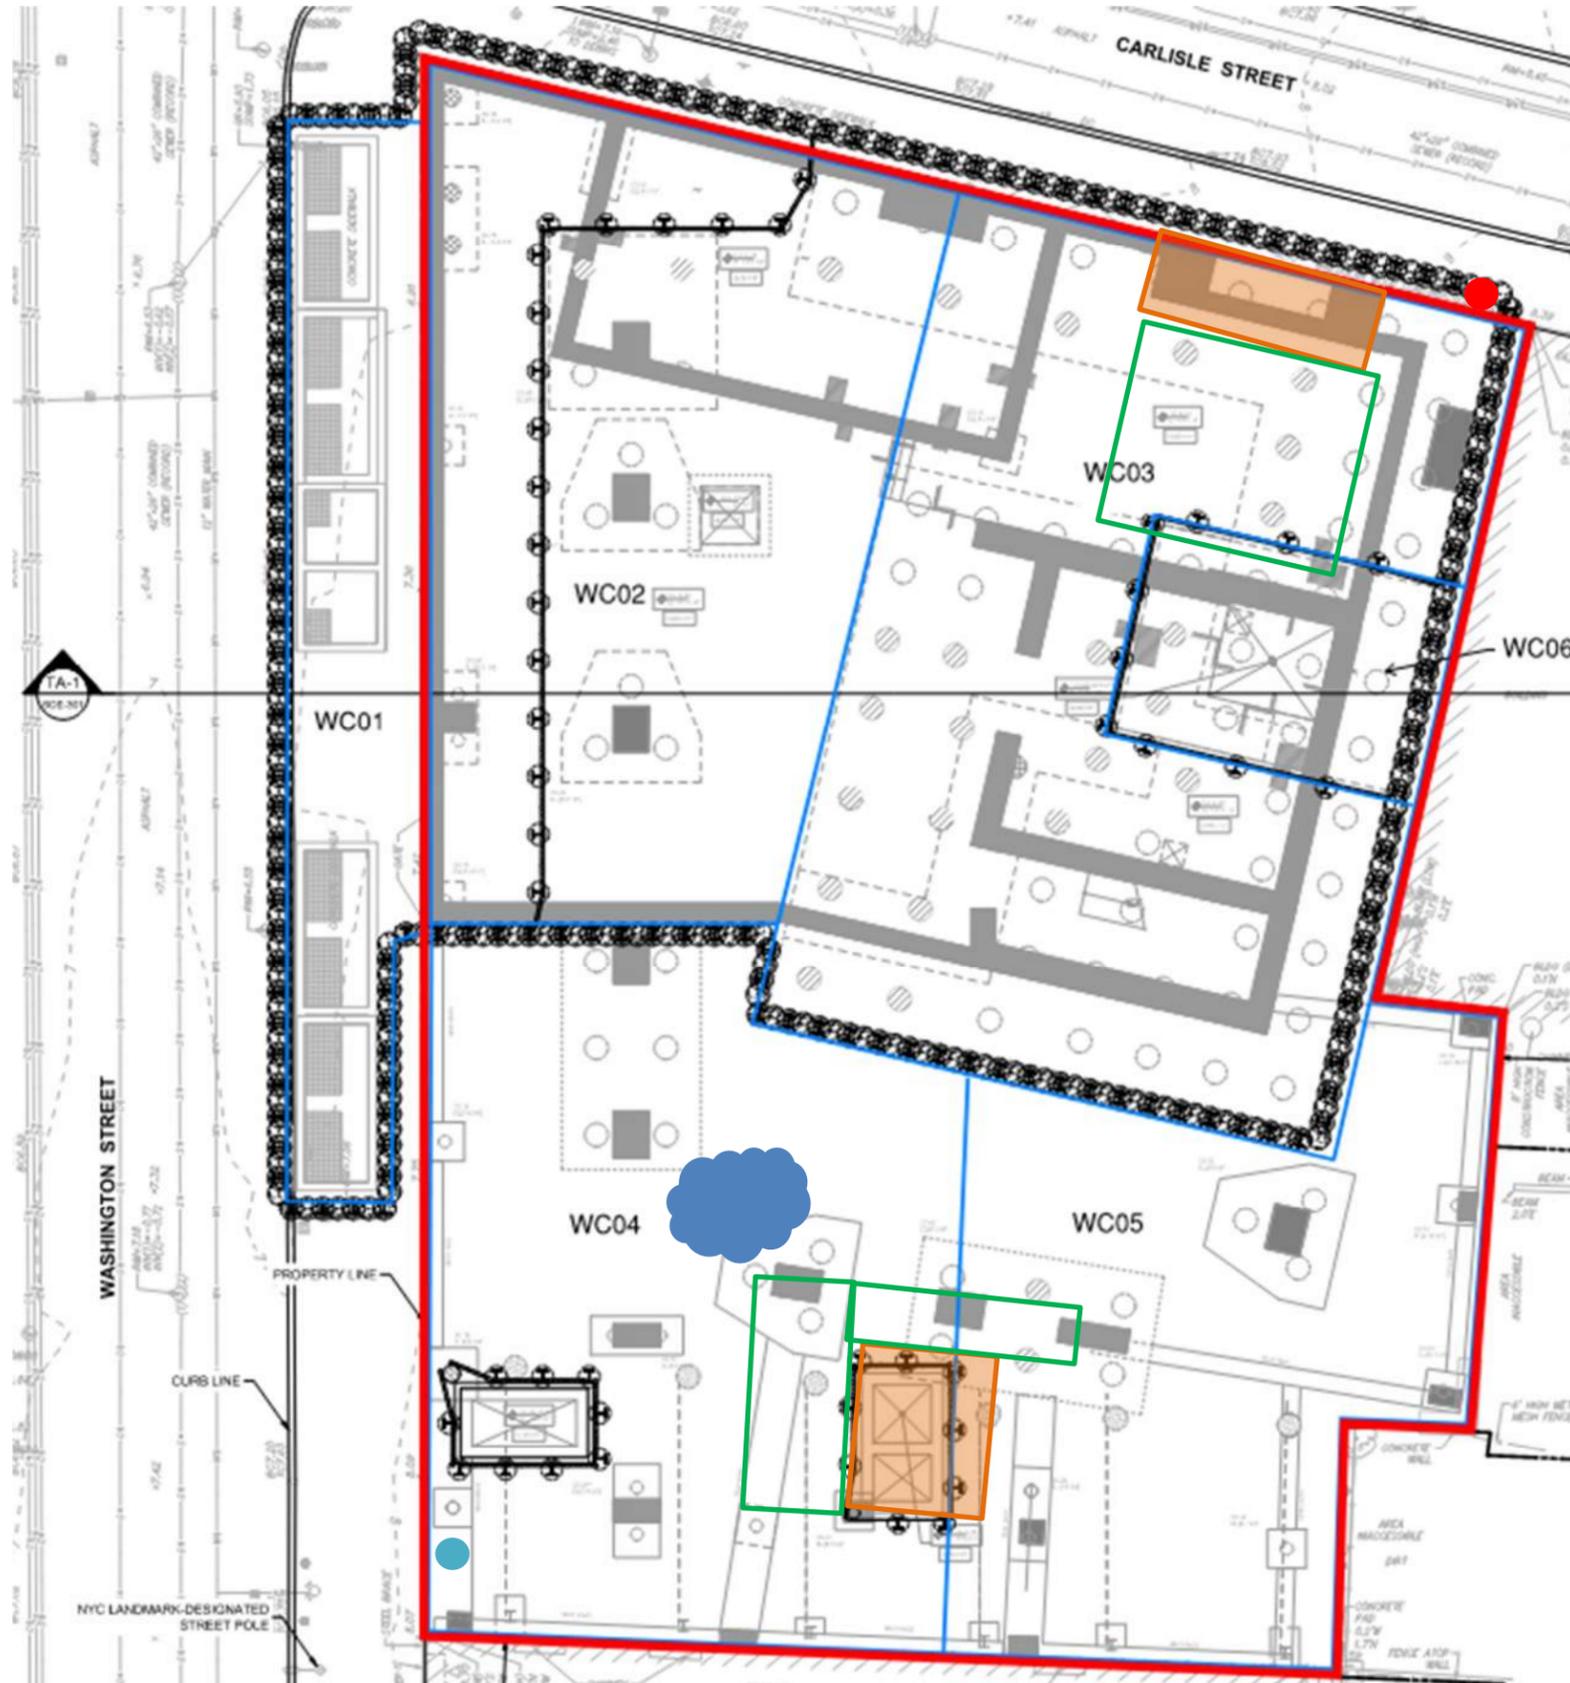
SITE PLAN

Note: Waste characterization grid areas were developed by PT Consultants and Urban and shown on this site plan for reference only.

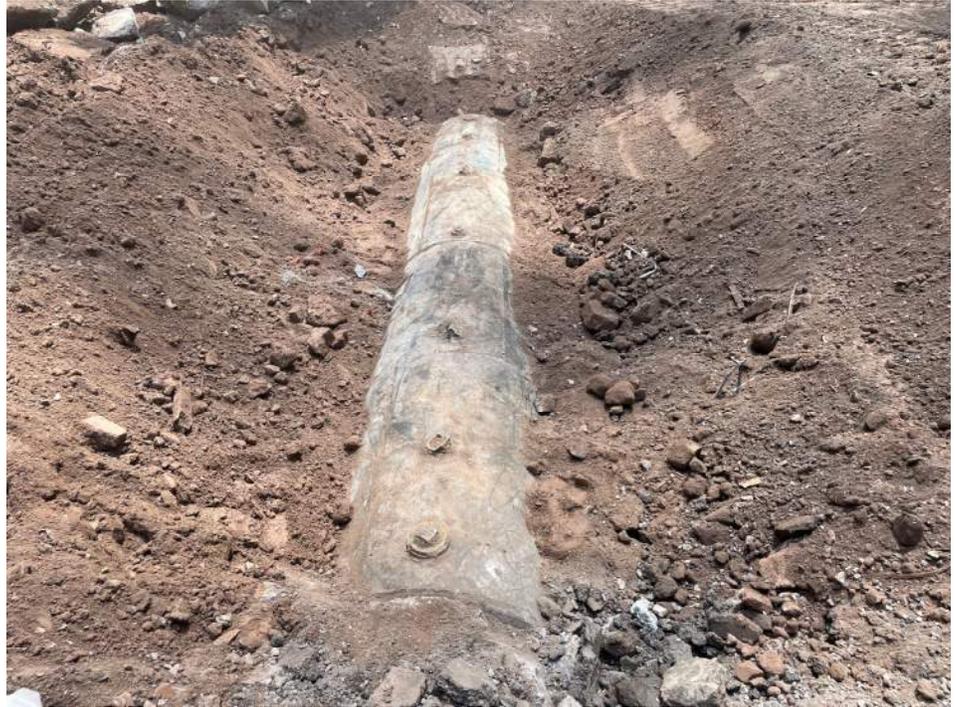
- Urban removed the top of the concrete enclosure around the UST in the southern part of waste characterization grids WC04_0-5 and WC05_0-5 to uncover the closed-in-place 3,000-gallon underground storage tank (UST). Concrete and demolition debris (C&D) was stockpiled in the central area of waste characterization grid WC04. Impacts, including odors and staining were not observed; headspace readings of a UST port with a photoionization detector (PID) were measured at a maximum of 703 parts per million (ppm). Contents of the UST appeared to include petroleum-impacted sand. The exposed UST was covered with polyethylene sheeting at the end of the day.

Photo 1: View of the 3,000-gallon UST in the southern parts of WC04 and WC05 (facing north).

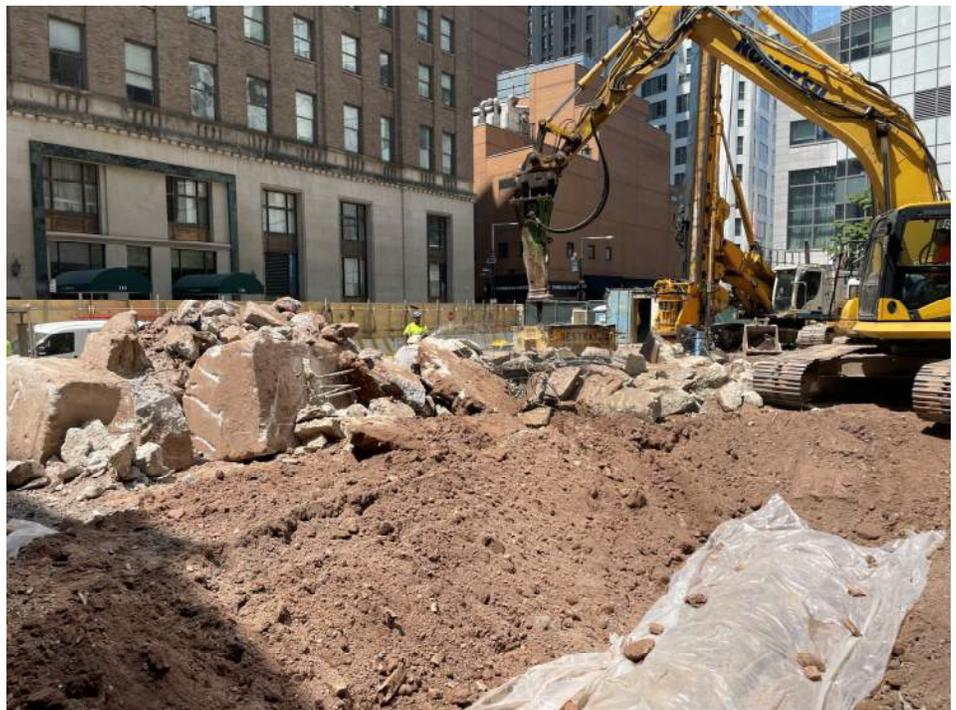
- Urban removed concrete in the northern and eastern parts of waste characterization grid WC03. C&D was separated and stockpiled in the central area of waste characterization grid WC04.

Photo 2: View of the covered UST and demolition of concrete in the central part of the site (facing northwest).

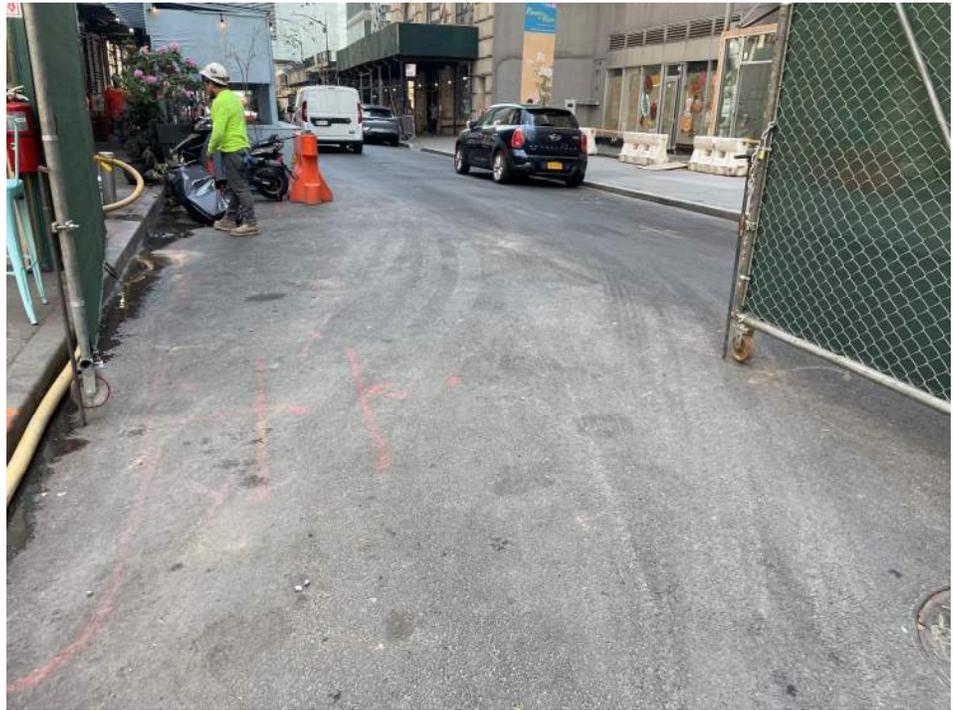
Photo 3: View of the site entrance/exit along Washington Street at the end of the work day (facing northeast).

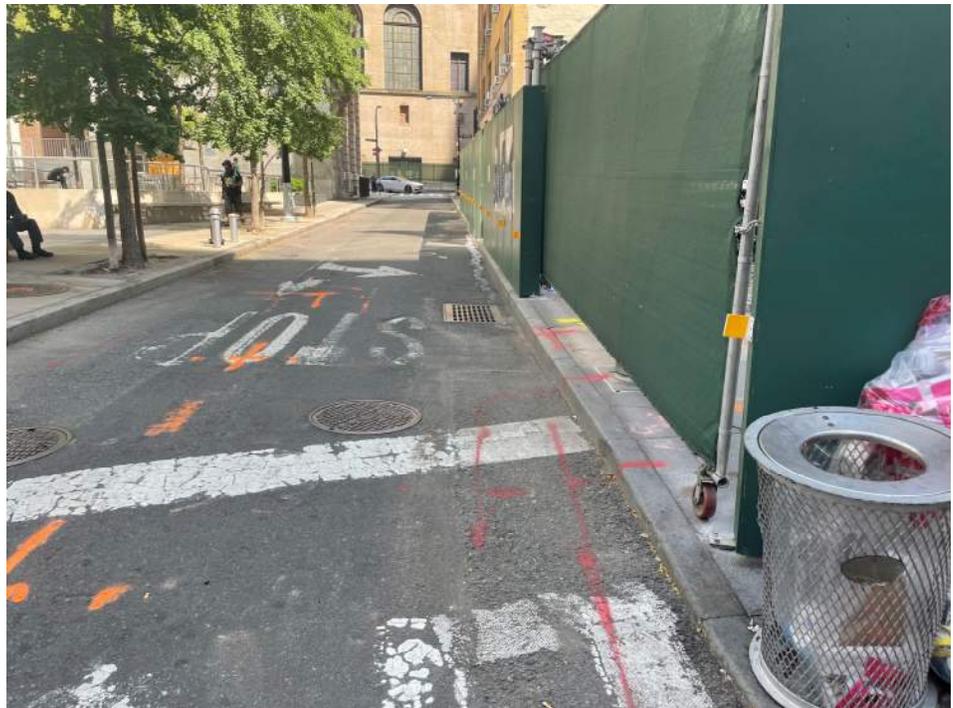
Photo 4: View of the site entrance/exit at the corner of Washington and Carlisle Street at the end of the work day (facing east).
