**DAILY FIELD REPORT 168**

<b>BCP Project No:</b>	C231153	<b>Date:</b>	January 16, 2024
------------------------	---------	--------------	------------------

<b>Project Name:</b>	Kasser Scrap Metal and Rector Cleaners Site	<b>Time:</b>	6:45 am to 3:30 pm
----------------------	---	--------------	--------------------

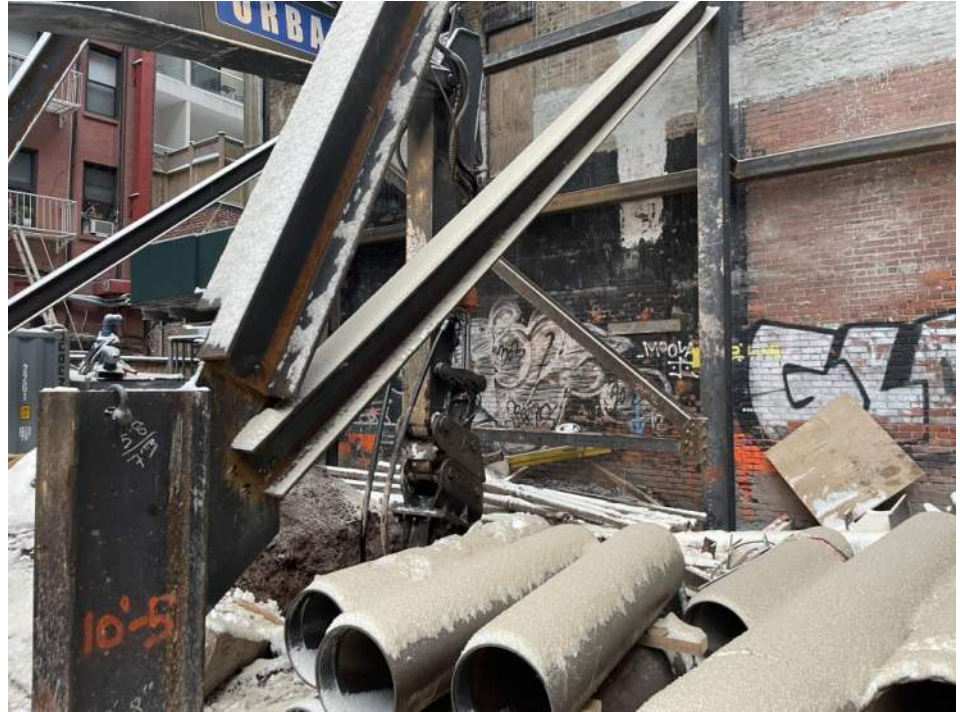
- Urban used an excavator with a jackhammer attachment to remove concrete from historical foundational elements in the southern part of the site to prepare for subsurface activities.

**Photo 1:** Urban removing concrete in the southern part of the site (facing southwest).

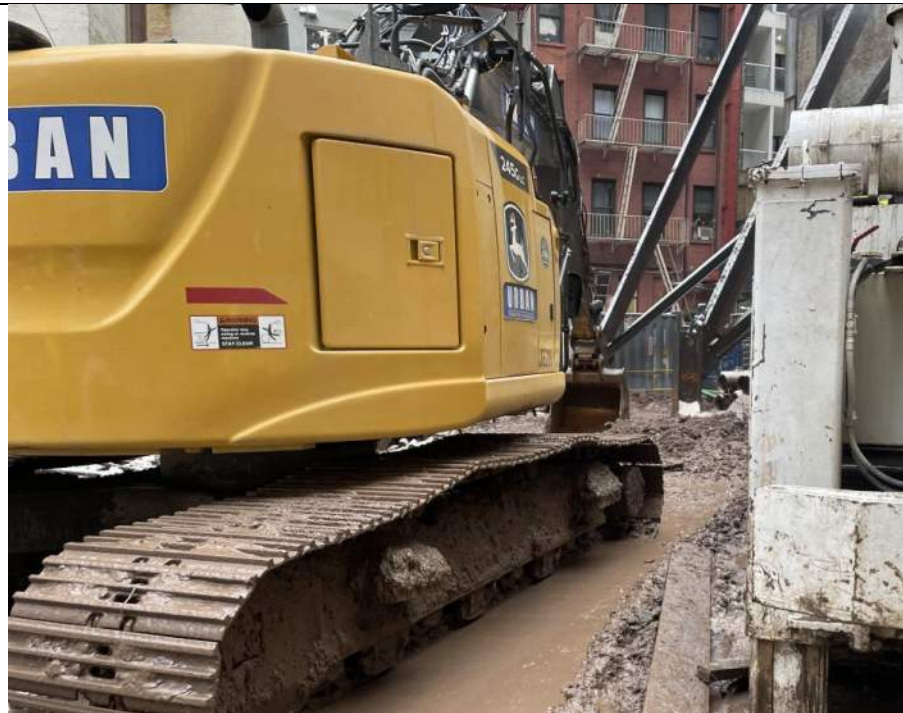
- Urban graded an about 20-foot-long by 8-foot-wide area in the central part of grid WC05 to prepare for equipment mobilization.
- Excavated and graded soil/fill consisted of non-native soil; odors, staining, elevated photoionization detector (PID) readings, or other evidence of a petroleum or chemical release were not observed.

**Photo 2:** Urban grading soil/fill in WC05 (facing southwest).
