Daily Progress Report #8
Remedial Investigation Activities
March 28, 2025

245 West 55th Street
Block 1027, Lot 7
New York, New York
Brownfield Cleanup Program Site #:C231157

Attachment - Photograph Log – March 28, 2025

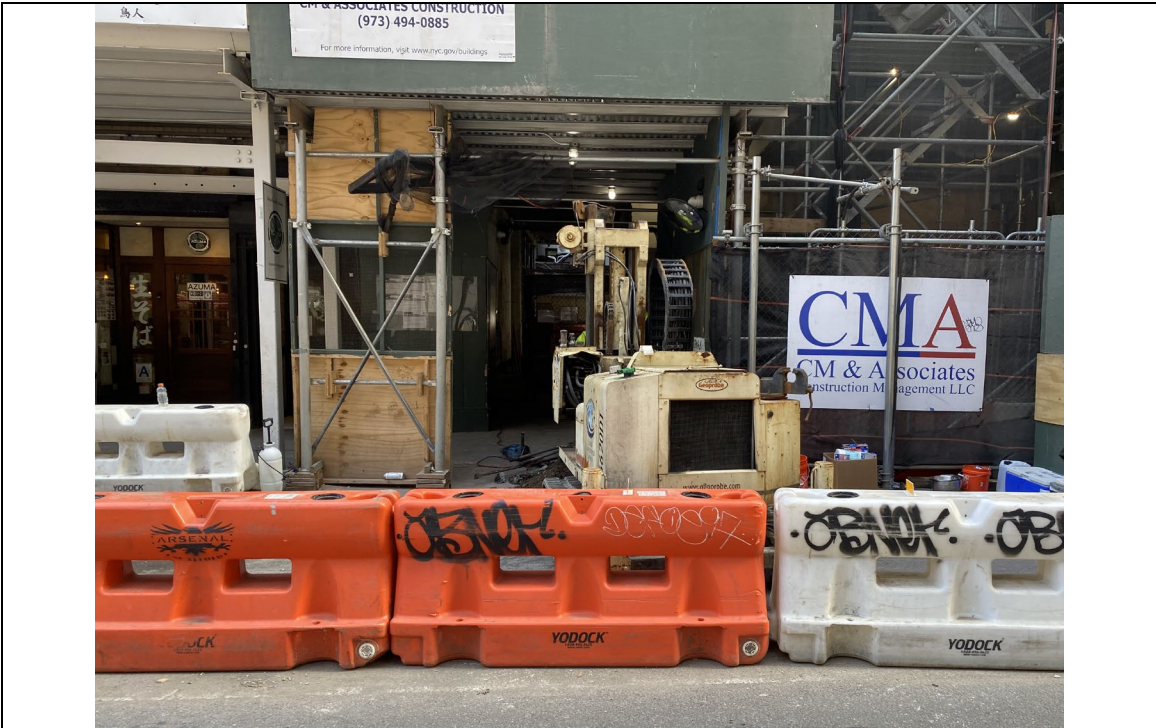
Photo 1: Drilling at SB-8/MW-8 location on the sidewalk off the southwestern corner of the building.

On March 28, 2025, EL mobilized to the Site with a licensed driller to install SB-8/MW-8 (see attached Photolog). Based on the available site plans, this location was assumed to be beyond the area where the basement extends beneath the sidewalk and was the only feasible drilling location due to the positioning of scaffolding and barricades associated with the building's demolition and renovation. SB-8/MW-8 was installed in an off-site location in the sidewalk adjacent to the southwestern corner of the Site building. Samples from the newly installed monitoring well will be collected in approximately 2 weeks following the well installation. NYSDEC will be apprised of the sampling date.

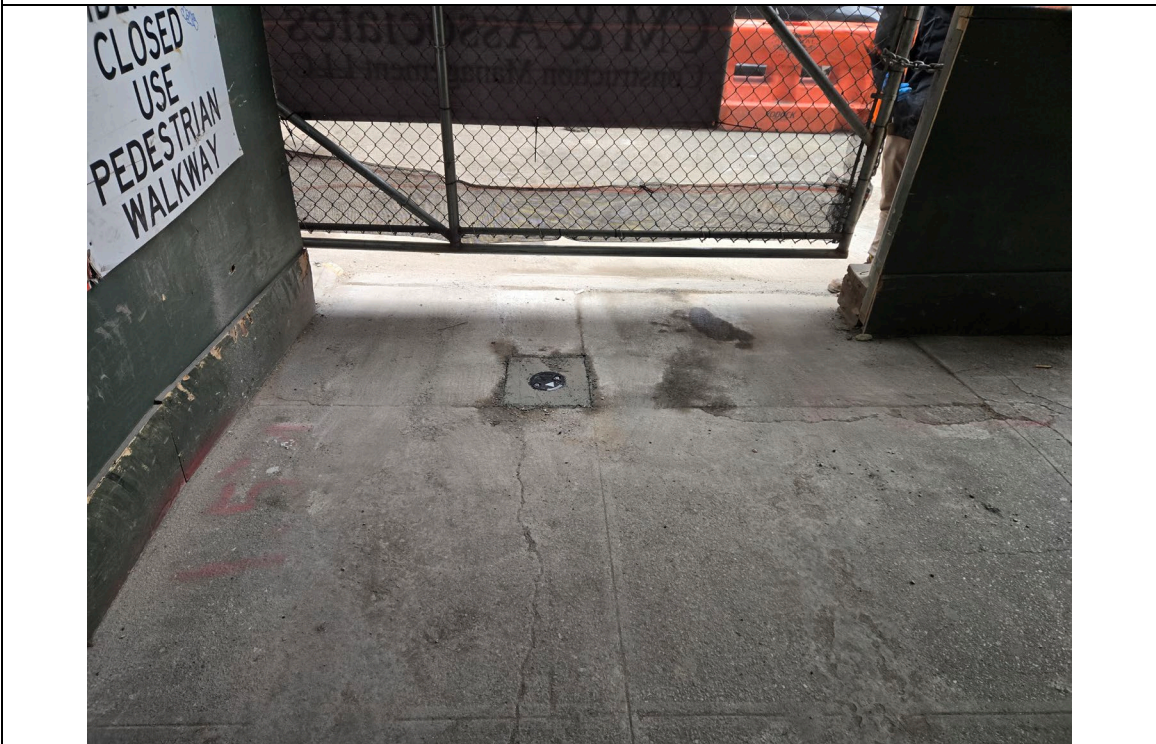
Photo 2: Completed monitoring well MW-8.
