Reference: #C241005 - Review Avenue Development II Site (RAD II)  
Long Island City, Queens, New York  
Period Review Report #5 - April 1, 2020 through March 31, 2021

Site Inspection Form – RAD II – Annual

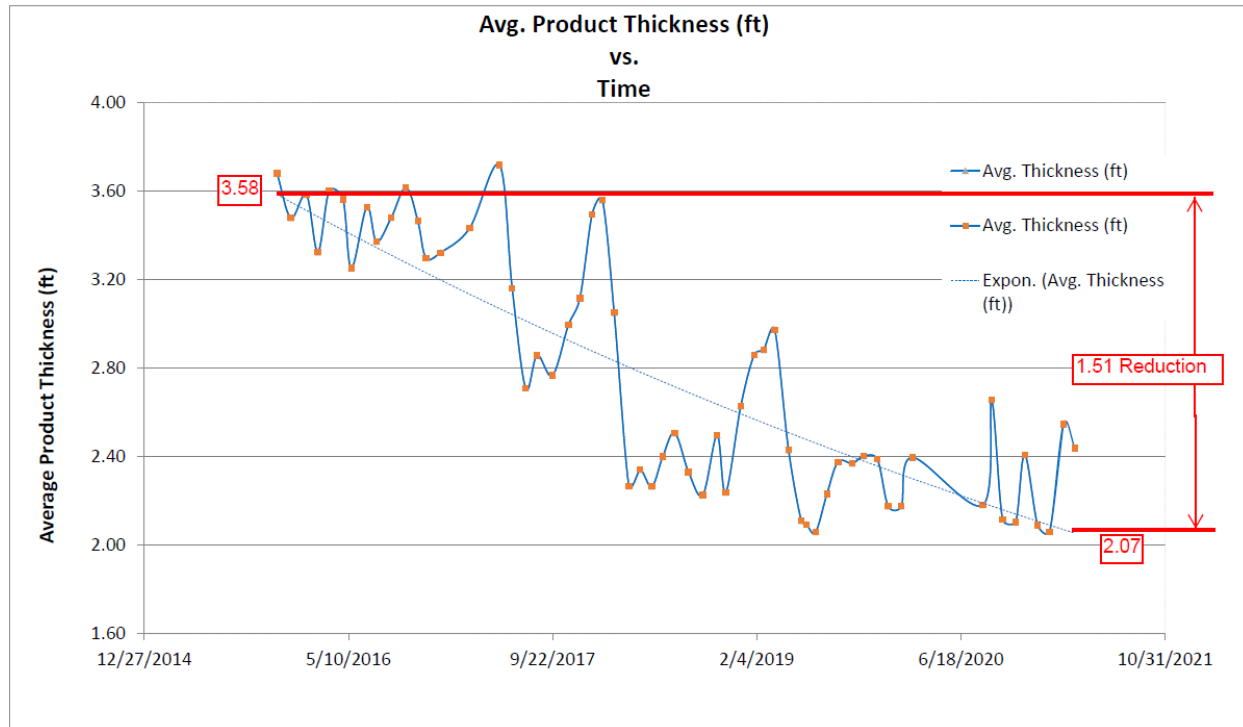
Site wide LNAPL gauging events at thirty-three (33) LNAPL monitoring wells on RAD I and RAD II provide evidence that average LNAPL thickness is trending downwards across the site and has decreased by approximately 1.51 feet (on average) at the end of March 2021 as illustrated in the figure below (note that the March through June 2020 gauging events were canceled due to COVID 19 safety concerns). This average thickness decrease is significantly greater than the 0.17 feet average decrease presented approximately four (4) years earlier at the end of March 2017, 0.68 feet average decrease presented three (3) years earlier at the end of March 2018, 1.44 feet average decrease presented two (2) years earlier at the end of March 2019. Although the average decrease at the end of March 2021 does not show a reduction as compared to 1 year earlier, a recent sudden drop in groundwater elevations may have contributed to a temporary increase in apparent product thickness during February, 2021. We believe that this apparent product thickness increase will reverse as it has already begun to do so based on the March 2021 gauging data. We also believe that the overall downward product thickness trend will continue during the 6th reporting period.

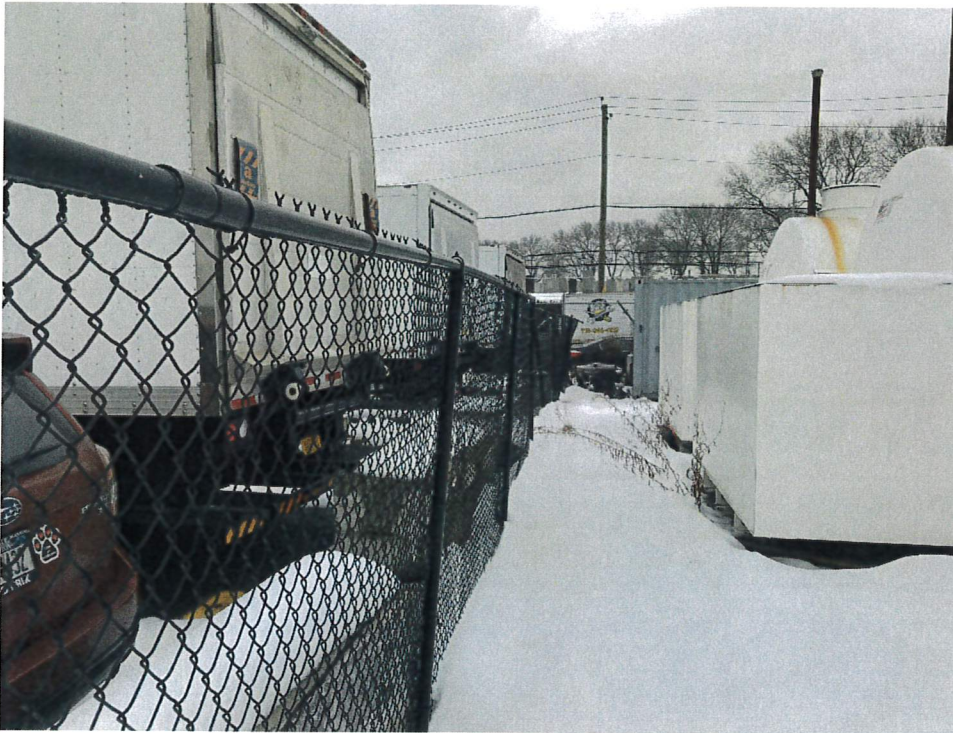
Photo 1. West side of treatment Compound

a.	Monitoring Wells (Check if secured, inspect condition of well, well cap, etc.)	X			In good condition.
b.	Security (Check fence, gates, locks, etc.)	X			Ok, however, fence between RAD II and phoenix in the back needs repair Fence on west side of treatment compound must be repaired or replaced.

Fence between RAD II and phoenix in the back needs repair. Fence along west side of treatment compound needs to be repaired or replaced. Recommend crack sealing in some areas of the site where cracks have started to appear.

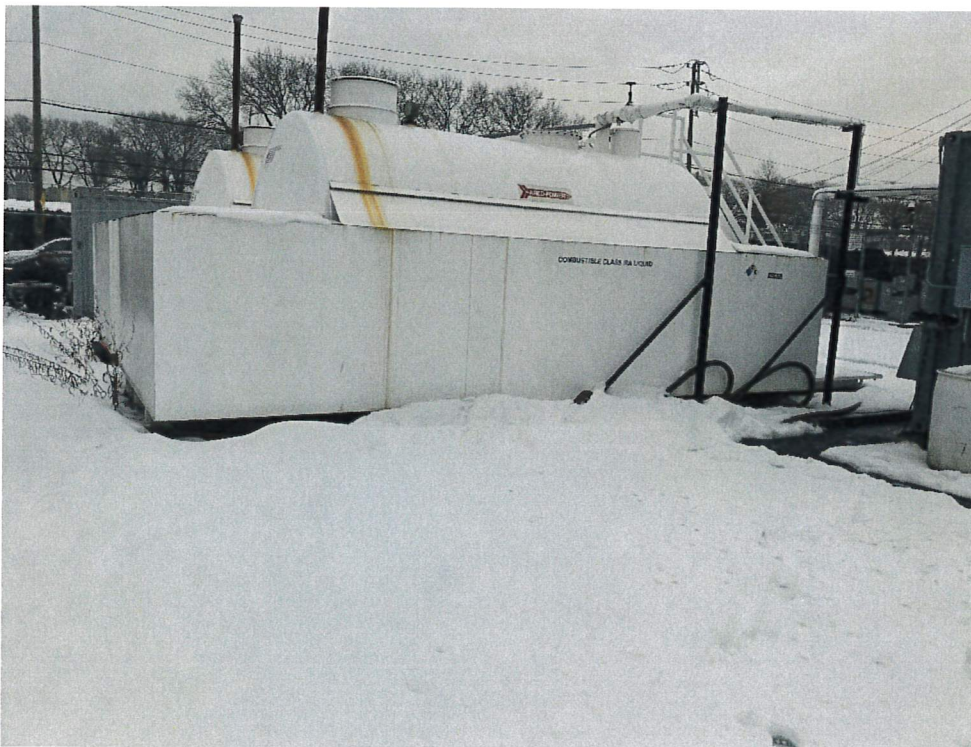
Photo 2. Waste Oil Storage Tanks

a.	Recovery Well Vaults and Pumps (Check for leaks, operation, vault security, etc.)	X			Check list and photo's on file
b.	LNAPL Storage Tanks (Check capacity, inspect for leaks, corrosion, etc.)	X			In serviceable condition. Signs of corrosion on exterior containment.

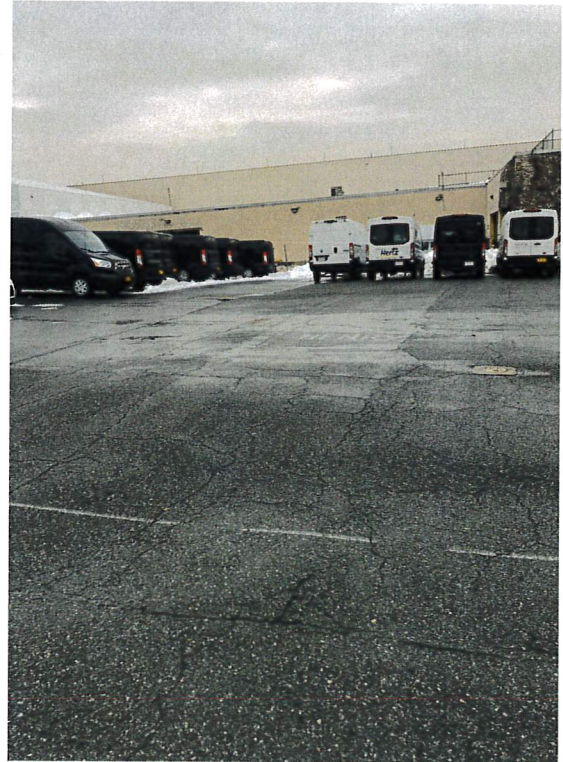
Photo 5. Pavement Cracking RAD II

- **Cap/Pavement system on RAD II** – Per the December 21, 2020 inspection, signs of pavement wear have been identified including cracks which have formed in the cap main area. The cracks do not completely penetrate the pavement profile but should be sealed.
