Reference: #C241089- Review Avenue Development I Site (RAD I)  
Long Island City, Queens, New York  
Period Review Report #5 -April 1, 2020 through March 31, 2021

Enclosure 2  
NEW YORK STATE DEPARTMENT OF ENVIRONMENTAL CONSERVATION  
Site Management Periodic Review Report Notice  
Institutional and Engineering Controls Certification Form

**Site Name** Review Avenue Development I

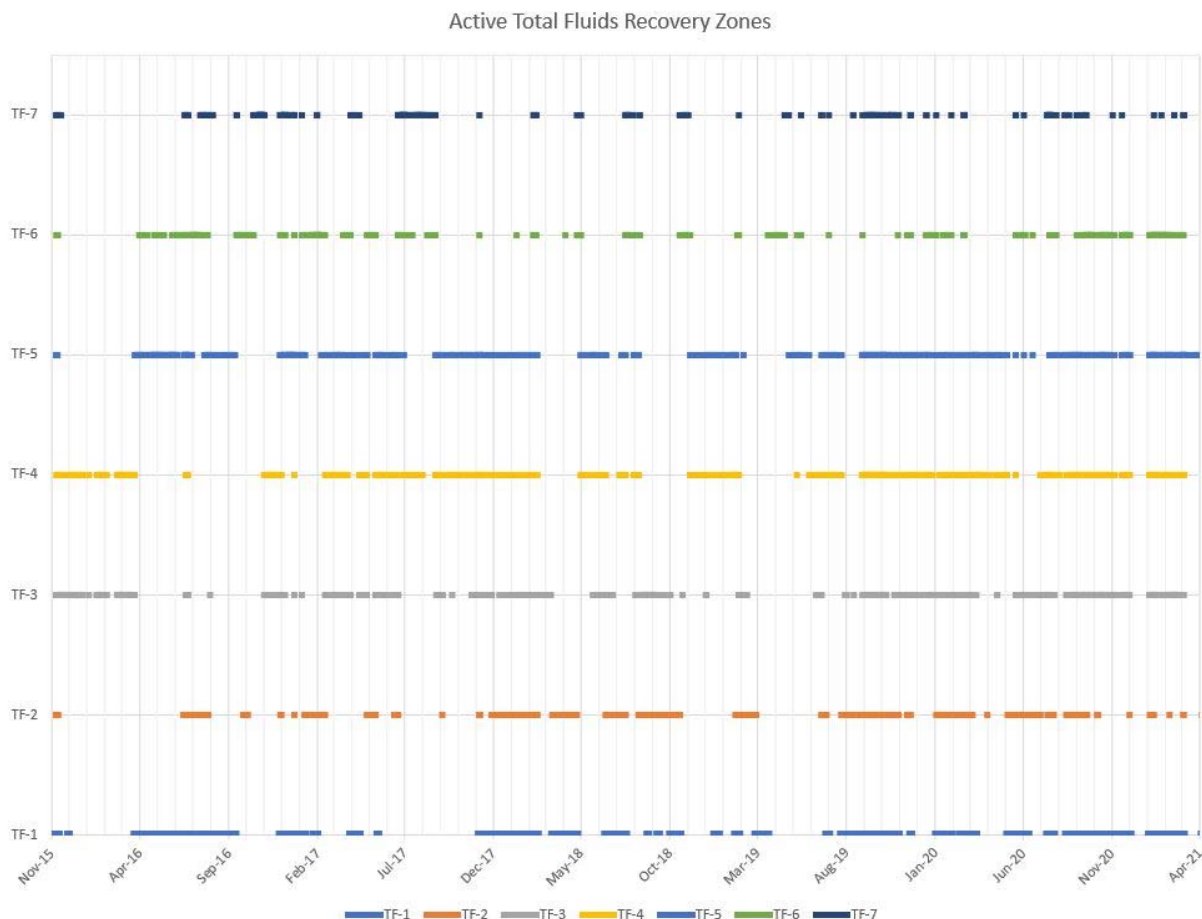
the reporting period. Actual system uptime averaged 86.2% for the year ranged from a low of 55.8% to a high of 96.8%. System uptime has increased significantly from the 68.02% average realized during the first 16-1/2 months of operation. This uptime improvement is largely a result of upgrading the Oil/Water separation system with the addition of a Tube Skimmer and changing the type of Biocide injected which does not impact the performance of the Sequestering Agent. The following table provides a graphic summary of extraction zone operations during the reporting

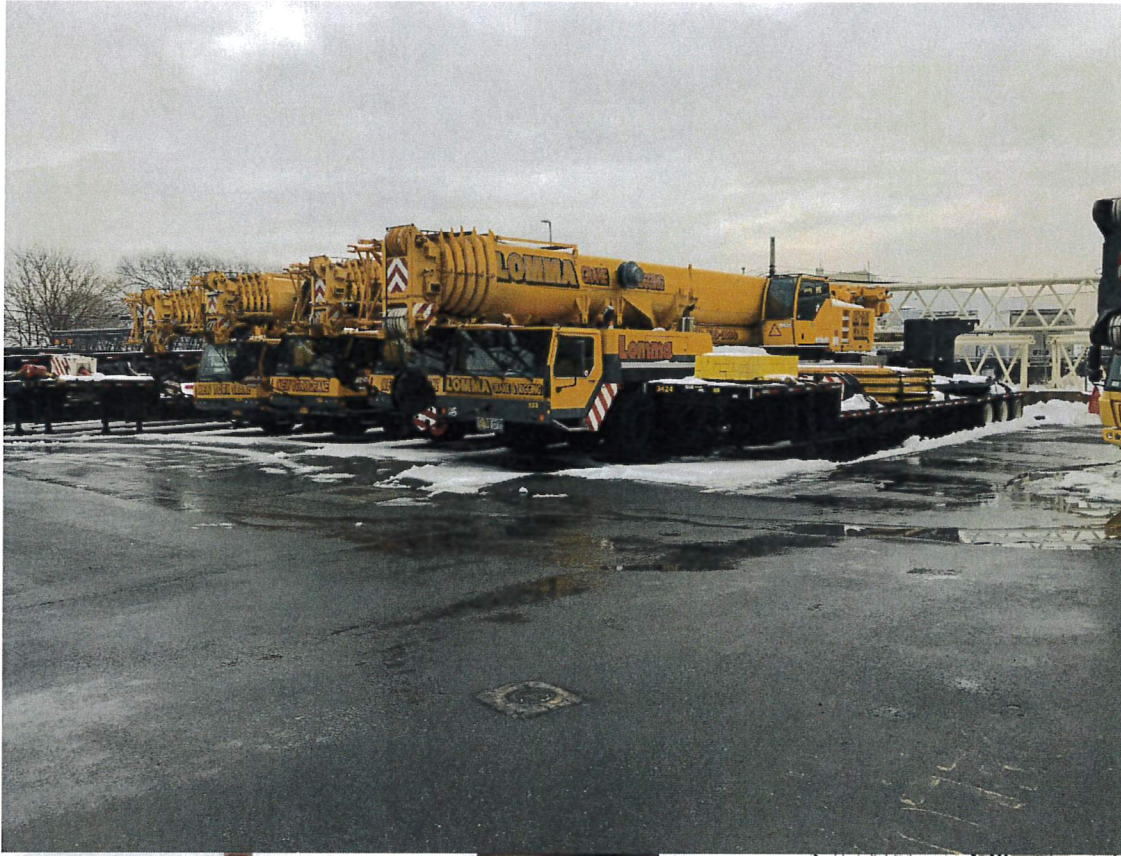
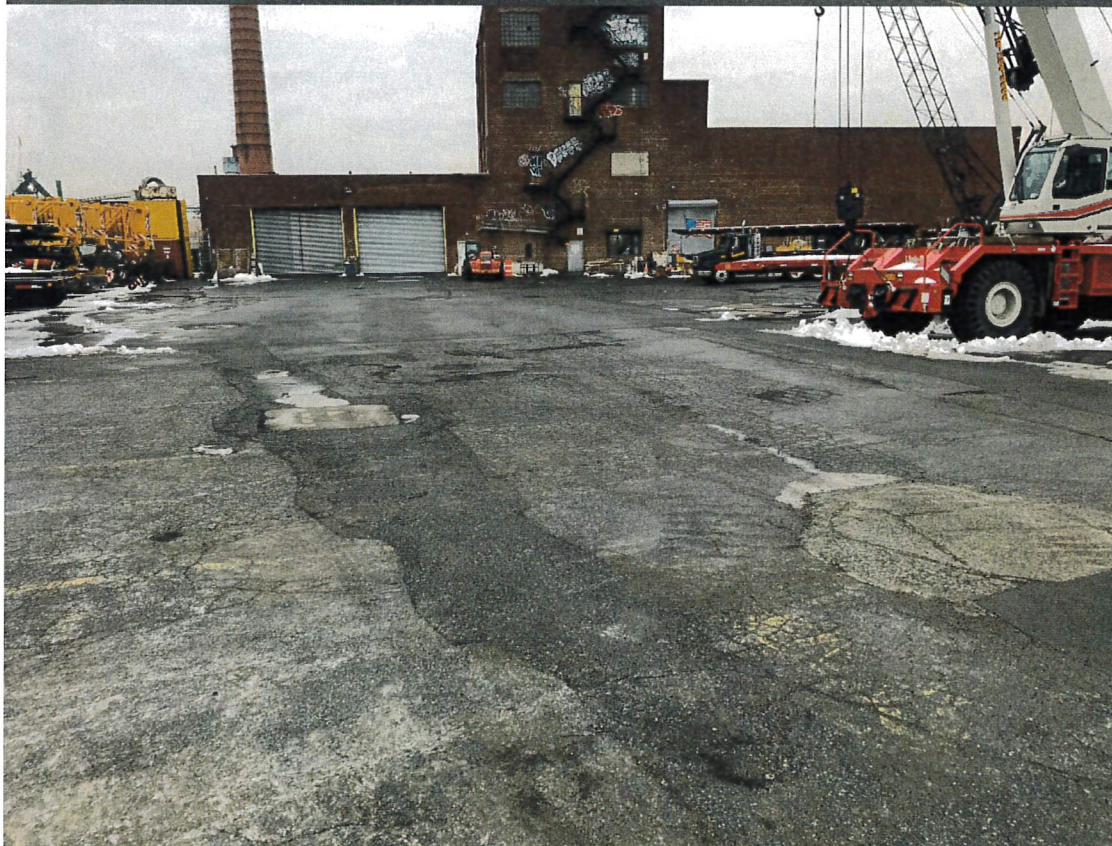
Site Inspection Form – RAD I

| VI. Institutional Controls | | | | |
|---|---|---|---|---|
| Signs of wear on pavement, cracks have formed in the cap main area. Do not go completely thru but should be sealed. | | | | |

Cap Repairs referenced in previous inspections were completed. Triangular area repairs were completed, however ongoing and continued maintenance is necessary. Evidence of grass growing thru pavement and compacted soils in some areas. No evidence of material exposure. Repairs to cap in the middle of the site have been completed and coverage is in better shape than in the past. Requires inspections and maintenance to ensure it stays protective.

A new tenant stores petroleum products on top of the protective covers. Adequate spill containment and maintenance/housekeeping should be performed to ensure no accidental spills could occur that could damage the cap.
