Periodic Review Report

Review Period July 2024 – July 2025

OCA LIC Fifth Street Mixed-Use Housing Site 5-20 46th Road,
Long Island City, Queens, New York 11101

NYSDEC BCP # C241098

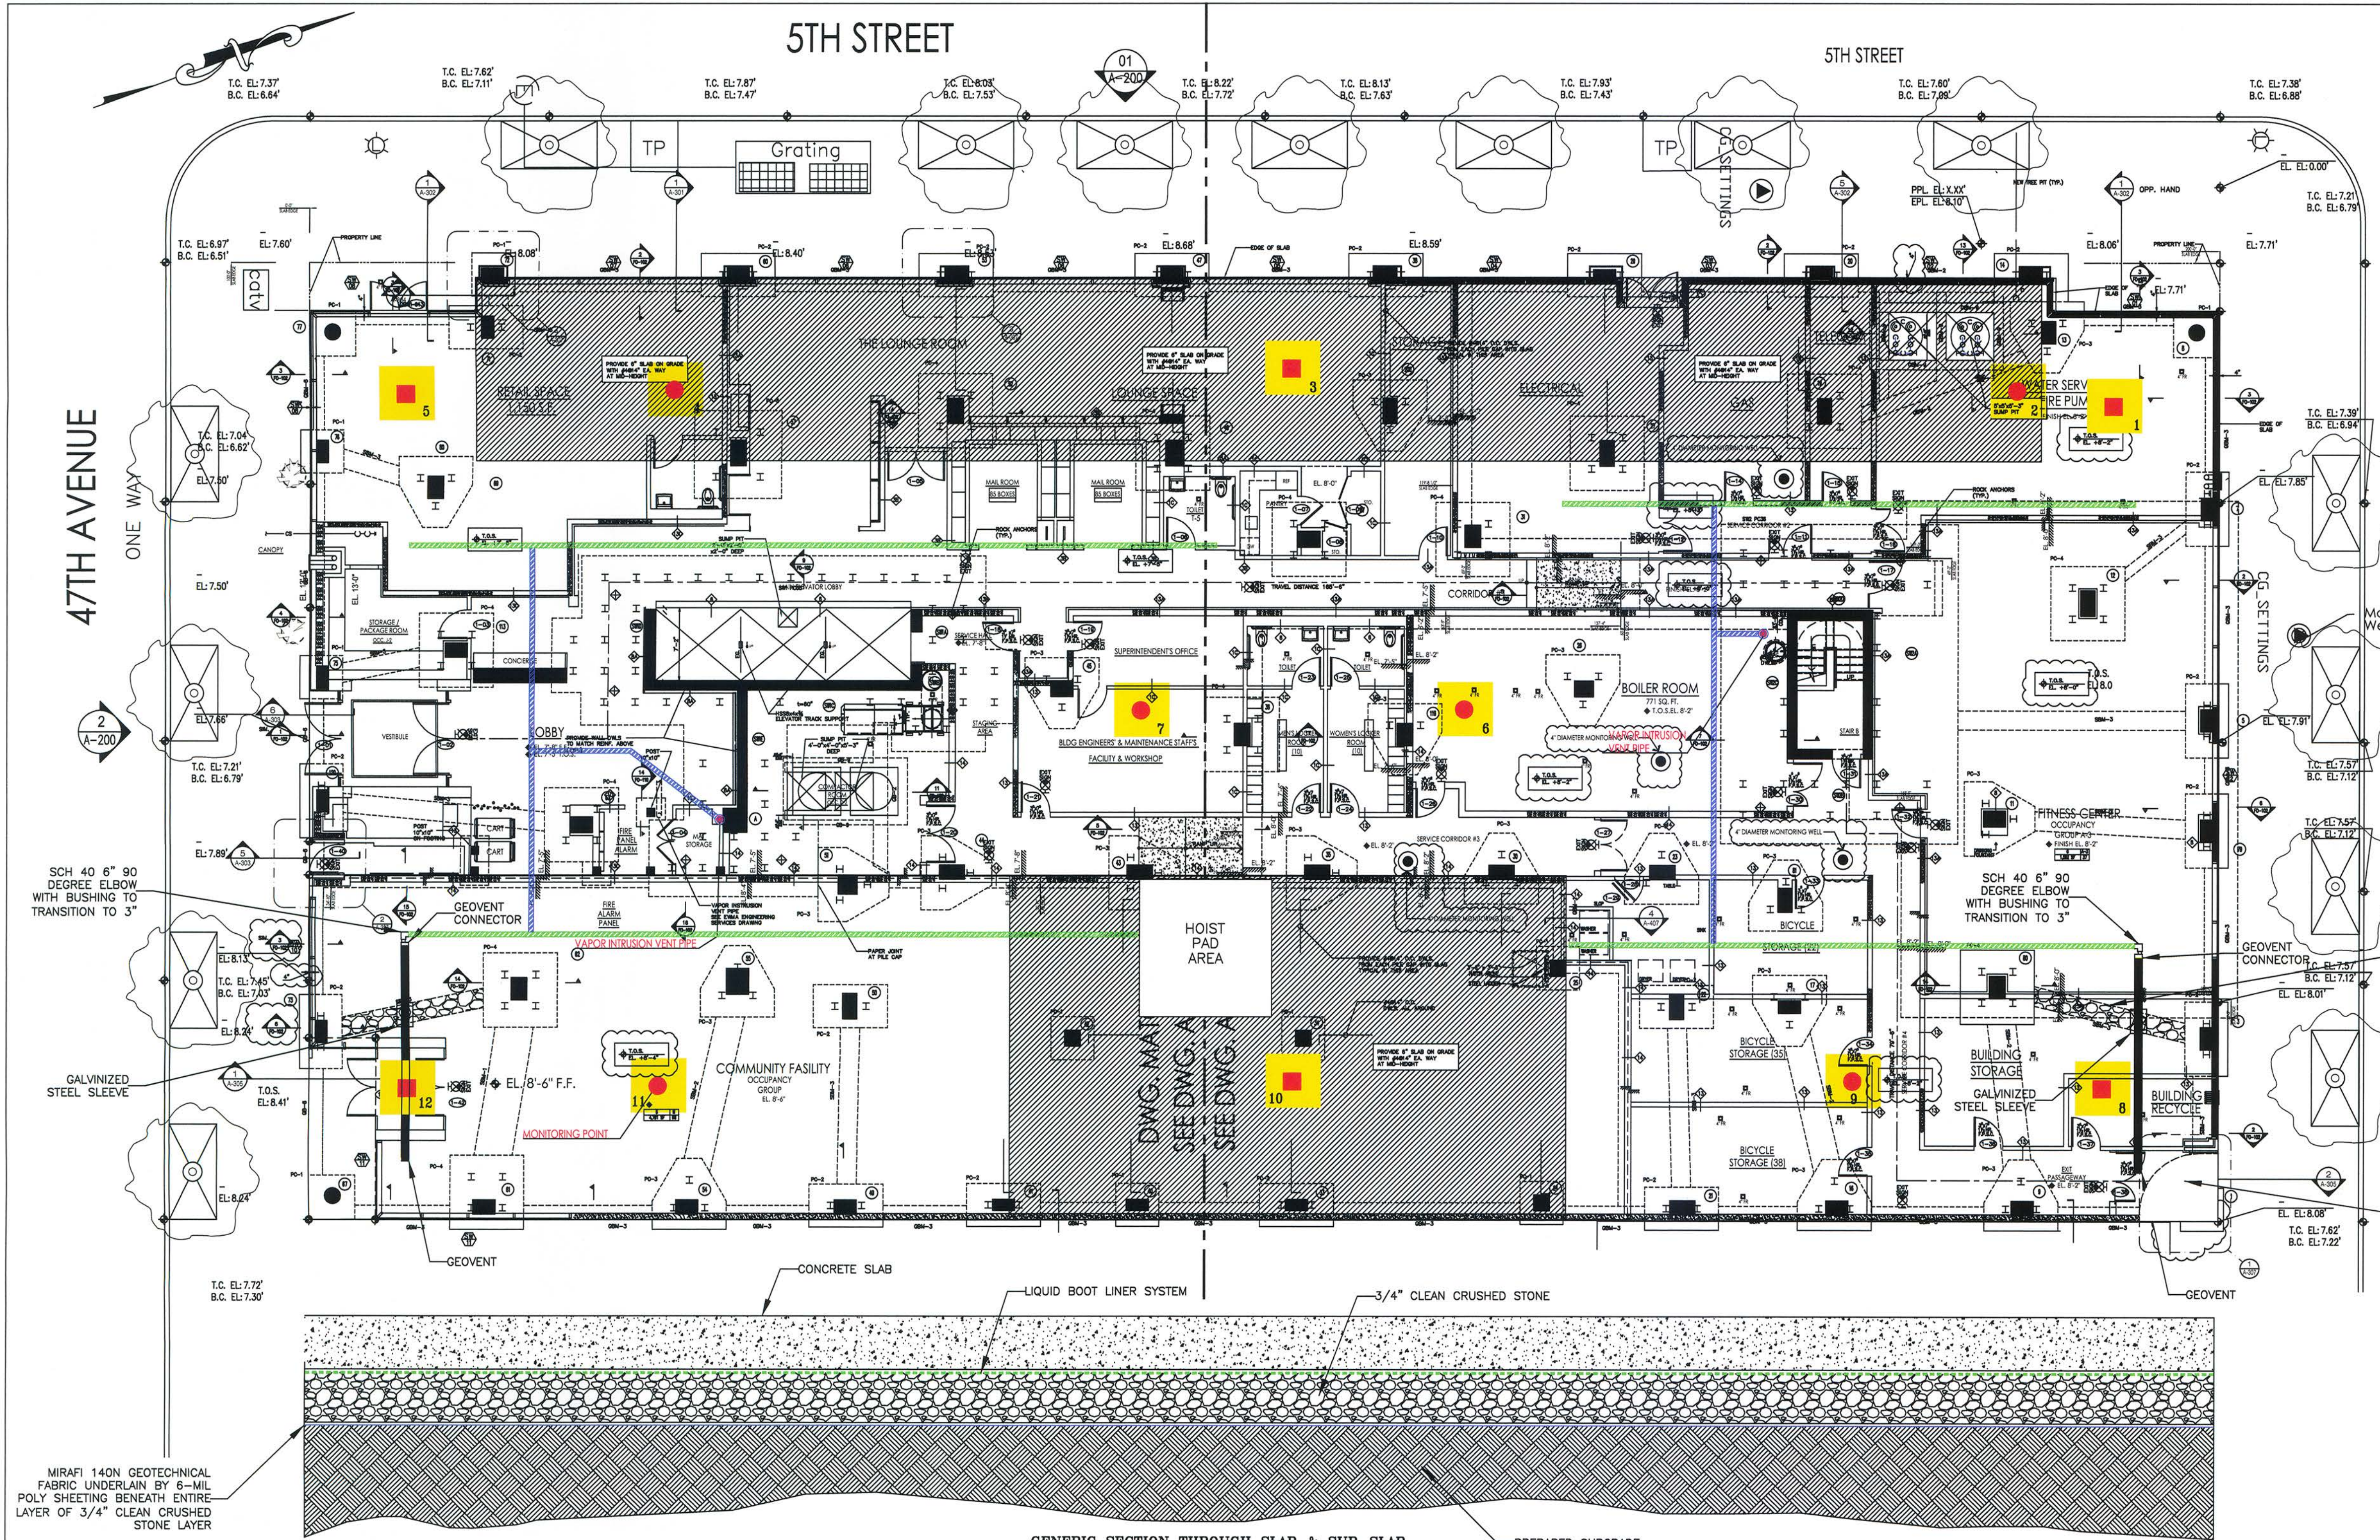
<div>Environmental Consulting & Remediation 100 Misty Lane P.O. Box 5430 Parsippany, NJ 07054</div>	SCALE: AS SHOWN	PROJECT# 209014
	DATE: 5/15/25	
	DRAWN BY: RR/JS CHECKED BY: JS	
	LOWER SAND UNIT WELL LOCATION MAP AS OF JULY 2025 5-20 47TH AVENUE LONG ISLAND CITY, NEW YORK	
		FIGURE# 2

Refer to **Figures 1 and 2** for the remaining perimeter monitoring well locations as of the date of this PRR.

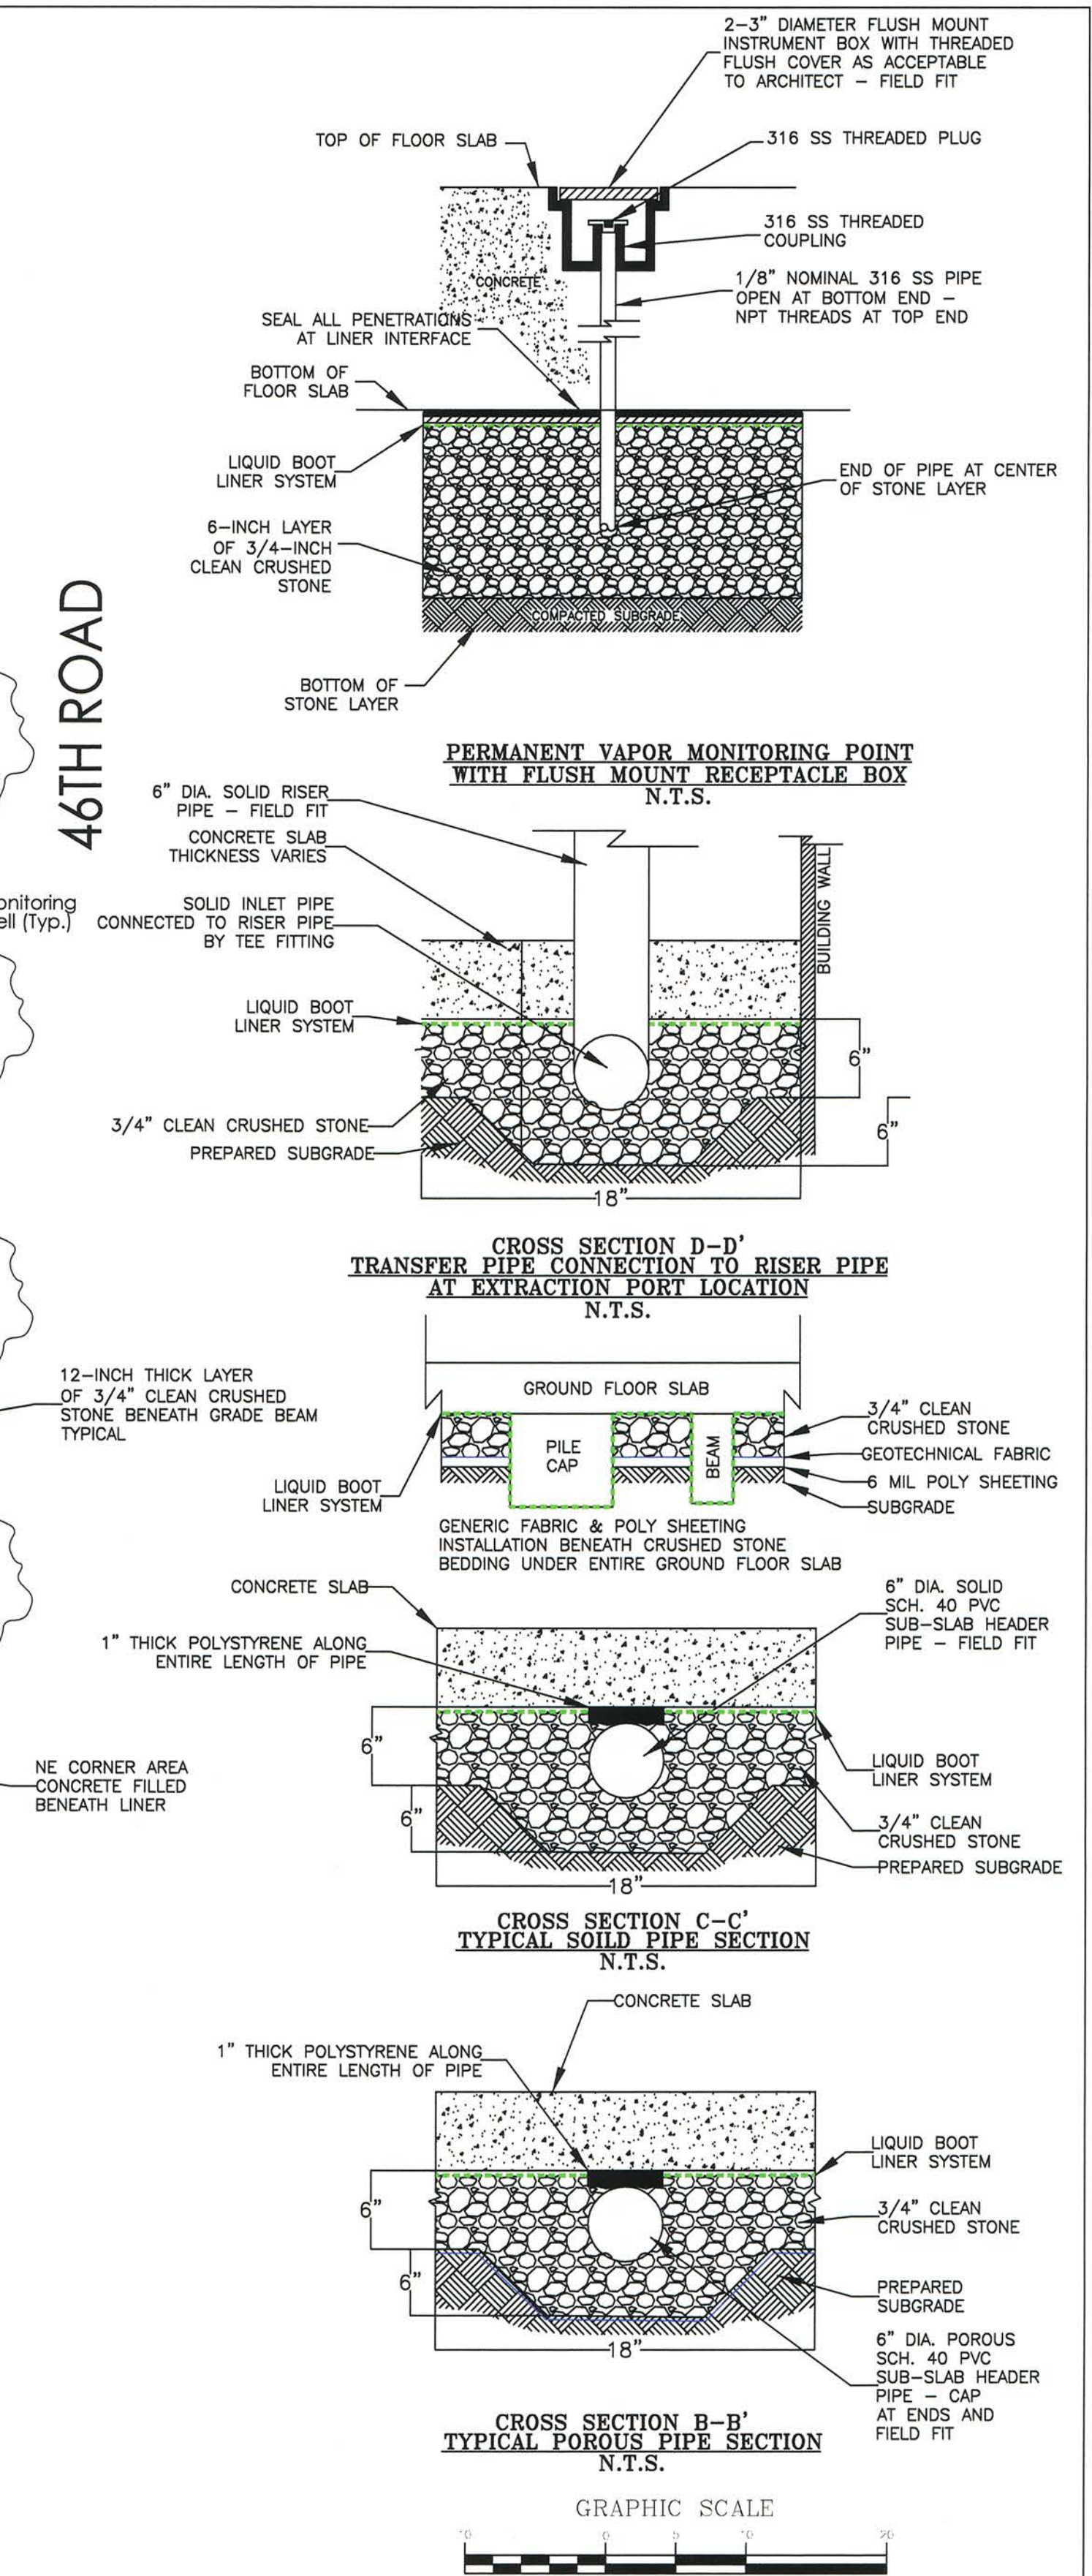
SUMMARY OF AS-BUILT VAPOR INTRUSION CONTROL (VIC) INSTALLATION

GENERIC SECTION THROUGH SLAB & SUB-SLAB
STRUCTURAL AND PIPE CROSSINGS NOT SHOWN
N.T.S.

2. LIQUID BOOT LINER - A CONTINUOUS 40-MIL LIQUID BOOT LINER WAS INSTALLED DIRECTLY BENEATH THE GROUND FLOOR SLAB AND FOUNDATION ELEMENTS, AND BONDED TO THE CONCRETE SLAB AND FOUNDATION SURFACES.

1. DURING TESTING AND MEASUREMENT, THE VIC DESIGN PERFORMANCE STANDARDS WERE CONFIRMED. FLOW RATES THROUGH THE EXTRACTION PIPING WERE FOUND TO BE GREATER THAN 20 FEET PER MINUTE, AND VACUUM LEVELS WITHIN THE EXTRACTION PIPING WERE FOUND TO BE GREATER THAN 4-INCHES OF WATER. SUB-SLAB VACUUM LEVELS WERE FOUND TO BE GREATER THAN THE NYDOH STANDARD OF 4 PASCALS.
