# Periodic Review Report

Former Paragon Paint and Varnish Site  
5-43 to 5-49 46th Avenue and  
45-38 to 45-40 Vernon Boulevard,  
Long Island City, New York

May 22, 2026

**Roux Environmental Engineering  
and Geology, D.P.C.**  
209 Shafter Street  
Islandia, New York 11749

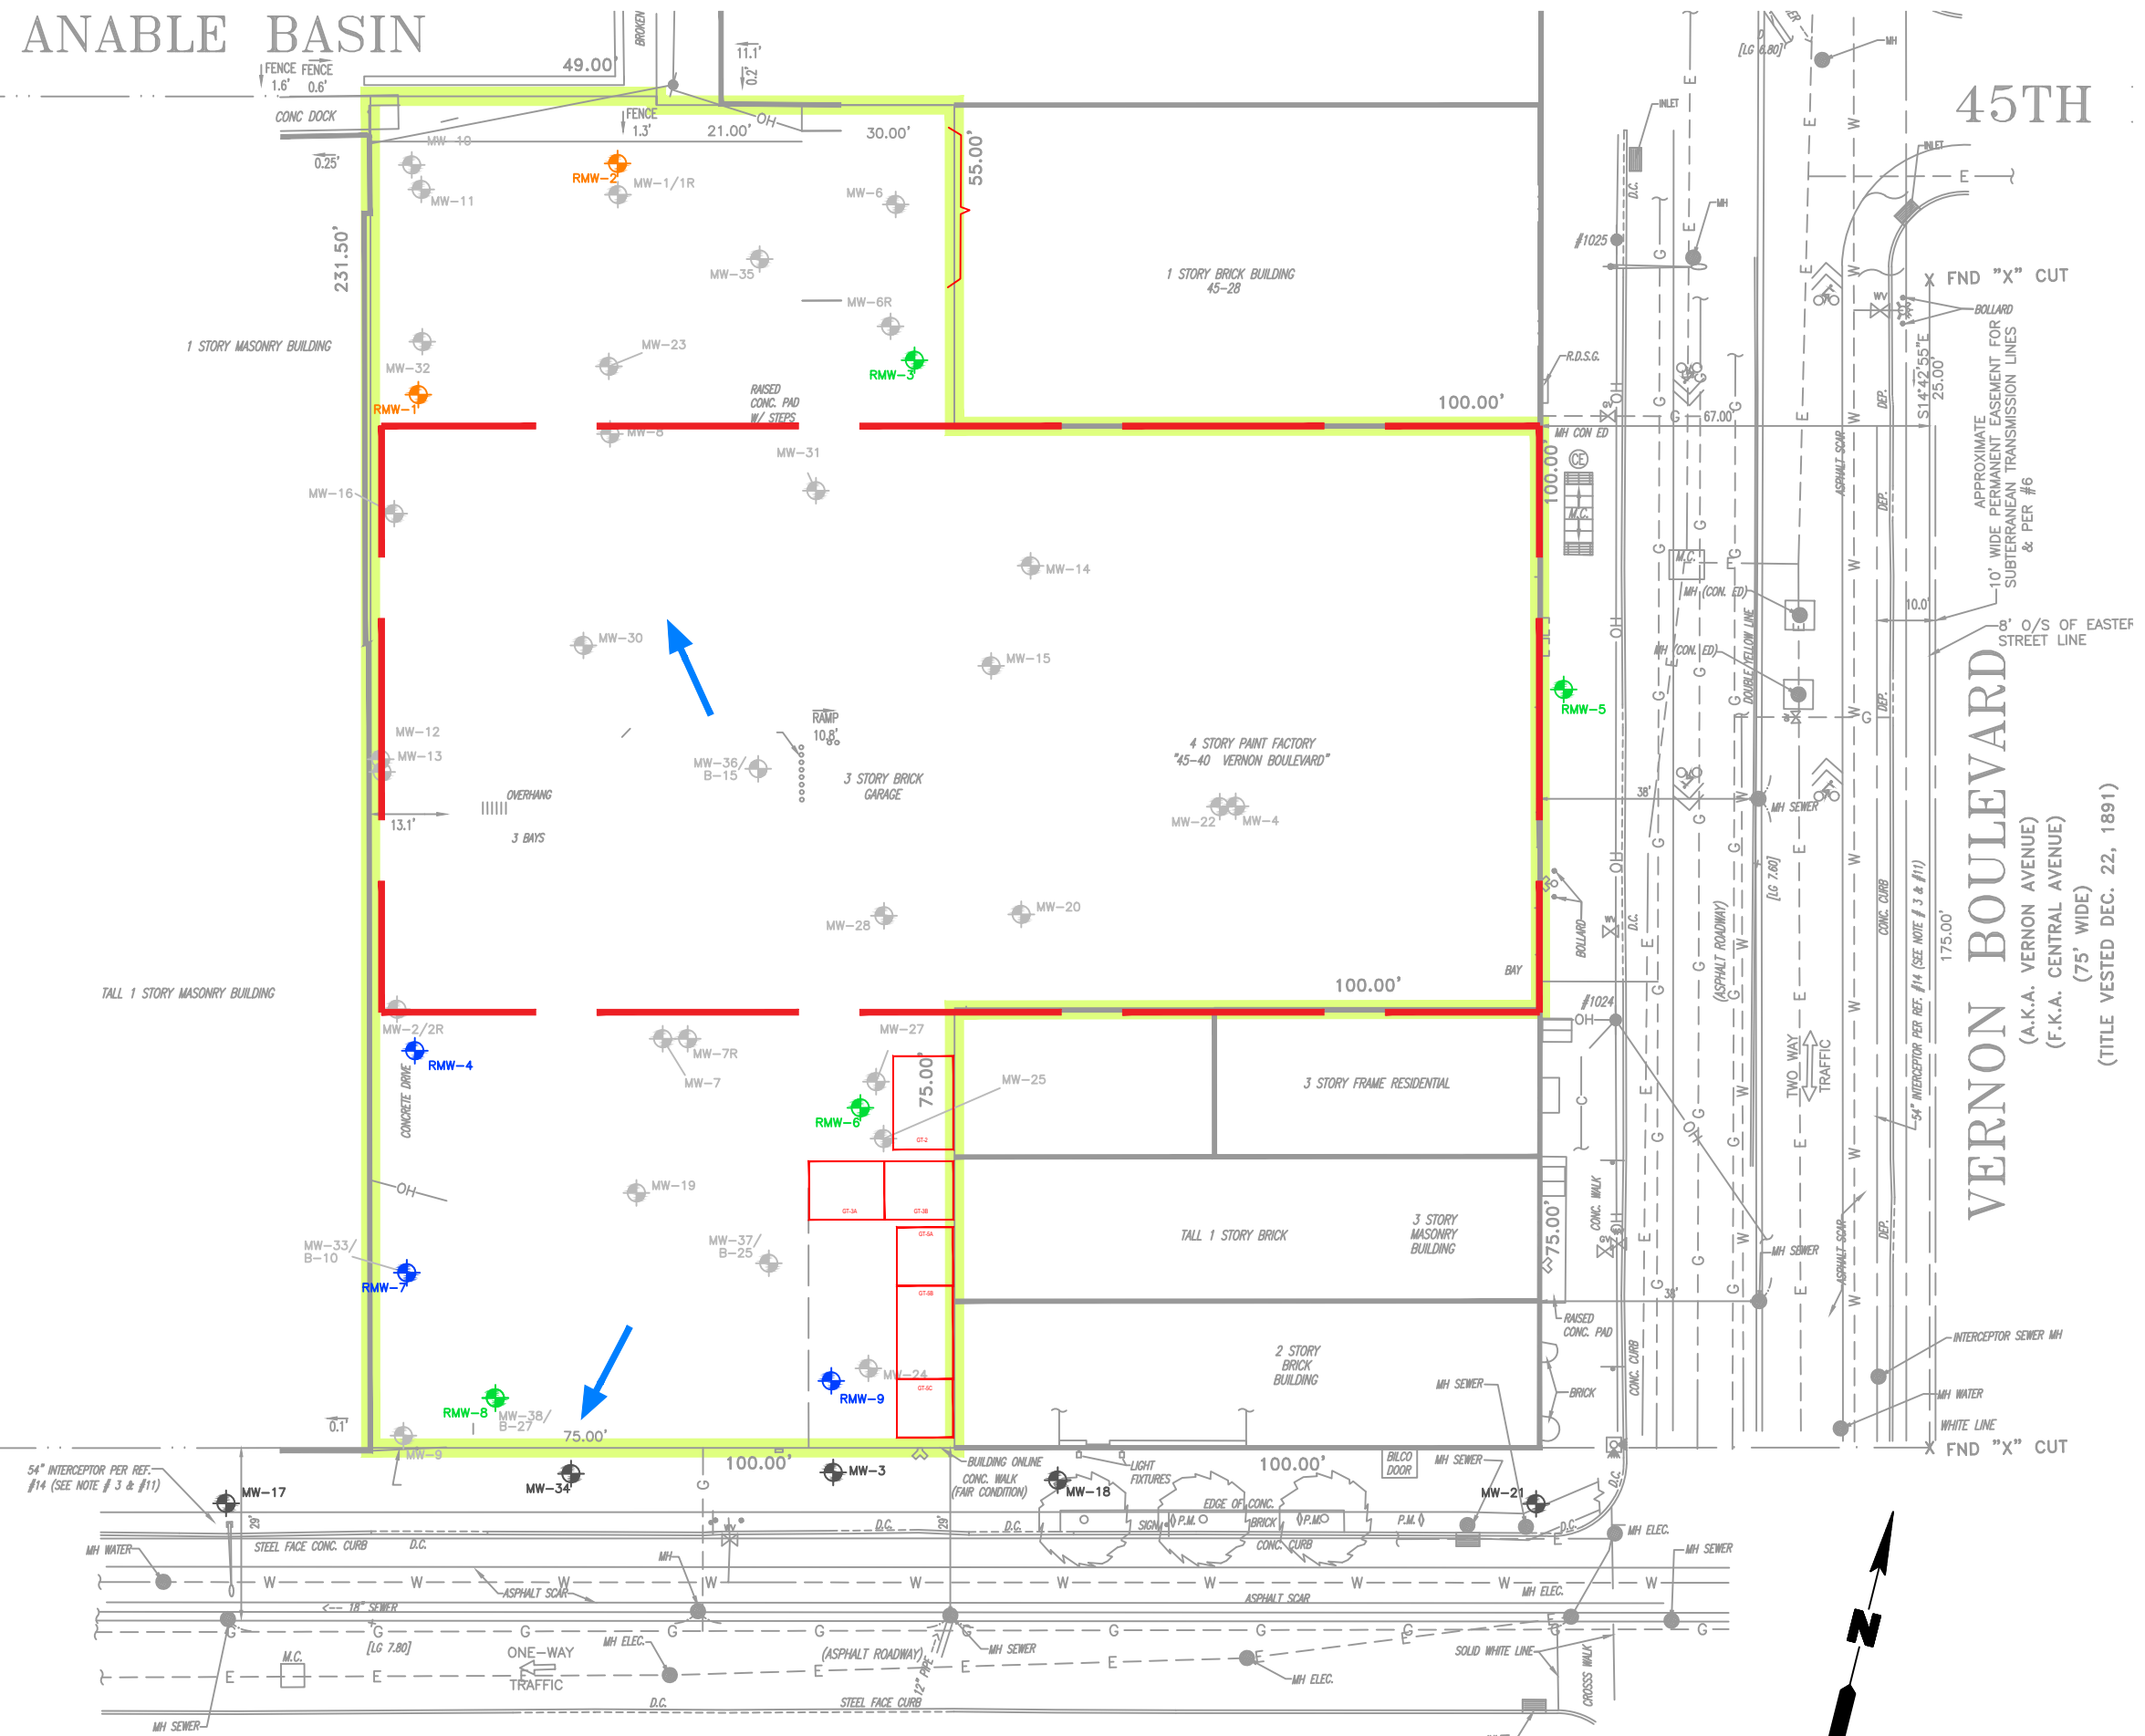
- MW-5 ABANDONED MONITORING WELL LOCATION AND DESIGNATION
- RMW-4 MONITORING WELL INSTALLED IN THE REPORTING PERIOD LOCATION AND DESIGNATION
- RMW-1 MONITORING WELL INSTALLED AND DESTROYED IN THE REPORTING PERIOD LOCATION AND DESIGNATION
- RMW-3 PROPOSED MONITORING WELL LOCATION AND DESIGNATION
- MW-17 EXISTING MONITORING WELL LOCATION AND DESIGNATION
- PROPERTY BOUNDARY
- NEW BUILDING FOUNDATION
- GT-3A ABANDONED IN PLACE UST LOCATION
- GROUNDWATER FLOW DIRECTION

Installation of the remaining approved monitoring wells (RMW-3, RMW-5, RM-6, and RMW-8) was deferred due to ongoing construction activities and site access limitations. NYSDEC was notified of the wells that could not be installed at that time, and approval was received to postpone installation until access becomes available. The remaining wells will be installed in accordance with the SMP and NYSDEC approval when Site conditions allow. The locations of the installed and remaining approved monitoring wells are presented in Figure 4 of this PRR.

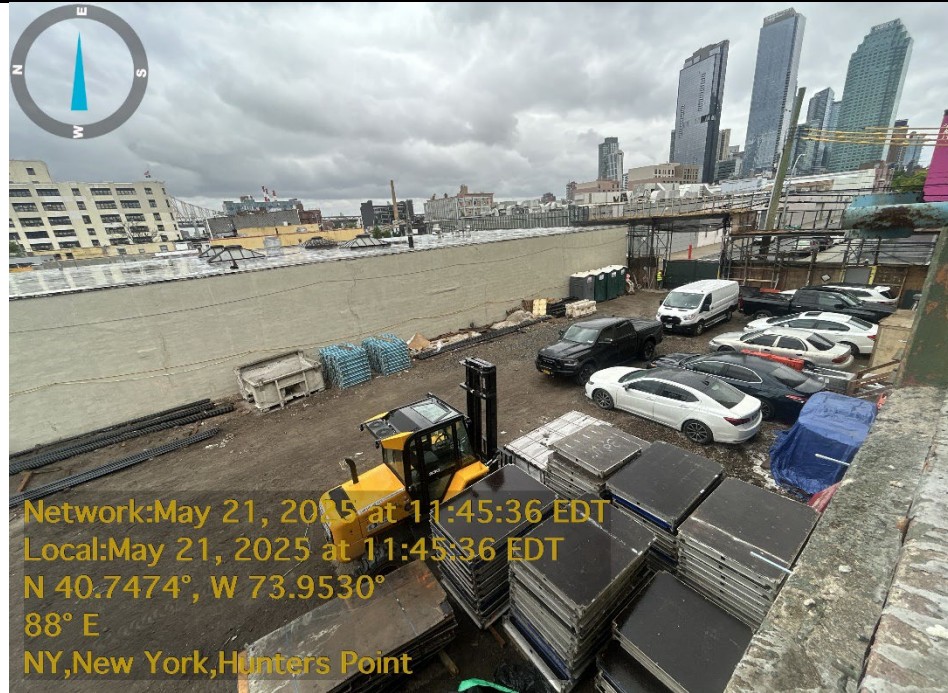
**Photo 1:**  
Facing northeast, view of the general condition in northern region of the Site.

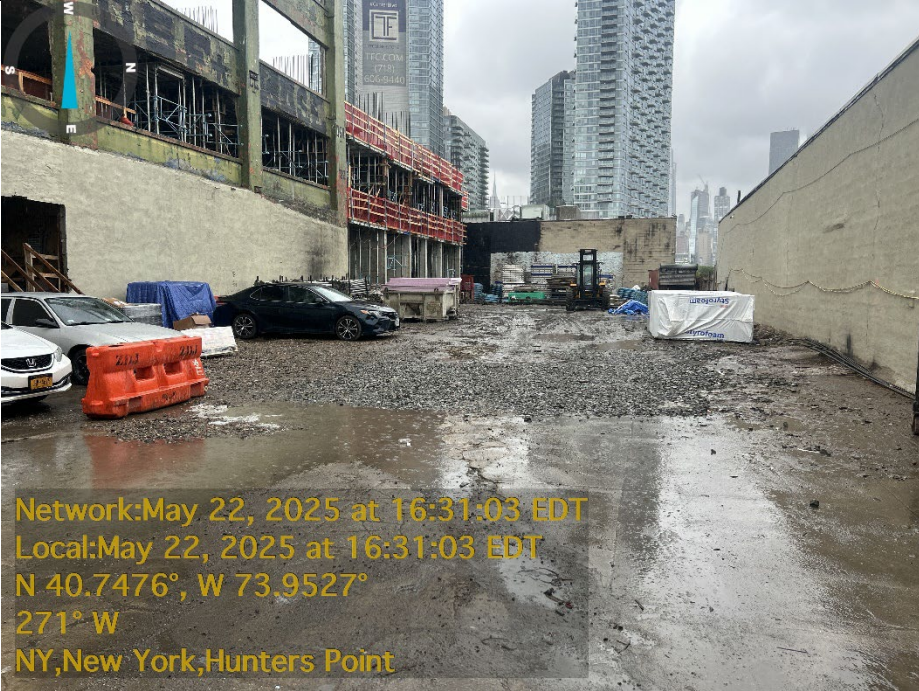
<p>Network: May 22, 2025 at 16:31:03 EDT Local: May 22, 2025 at 16:31:03 EDT N 40.7476°, W 73.9527° 271° W NY, New York, Hunters Point</p>	<p><b>Photo 1:</b> Facing west, view of the general condition in northern region of the Site.</p>

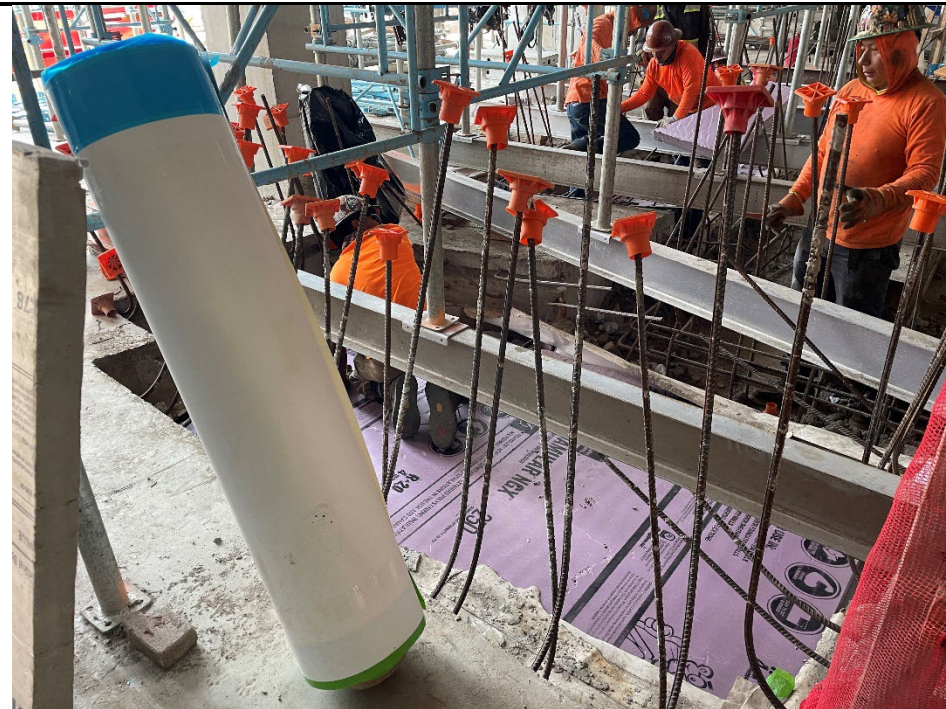
**Photo 1:**  
Facing southwest, view of NY Axon laying Styrofoam within the unpoured foundation slab sections.

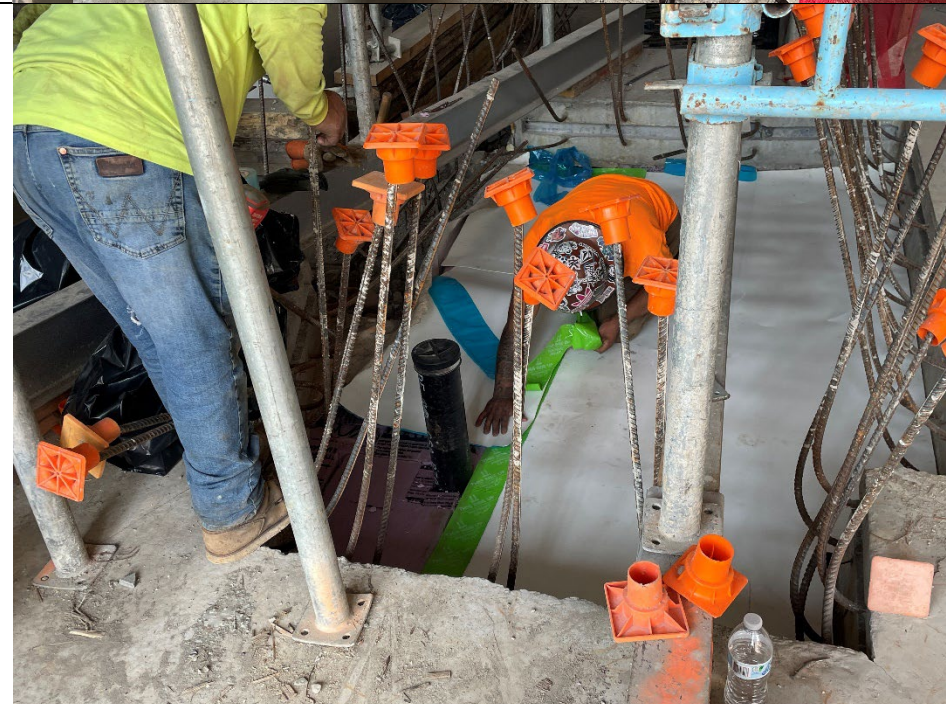
**Photo 2:**  
Facing northwest, view of an exposed pit requiring further vapor barrier installation.
