NYSDEC Division of Environmental Remediation

NEW YORK STATE OF OPPORTUNITY		Department of Environmental Conservation		Contract No. D009808-38 DEC Insp. – NA DEC PM – Wendi Zheng Contractor Supt. – AARCO Env Engineer PM – Patrick Montuori Engineer Insp. – Liam Whalen, Noah Zaffino	
Site Location: 5-49 46th Avenue Long Island City, NY							
Weather Conditions							
General Description	Rain	AM	Sunny	PM			
Temperature	85	AM	90	PM			
Wind	SSW 8 -20 mph	AM	SSW 6-13 mph	PM

DAILY INSPECTION REPORT
Paragon Paint and Varnish Corp. Off-Site No. C241108A

Site Plan and Proposed Well Installation Locations

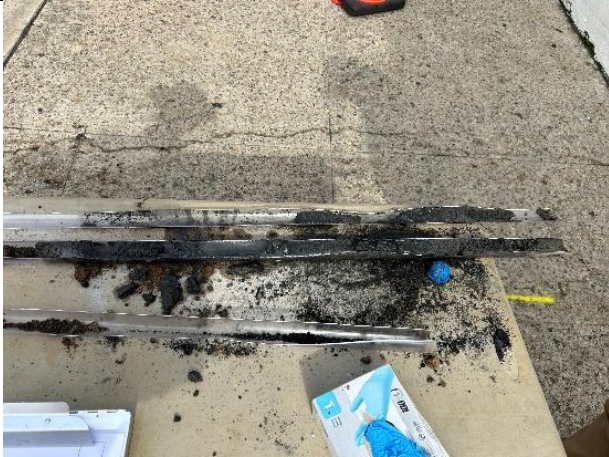
- Install soil borings (Dual tube sampling) at OS-SB-5 (20 ft bg) and OS-SB-6 (20 ft bg)
 - Soils generally consisted of sand and silt with peat layers evident.

- Groundwater was observed at approximately 10-15 ft bg.
 - Staining observed in both borings and elevated PID readings were observed.
 - PID readings in OS-SB-5 was recorded at 382 ppm at the groundwater interface (15-19 ft bg), and in OS-SB-6 was recorded at 498 at the groundwater interface (10-12 ft bg).

Soil profile from SB-5 (10-15 ft bg) with stained soil visible

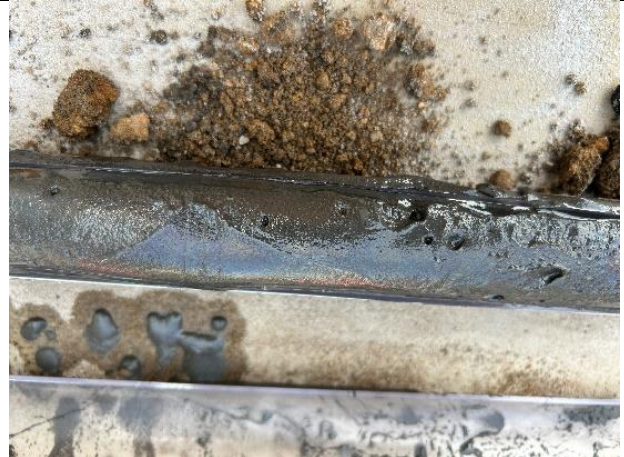
Visible sheen in SB-5 (15-19 ft bg).

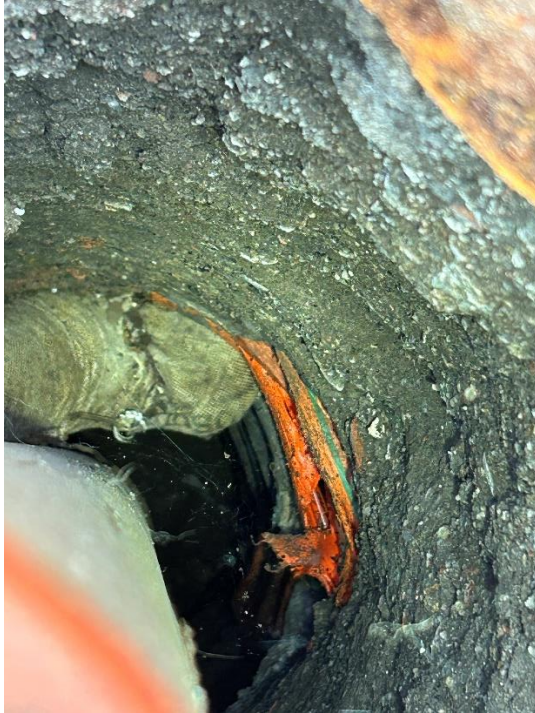
MW-17 with no visible backfill, petroleum sock, and cut wire insulation with no visible wires.

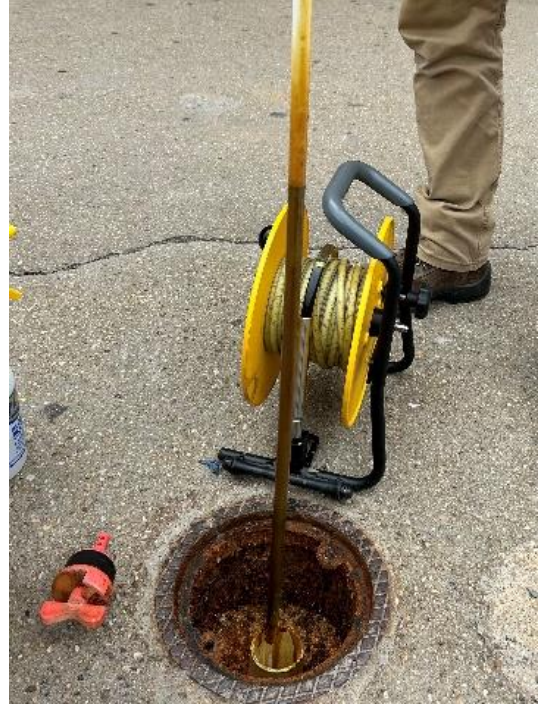
- Monitoring Well Gauging
 - Existing monitoring wells were gauged, and condition noted.
 - 0.28 inches of product was observed (measured with an interface probe at 7.93 ft bg) and a grab sample was collected from MW-37S.

Product observed coating and mixed within bailer from C241175 MW-37S .
